Newhey Quarry, Rochdale

Coal Mining Risk Assessment

JMC/C4315/8856 Rev A

February 2020

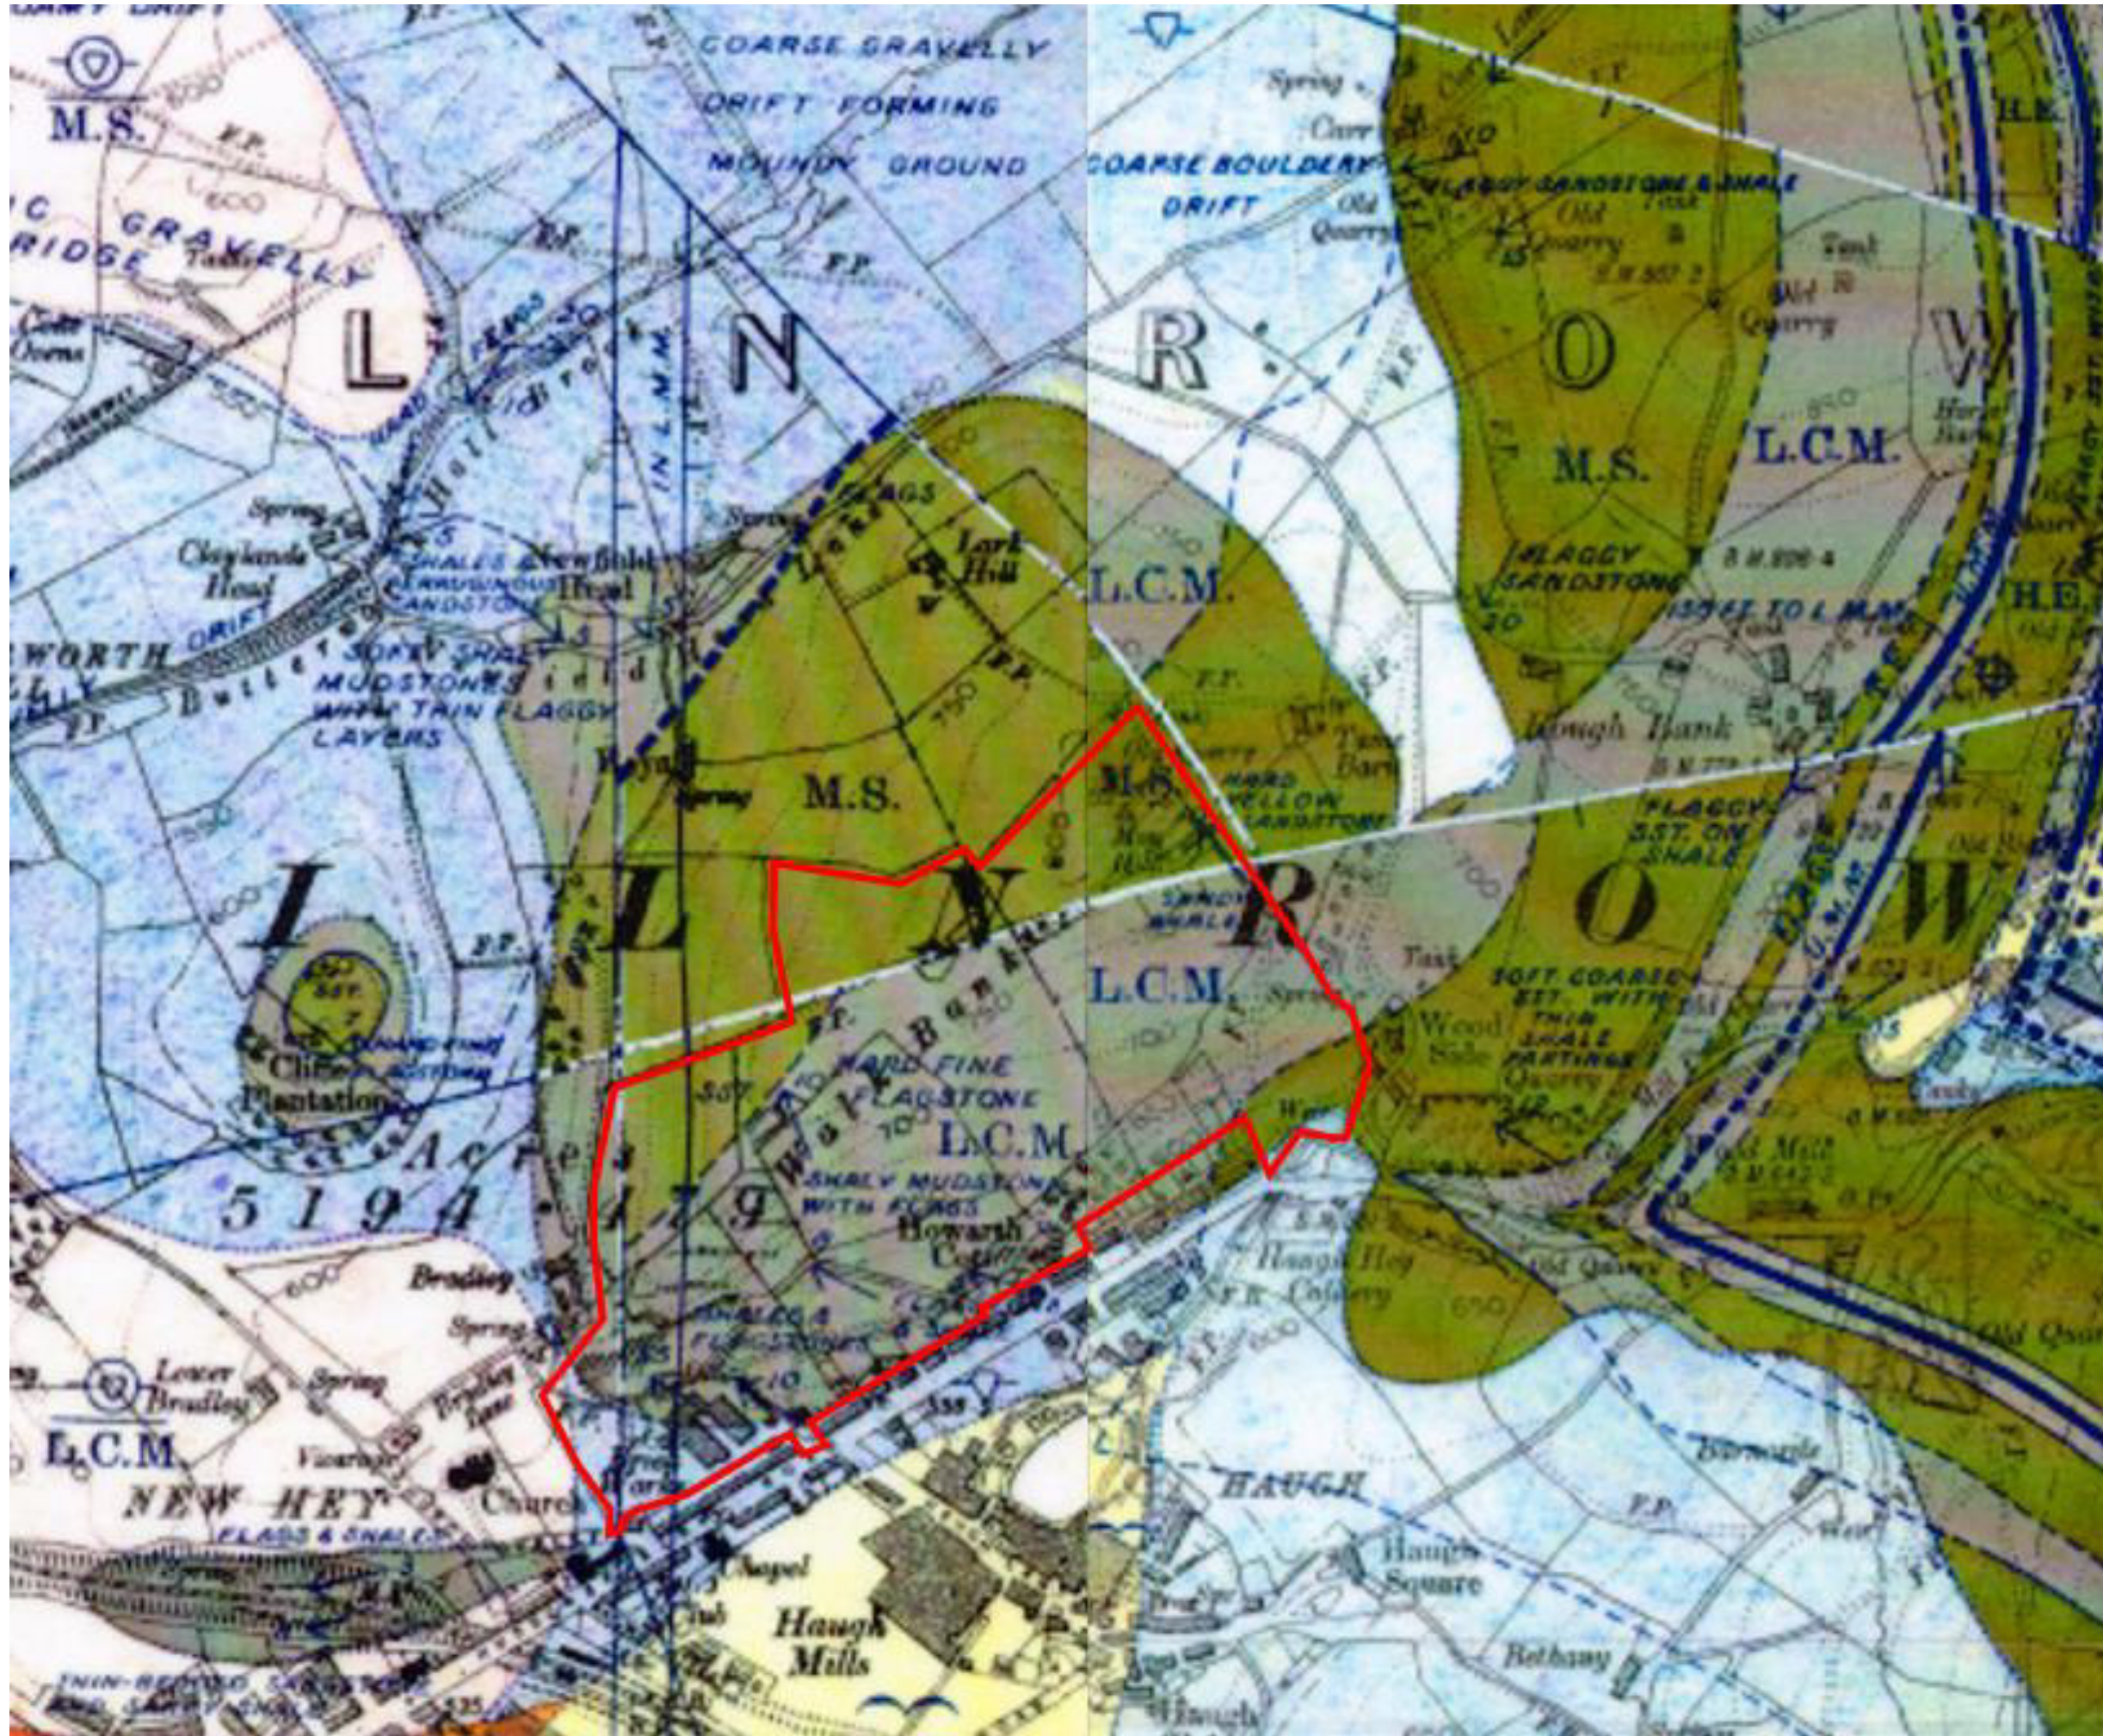
DRAWING TITLE
SHEET 89 SIX-INCH GEOLOGICAL MAP EXTRACT

The site appears to be located within a fault block according to the earlier maps (1930, 1975, Six inch extract). The unnamed faults are shown below and represented by a white line on drawing number C4315/02 Sheet 89 Six-Inch Geological Map Extract.

An extract of the Six-Inch Geological Maps (Sheet 89) is shown on Drawing number C4315/02 shows an unnamed coal seam circa 200m to the north of the site. The direction of dip in this area is 5 degrees south which would place this coal seam circa 17.5m beneath northern boundary of the site, and circa 32m beneath the site towards the southern boundary. However, this does not take into account the topography of the area, the fault on site and the removal of material during quarrying activities and could

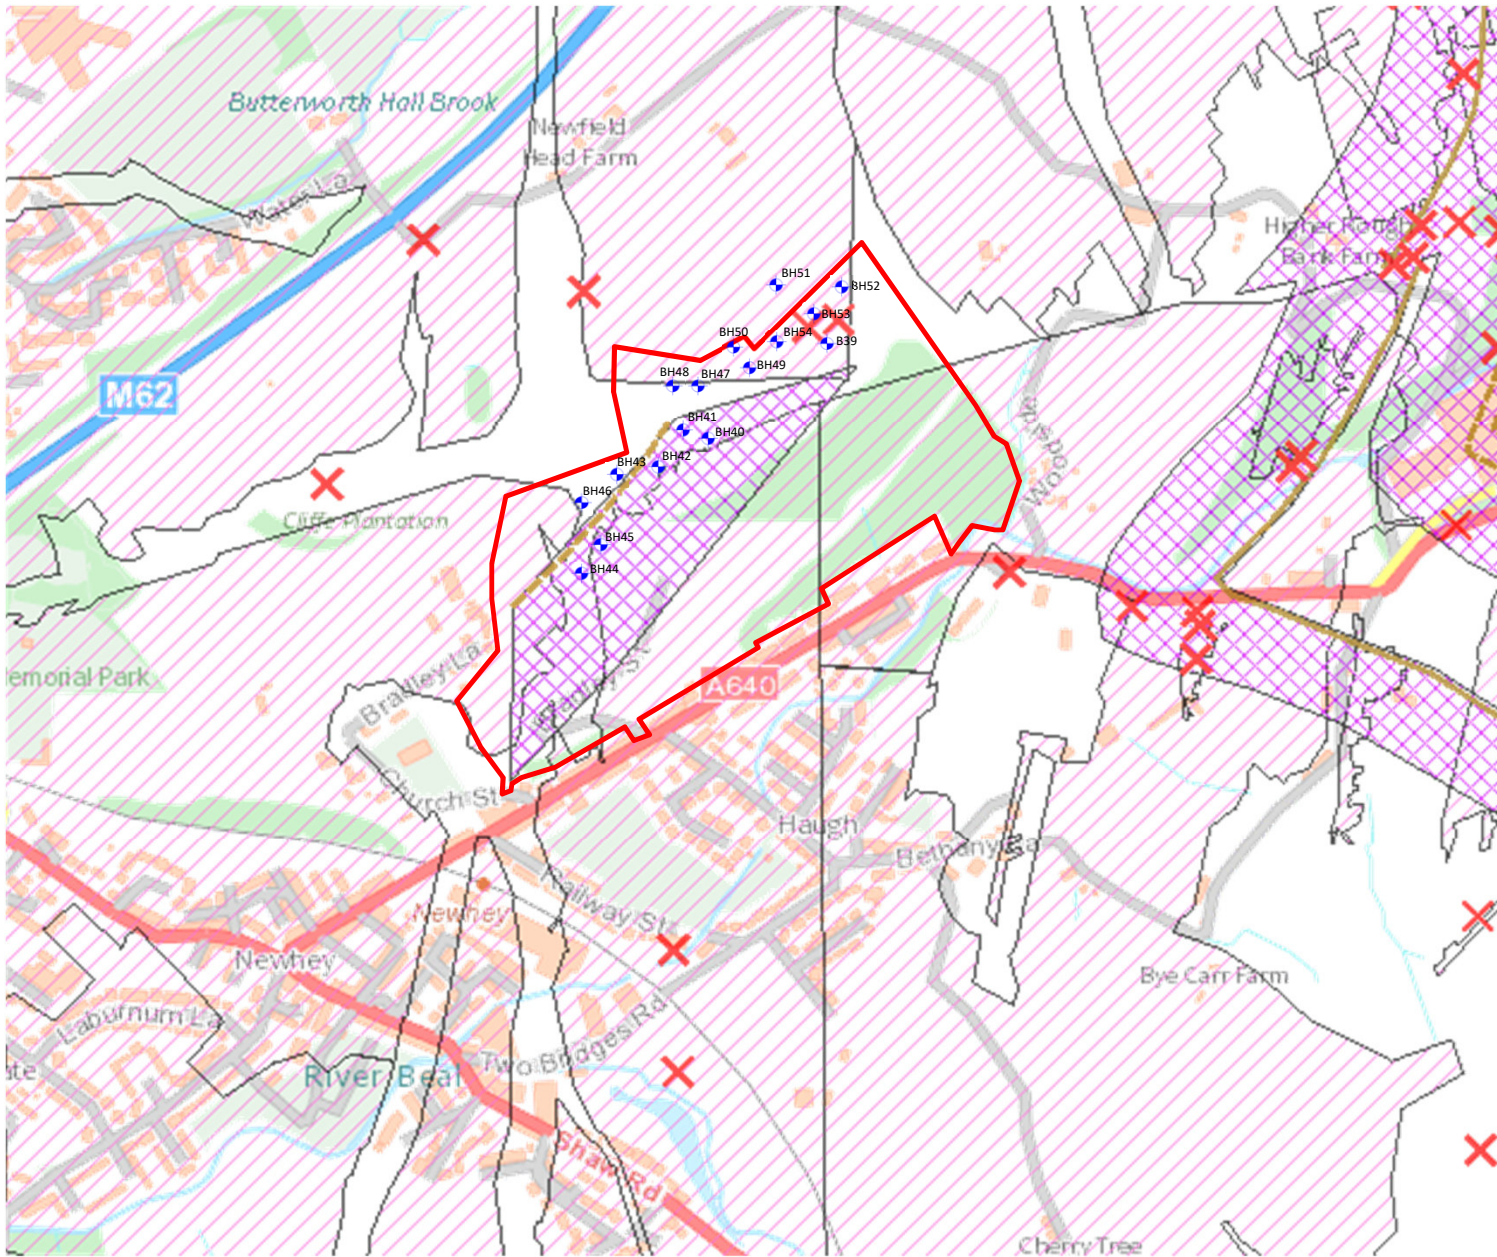
The approximate location of the BGS boreholes are shown on the Coal Authority Extract, Drawing No. C4315/03. The BGS Borehole Logs are presented in Appendix C.

The location of the site in relation to the above points is shown on The Coal Authority Interactive Map Extract, on Drawing No. C4315/03.
