Ashton Moss

Accessible Version Preliminary Geotechnical  
Report

REP/252590/G001

Issue 4 | 14 June 2021

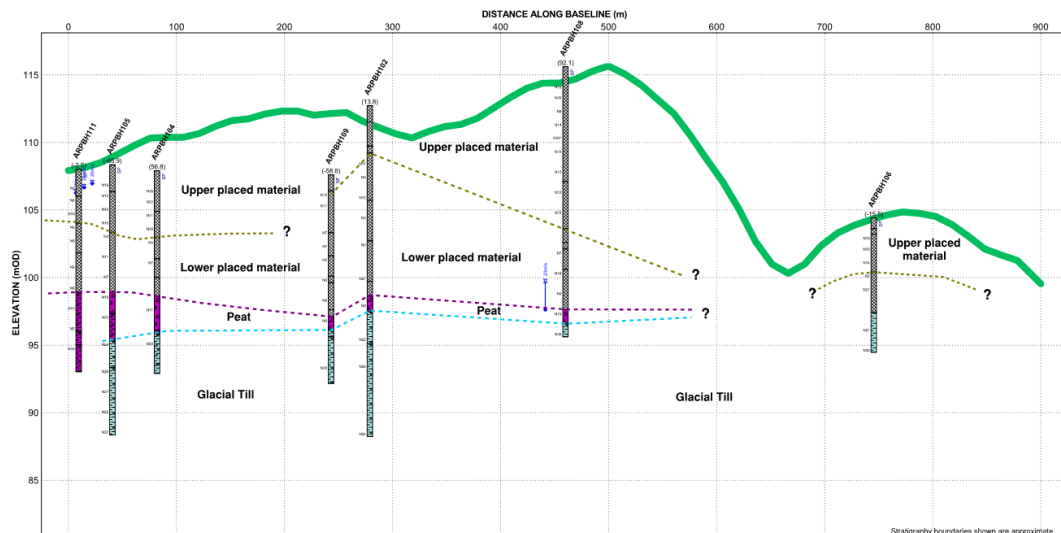
\*Left hand side of the graph is towards Lord Sheldon Way. The right hand side of the graph is towards M60

### Section AA - Geological cross section through the site orientated south west (Lord Sheldon Way) to north east (M60).

Above the coal measures are a layer of naturally occurring glacial till, which would be suitable as a foundation bearing strata, and a layer of natural peat ranging in thickness from 1.2m to 2.5m. The natural strata are overlaid by the placed materials.

- An upper covering layer of 'engineered fill material' understood to have been placed to form final site levels as a part of a regrading undertaken in the 2000s (**Upper placed material**). This covering layer was generally found to be up to 5m thick but reached up to 8.5m thick in BH108.
- A lower layer of peat and other soft materials likely to have been deposited there as part of an earthworks operation for the construction

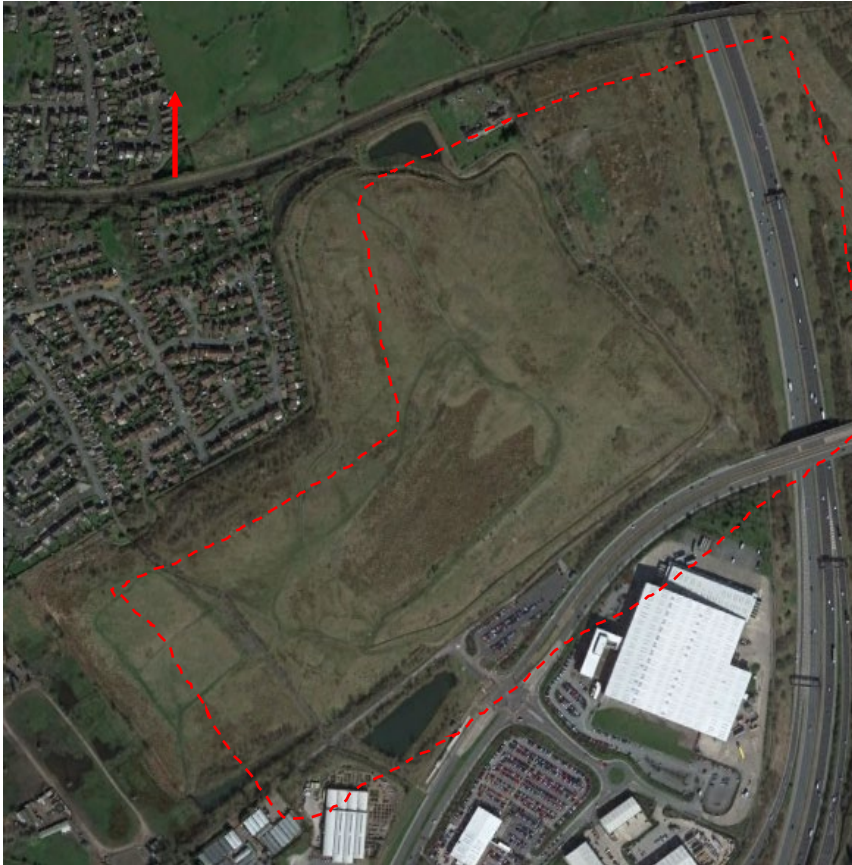
**Plate 1: Aerial view of site [1]**

The site is located between a tramway which runs adjacent to Lord Sheldon Way to the south and a railway to the north, approximately 1.9km west of Ashton-under-Lyne town centre. The site covers an area of approximately 42.5 ha and is centred on National Grid Reference SJ 919 988. Freely available LiDAR data indicates that ground levels range from approximately 100 to 118mOD. An aerial photograph of the site is shown in Plate 1.

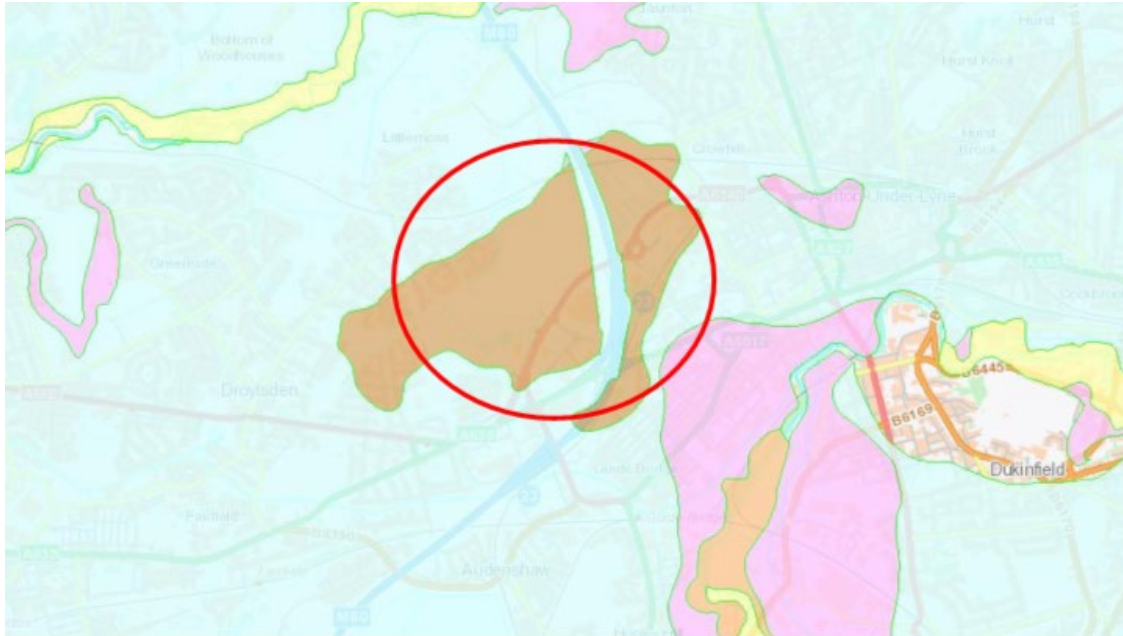
**Plate 2 Superficial deposits on site and in the surround areas. The colours represent the following materials; brown – peat, blue – glacial till, pink – glacial fluvial deposits, orange – river terrace deposits and yellow – alluvium. Accessed from the BGS [3]**

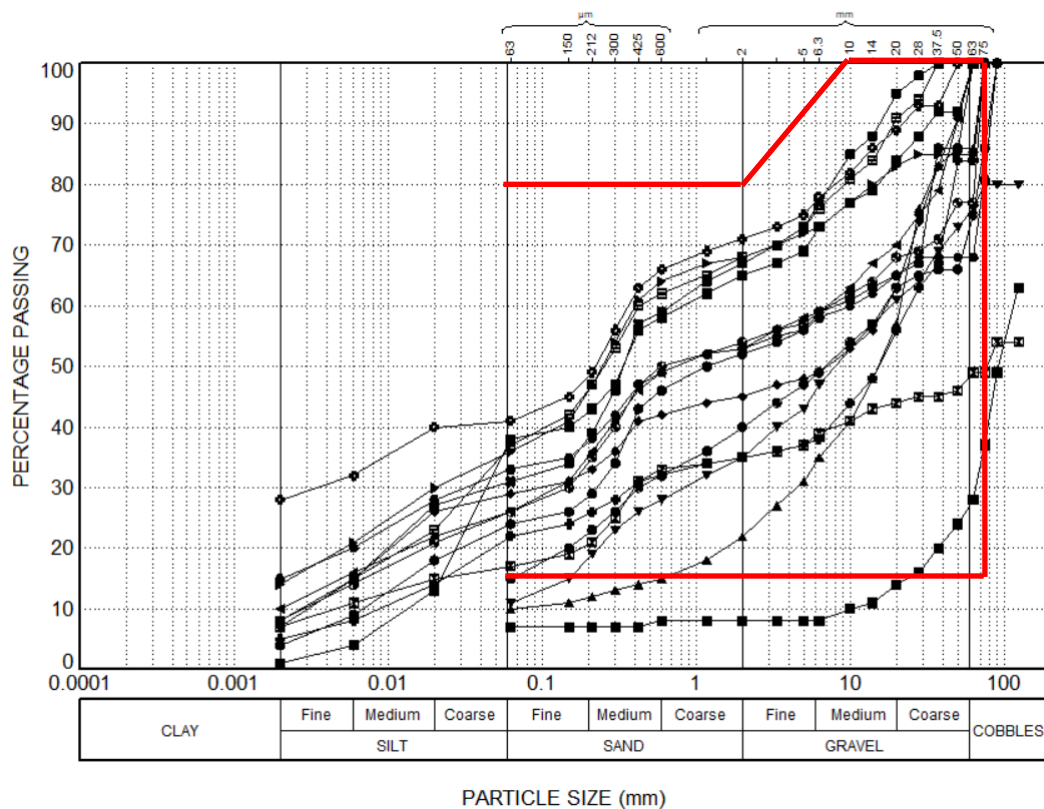
Sketch 3 Upper material grading curves with the grading envelopes for Class 2C fill shown in red [15].

The results of PSD testing for the upper placed material have been compared with grading envelopes for Class 2 (cohesive) materials as defined in the SHW (Appendix A). As shown in Sketch 3, because of the gravel and cobbles present within the fill, the upper material present on site generally meets the grading requirements of Class 2C – Stony cohesive fill material.

If this material was to form part of proposed reprofiling of the stockpile and was therefore available for re-use as engineered fill, a range of further testing would need to be undertaken to confirm the Class 2C classification that is suggested on the basis of the available PSD data. Amongst the additional testing required it will be necessary to establish the optimum moisture content of the material (OMC - noting that a range of OMC values may need to be determined in such variable material). Without OMC data, it is not currently possible to determine how much, if any, of the material will be suitable for re-use in an as-dug condition or whether some form of stabilisation or other treatment will be required.

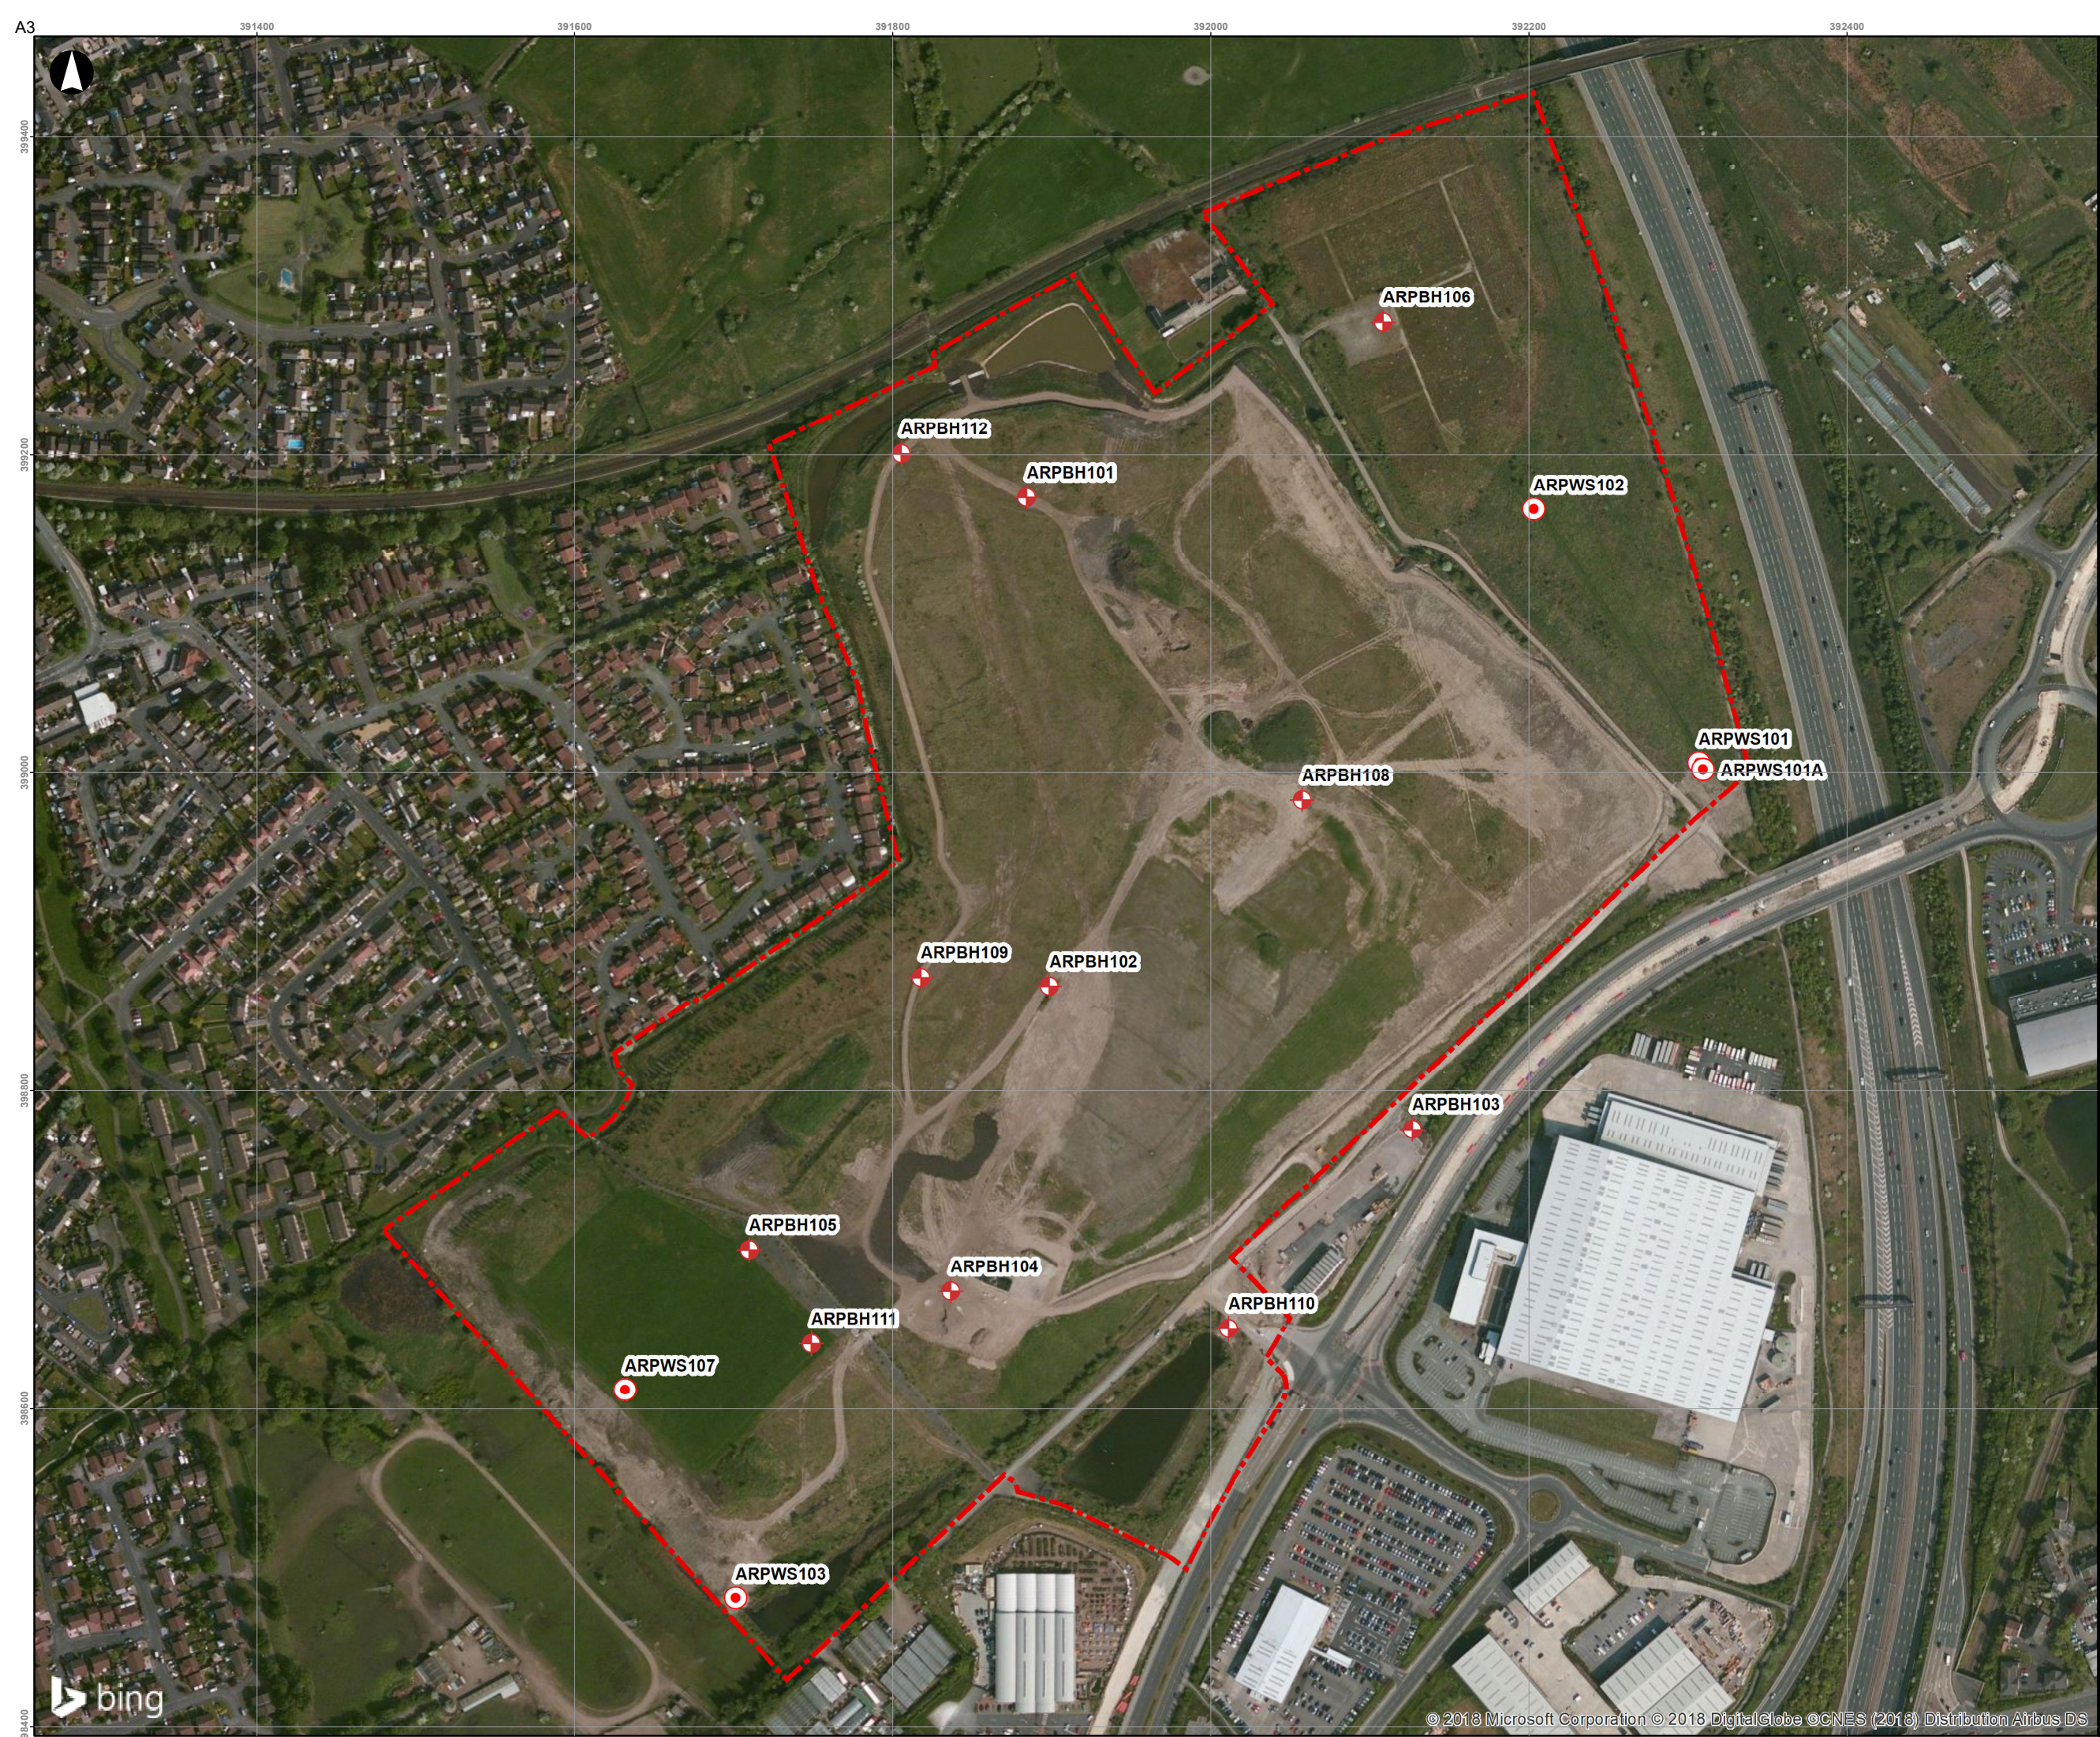
Name <b>Figure 5</b>	Rev <b>P0</b>
-------------------------	------------------

As shown on the 1910 OS map presented in Figure 5, Ashton Colliery was located directly south of the site. Geological maps suggest that any worked coal seams will dip beneath the site.

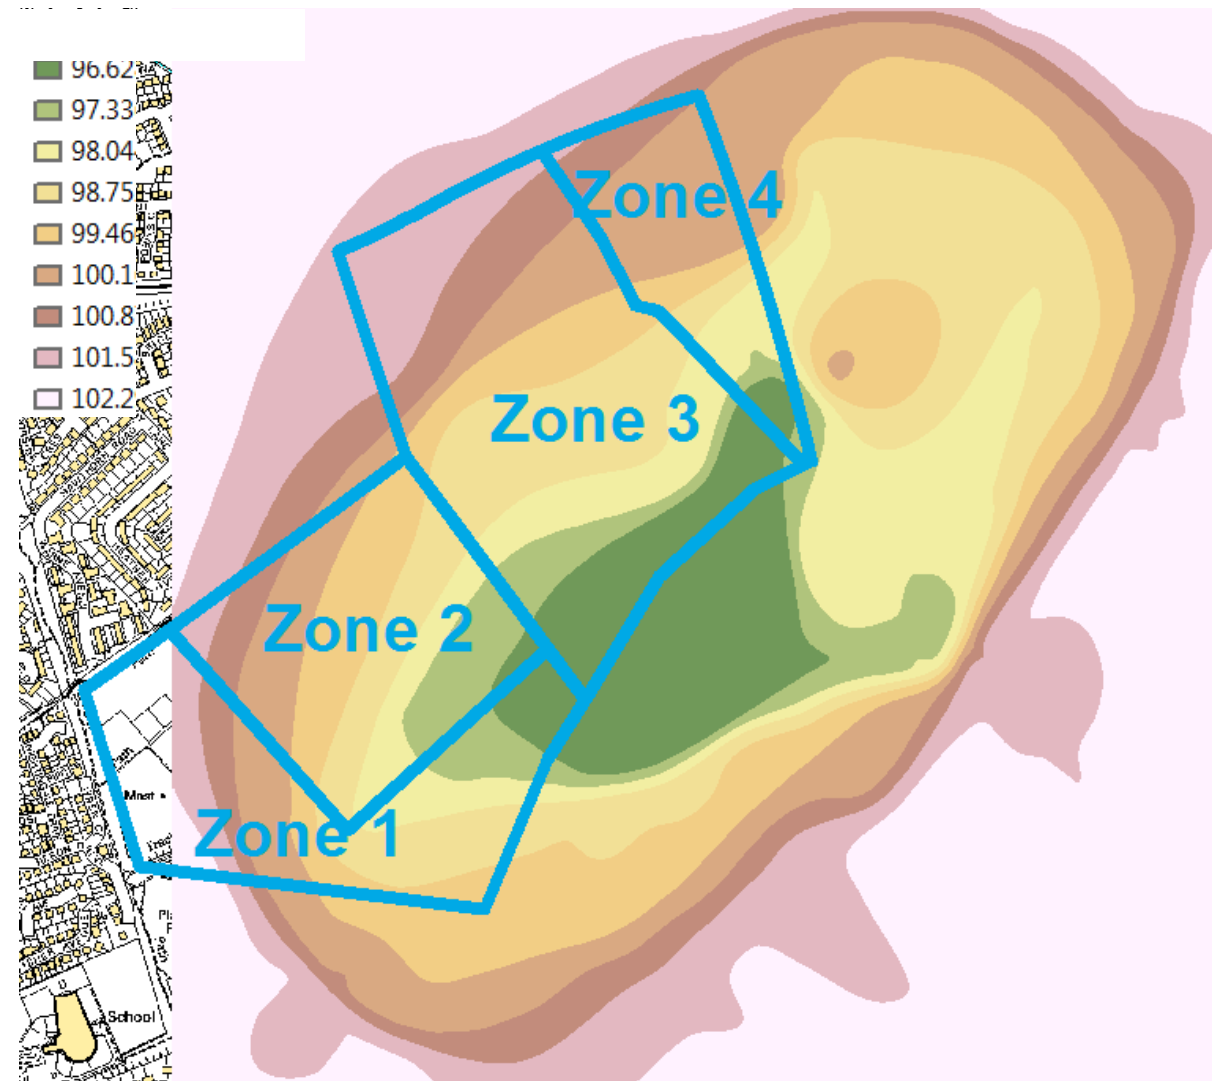
Estimated peat elevation (Mouchel)

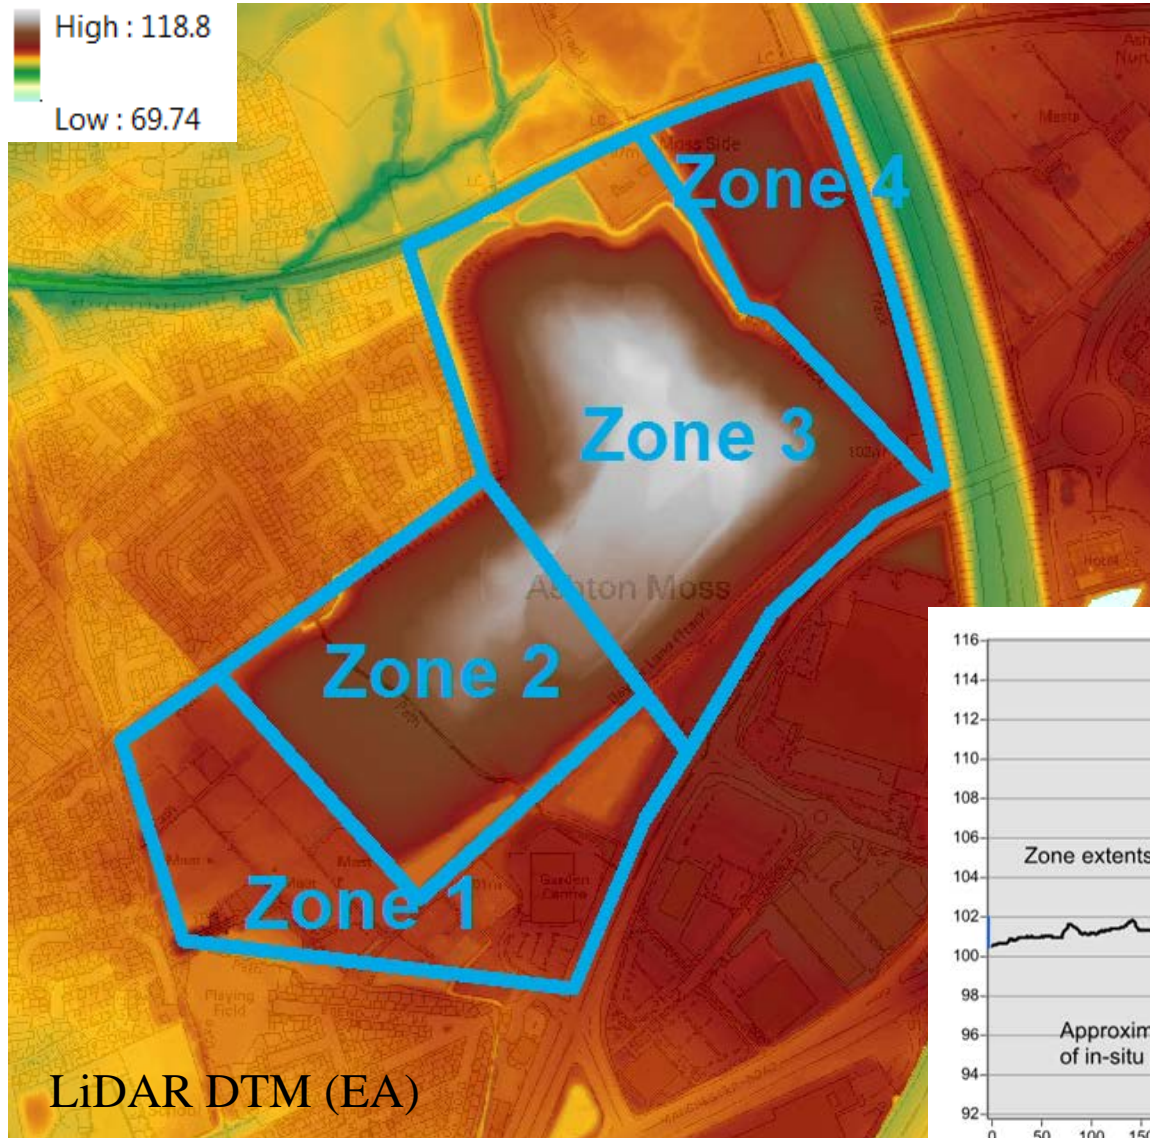
- Made ground fill is thickest in Zone 3
- Potentially absent in Zone 1
- Estimated thickness of 14 to 16m based on assumed former ground level of 102mOD
- Assumed to have been cuttings from M60, may include peat, clay from adjacent areas – assumed sand and gravel re-used elsewhere in M60 scheme

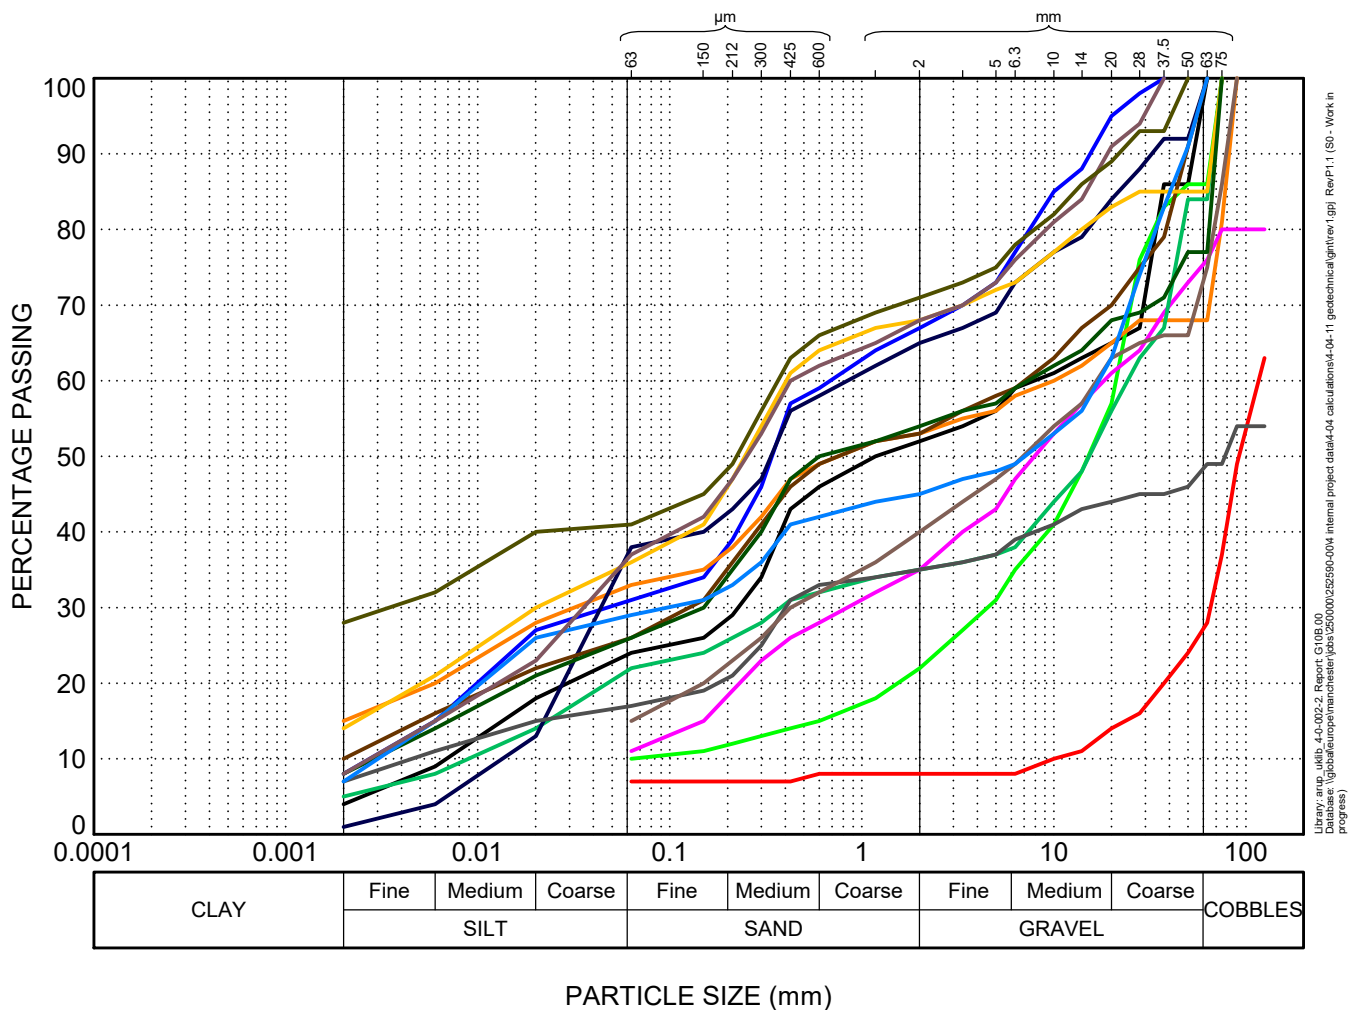
FIGURE **D1**

# ASHTON MOSS PARTICLE SIZE DISTRIBUTION COVERING MADE GROUND PARTICLE SIZE DISTRIBUTION

The particle size distribution curves of samples of the upper placed materials are presented in the IFA report and summarised in Appendix D. The results indicate that this material is predominantly a well graded clayey gravelly sand. Some samples contain higher gravel and cobble content. It can be noted from carrying out walkover surveys that cobble sized fill materials such as concrete flags and bricks are present in the near surface materials.

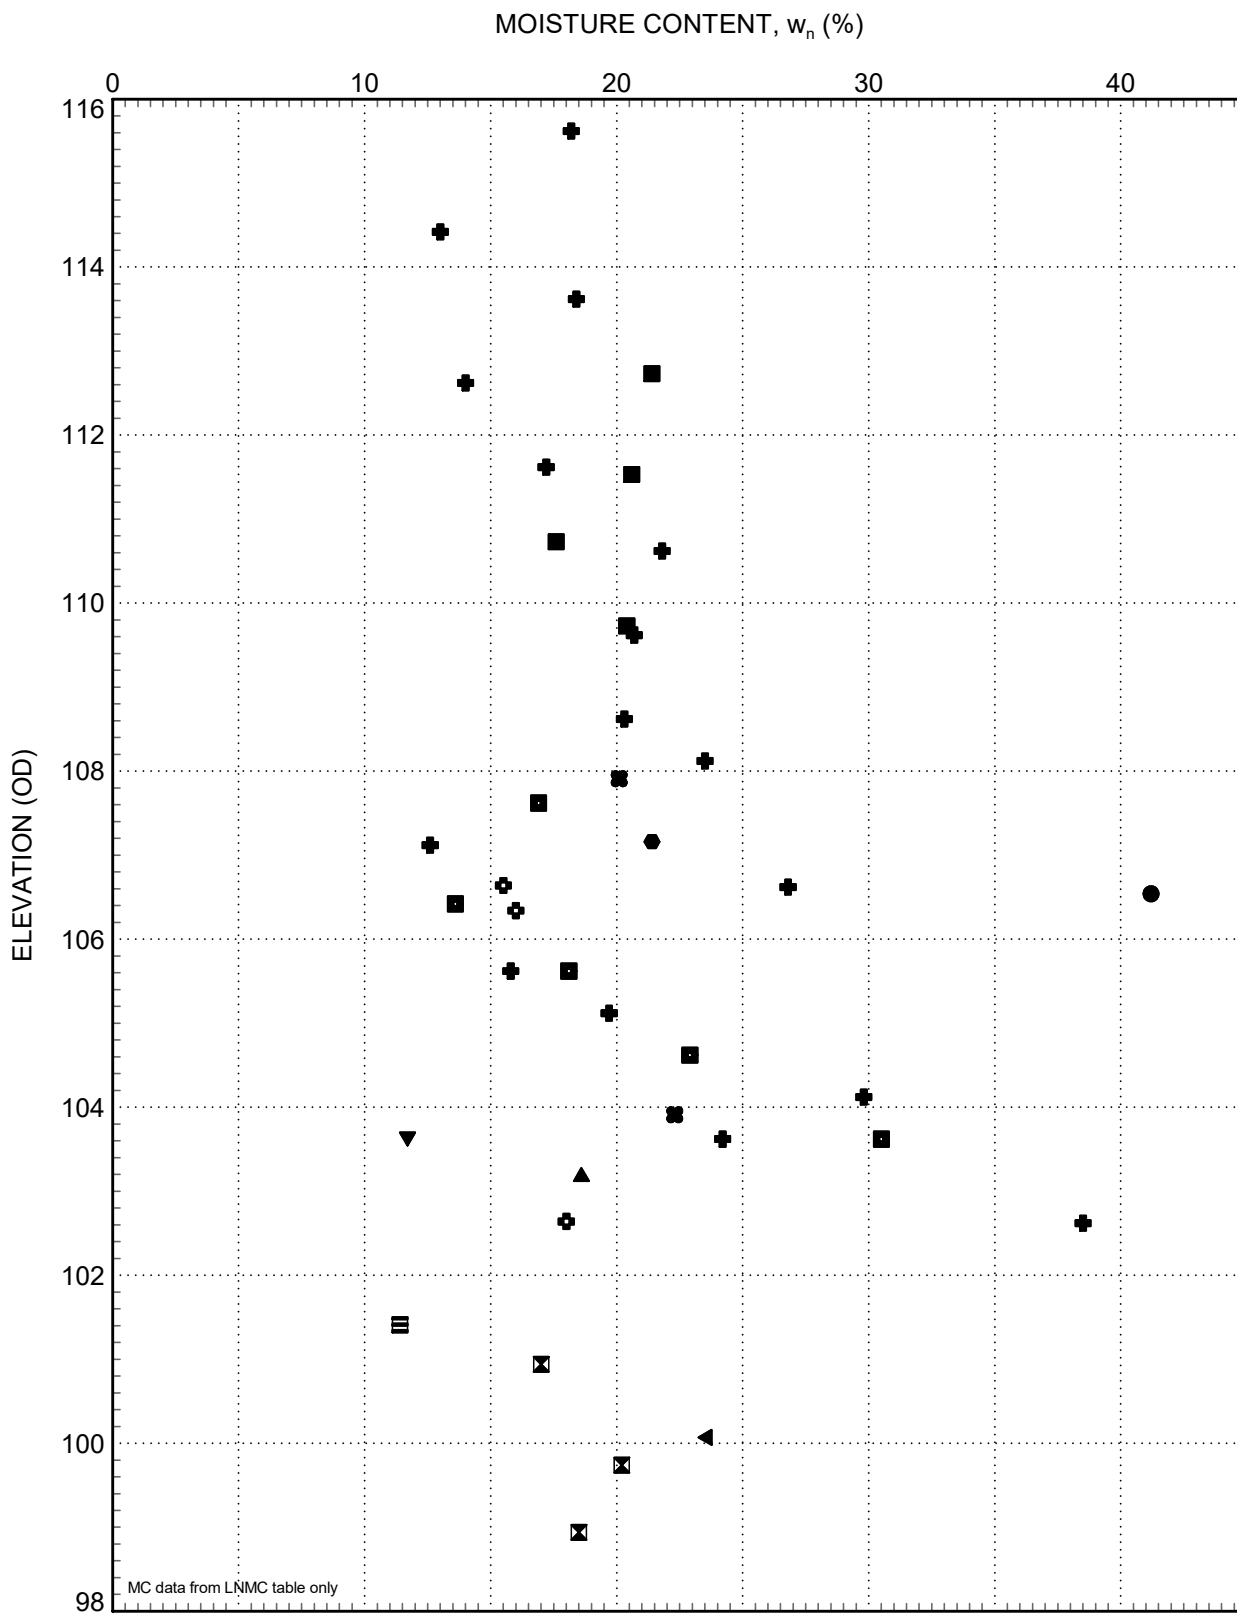
FIGURE **D2**

# ASHTON MOSS NATURAL MOISTURE CONTENT COVERING MADE GROUND MOISTURE CONTENT

Thirty-eight natural moisture content tests have been undertaken on samples of the covering layer, and the results range between 11 and 41%. Fourteen plasticity indices range between 7 and 21% as shown in Appendix C. These results indicate that the material is generally clay of low to intermediate plasticity, with one result indicating a high plasticity silt.

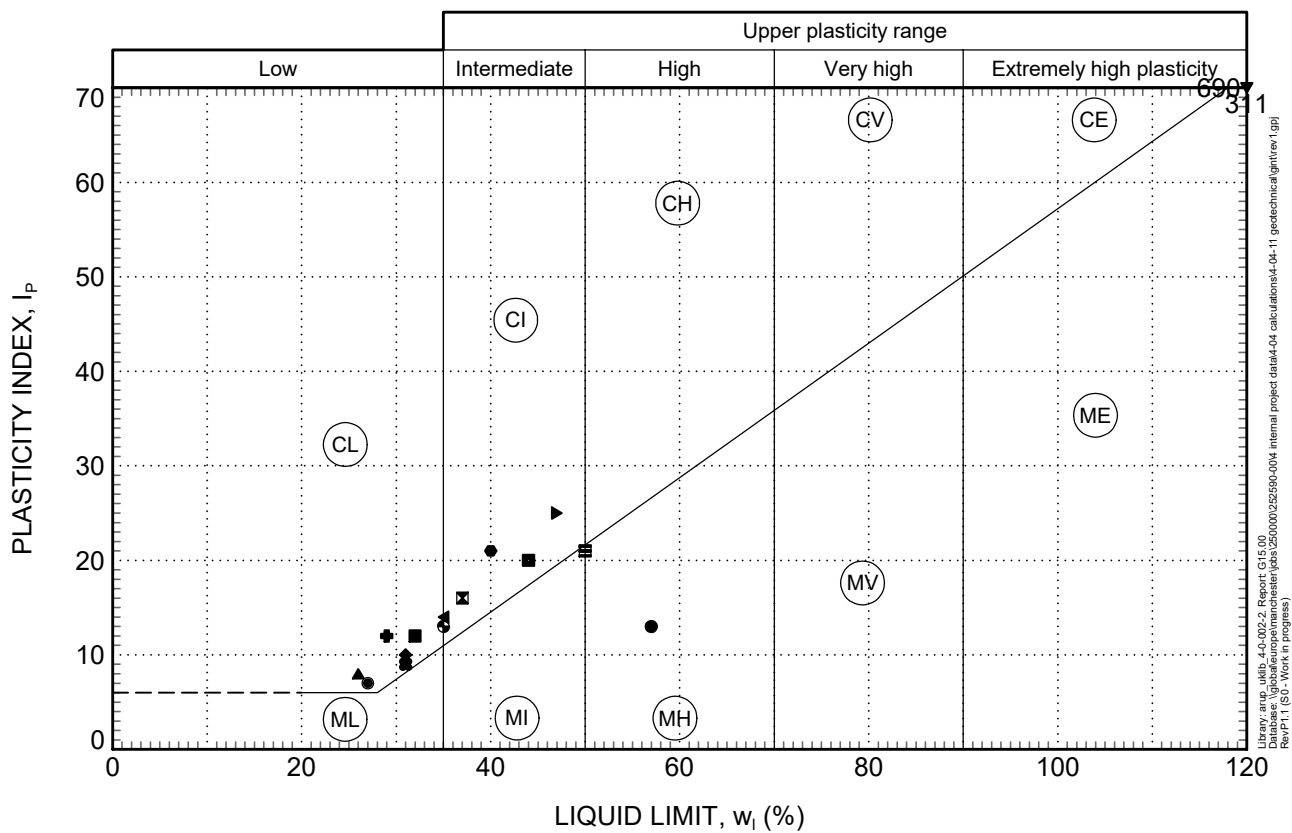
FIGURE **D3**

# ASHTON MOSS PLASTICITY CHART COVERING MADE GROUND PLASTICITY A-LINE

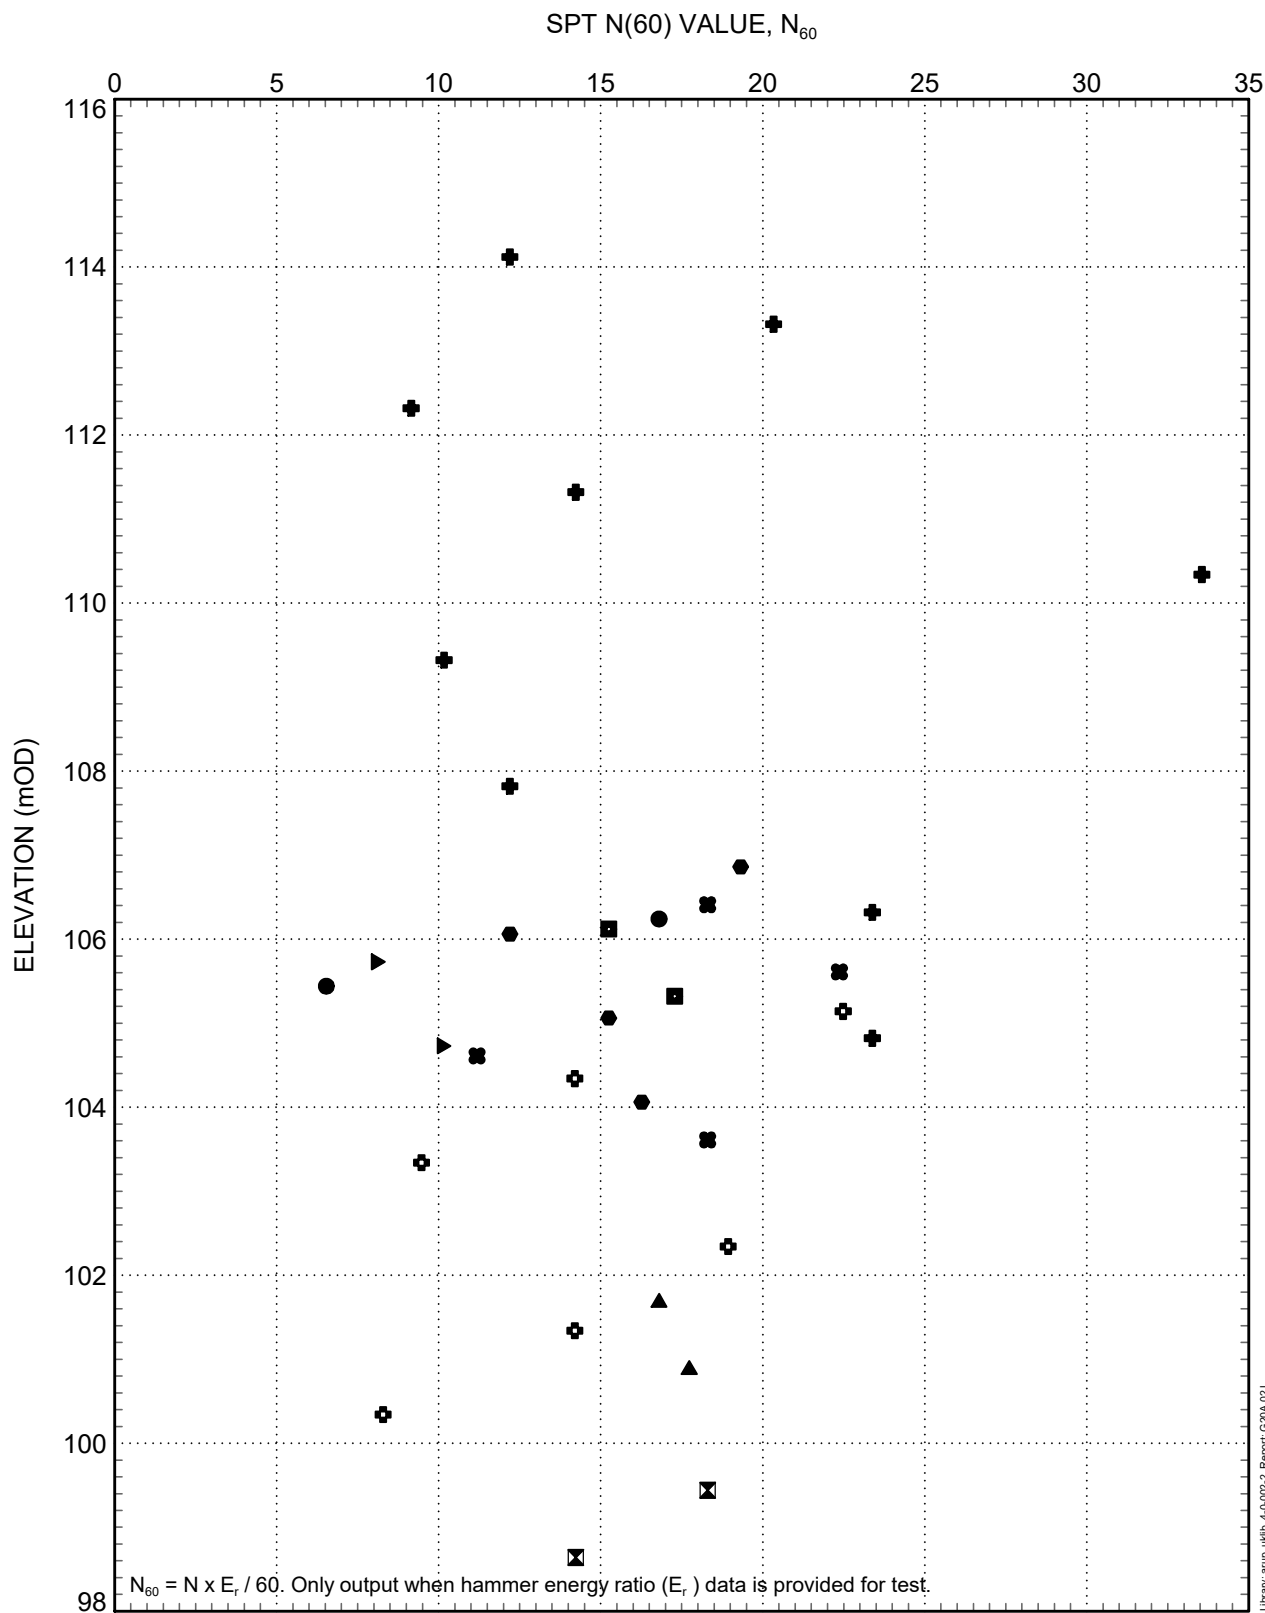
FIGURE **D4**

# ASHTON MOSS STANDARD PENETRATION TESTS COVERING MADE GROUND CORRECTED SPT N'60' VALUES

Standard penetration tests [6] were carried out within the covering upper layer fill and are summarised in Appendix C. Corrected 'N<sub>60</sub>' values ranged between 7 and 34, i.e. loose to dense for granular components.

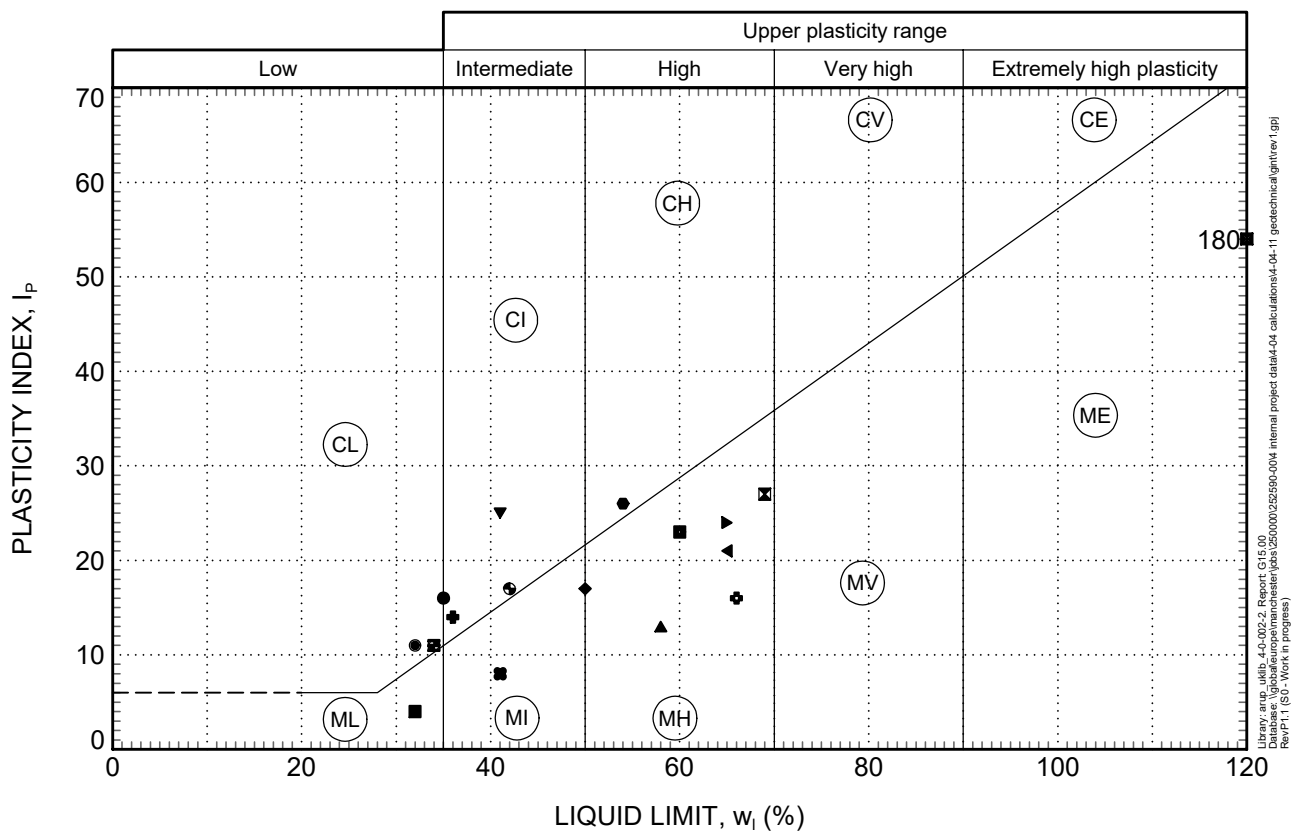
FIGURE **D7**

# ASHTON MOSS PLASTICITY CHART PLACED MADE GROUND PLASTICITY A-LINE

Thirty-three natural moisture content tests have been undertaken on samples of the lower placed made ground layer, and the results range between 12 and 214%. Higher percentages are likely to be associated with the peaty elements within this material. Sixteen plasticity indices range

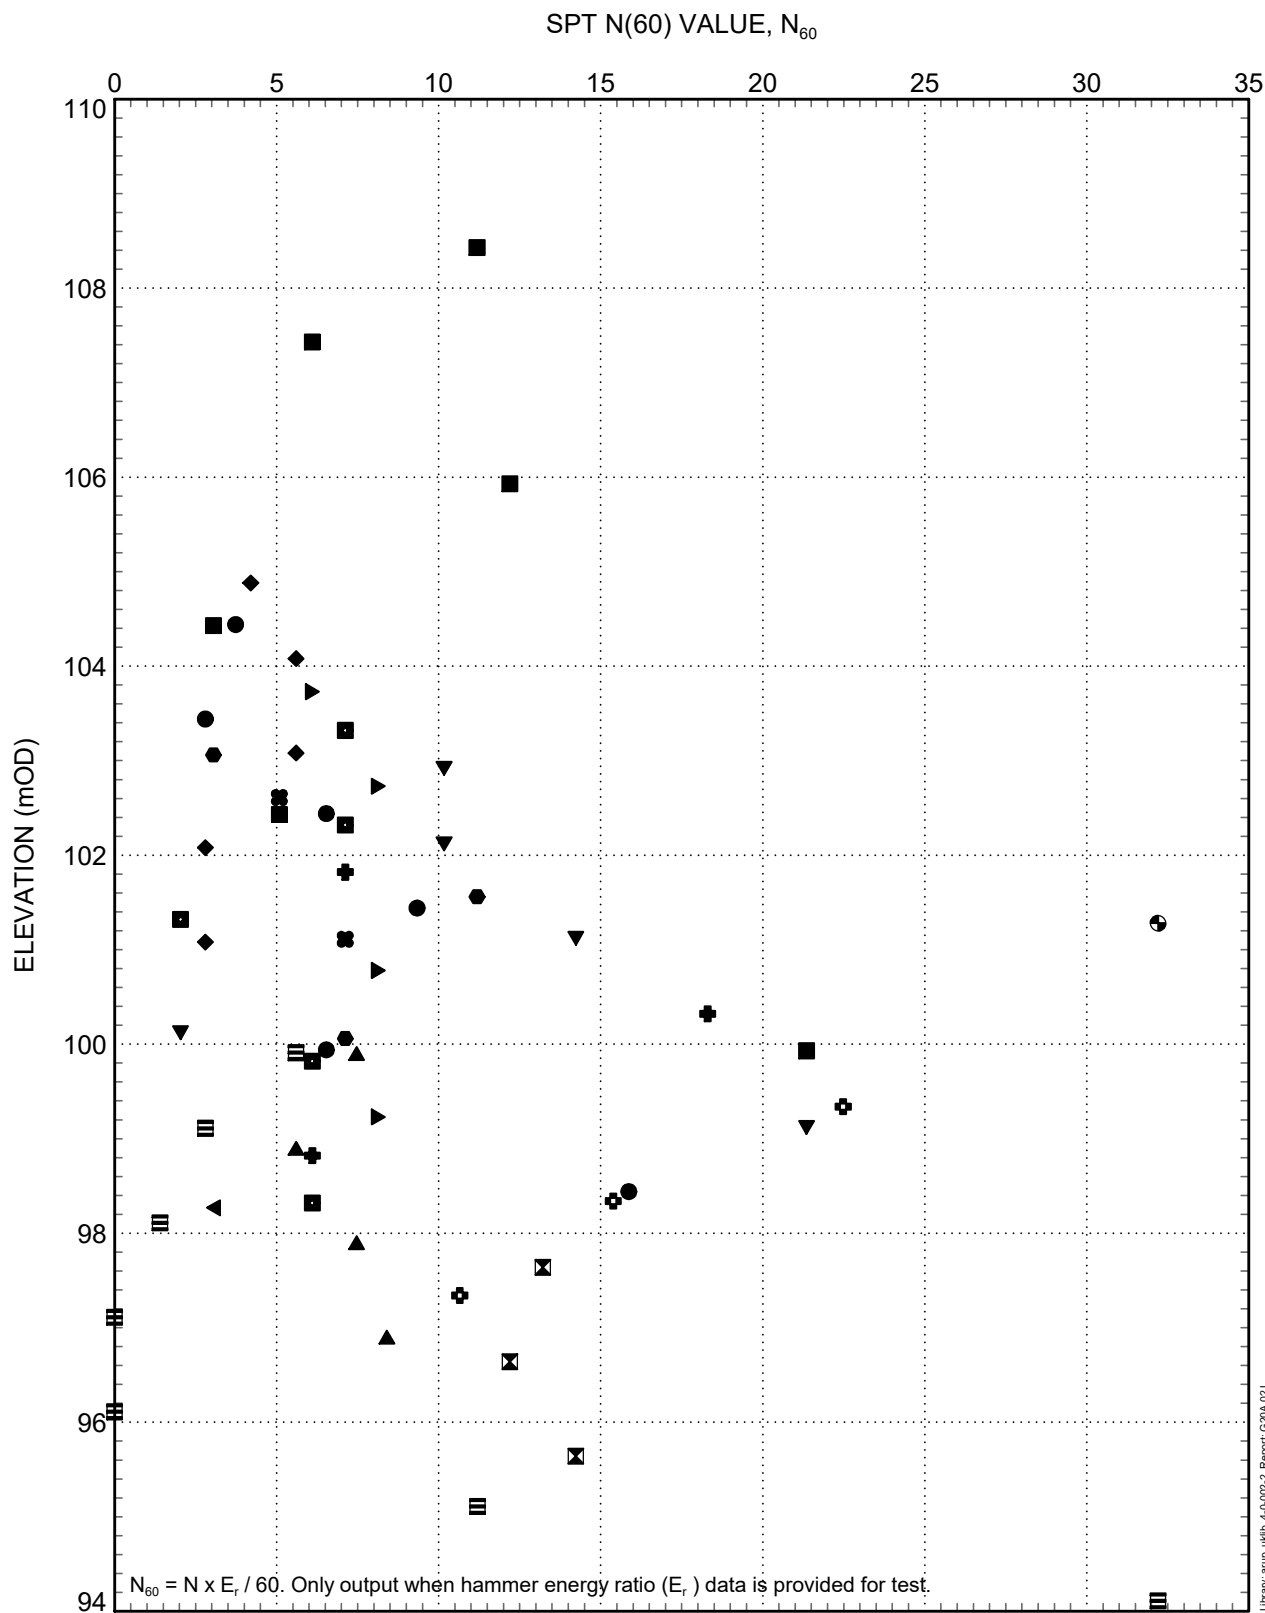
FIGURE **D8**

**ASHTON MOSS  
STANDARD PENETRATION TESTS  
PLACED MADE GROUND  
CORRECTED SPT N'60' VALUES**

Standard penetration tests [6] were carried out within the lower placed made ground layer fill and are summarised in Appendix C. Corrected 'N<sub>60</sub>' values ranged between 0 and 32, but typically 0-16 i.e. very loose to medium dense. It is noted that the higher range of 'N' values were recorded where obstructions were noted within the fill. The hand shear vanes indicated that the peak undrained shear strength ( $S_u$ ) ranges from 11 kPa to 174 kPa, but typically between 75 and 115 kPa. No laboratory shear strength testing was carried out during this investigation.

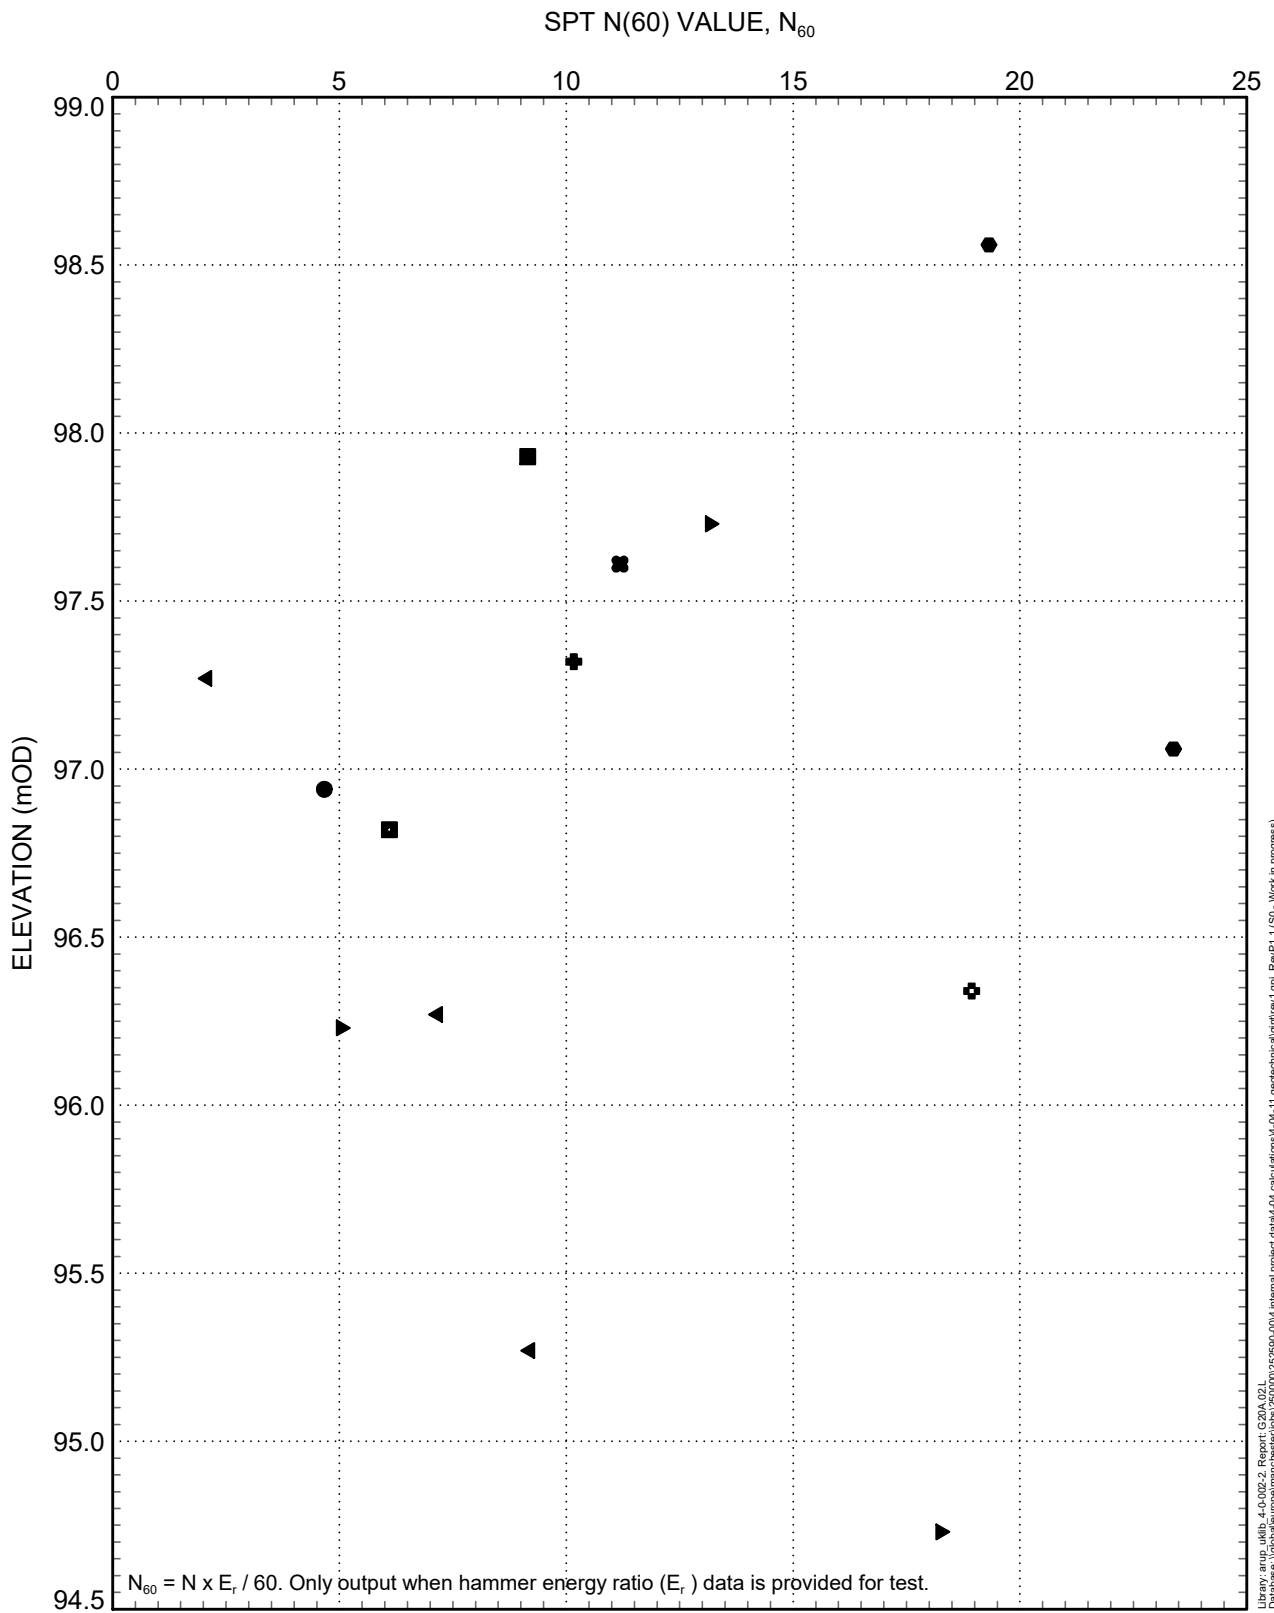
FIGURE **D12**

**ASHTON MOSS  
STANDARD PENETRATION TESTS  
NATURAL PEAT  
CORRECTED SPT N'60' VALUES**

Standard penetration tests Appendix A were carried out within the peat deposits and are summarised in Appendix C. Corrected 'N<sub>60</sub>' values ranged between 2 and 23, i.e. very loose to medium dense. It is noted that the higher range of 'N' values were recorded where gravels and cobbles were noted within the peat. The hand shear vanes indicated that the peak undrained shear strength ( $S_u$ ) ranges from 38 kPa to 166 kPa. No laboratory shear strength testing was carried out during this investigation.
