Ashton Moss

Accessible Version Preliminary Geotechnical  
Report

REP/252590/G001

Issue 4 | 14 June 2021

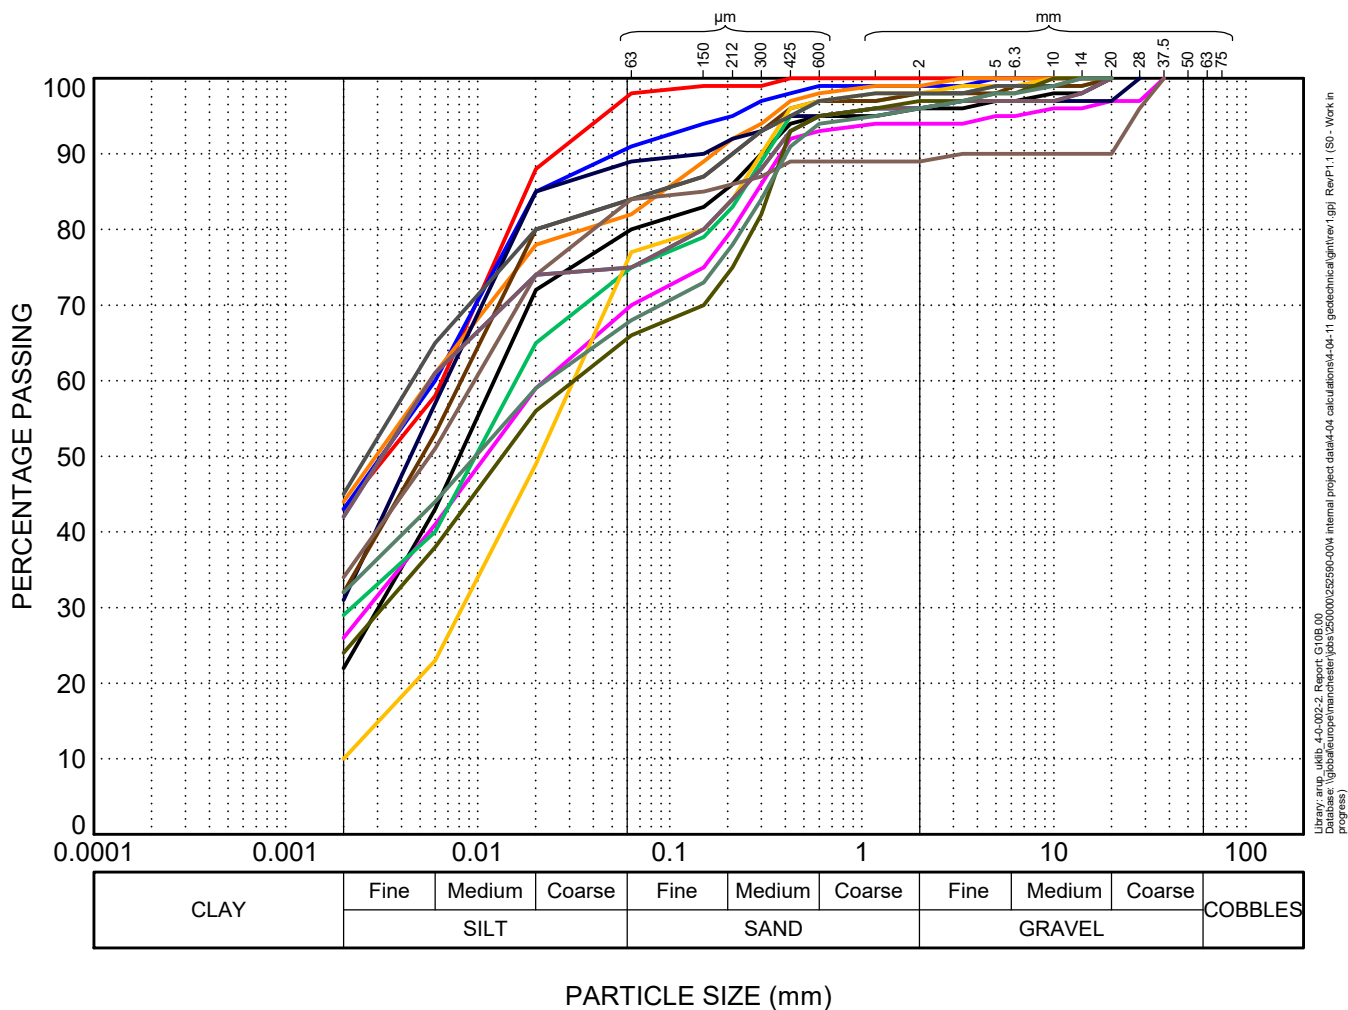
FIGURE **D14**

# ASHTON MOSS PARTICLE SIZE DISTRIBUTION GLACIAL TILL DEPOSITS PARTICLE SIZE DISTRIBUTION

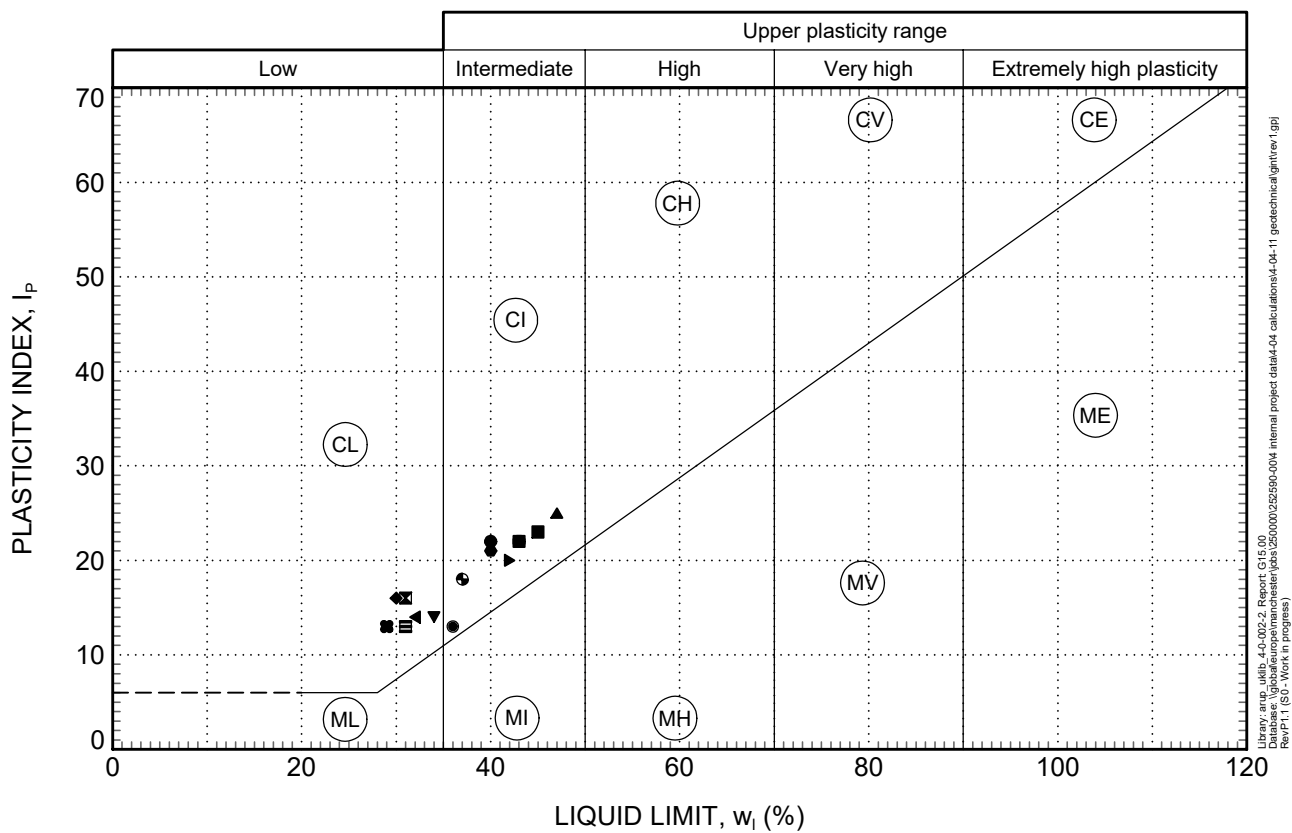
FIGURE **D15**

# **ASHTON MOSS PLASTICITY CHART GLACIAL TILL DEPOSITS PLASTICITY A-LINE**

Fifty-two natural moisture content tests have been undertaken on samples of glacial till, and the results range between 8 and 37%. Fourteen plasticity indices tests range between 12 and 25% as shown in Appendix C. These results indicate that the stratum is of low to intermediate plasticity.
