## North of Irlam Station Development Ground Investigation Report

July 2020

<b>Job No</b>	CS/099254		
<b>Project</b>	North of Irlam Station Development		
<b>Location</b>	Irlam, Greater Manchester		
<b>Title</b>	Ground Investigation Report		
<b>Document Ref</b>	IRL-CAP-00-XX-RP-GE-0001	<b>Issue / Revision</b>	P02
<b>Date</b>	17/07/2020		
<b>Prepared by</b>	R. Samuel	<b>Signature</b>

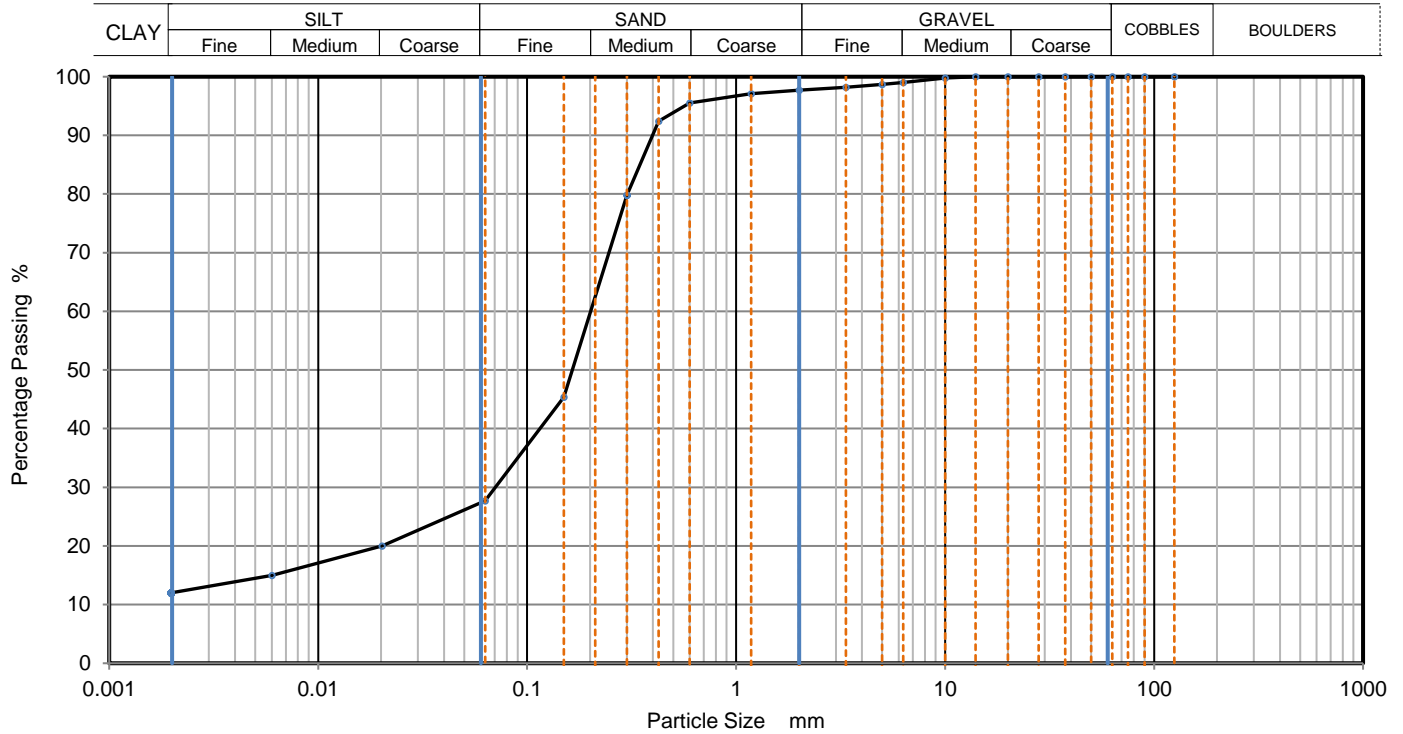
Operator	Checked	Approved	Sheet printed	<b>Fig 2</b>
Harry	Jude	Harry	31/10/2019	
				Sheet 1

<b>PARTICLE SIZE DISTRIBUTION</b>				Job Ref	<b>C251/19/L/372</b>
				Borehole/Pit No.	BH01
Site Name	Irlam, Stockport (YG 0134-19)			Sample No.	
Soil Description	Reddish brown silty SAND			Depth, m	5.00
Specimen Reference	D#	Specimen Depth	5 m	Sample Type	D
Test Method	BS1377:Part 2:1990, clauses 9.2 and 9.4			KeyLAB ID	RGS_201910186

Sieving		Sedimentation	
Particle Size mm	% Passing	Particle Size mm	% Passing
125	100	0.0202	20
90	100	0.0060	15
75	100	0.0020	12
63	100		
50	100		
37.5	100		
28	100		
20	100		
14	100		
10	100		
6.3	99		
5	99		
3.35	98		
2	98		
1.18	97		
0.6	96	Particle density (assumed) 2.65 Mg/m <sup>3</sup>	
0.425	92		
0.3	80		
0.15	45		
0.063	28

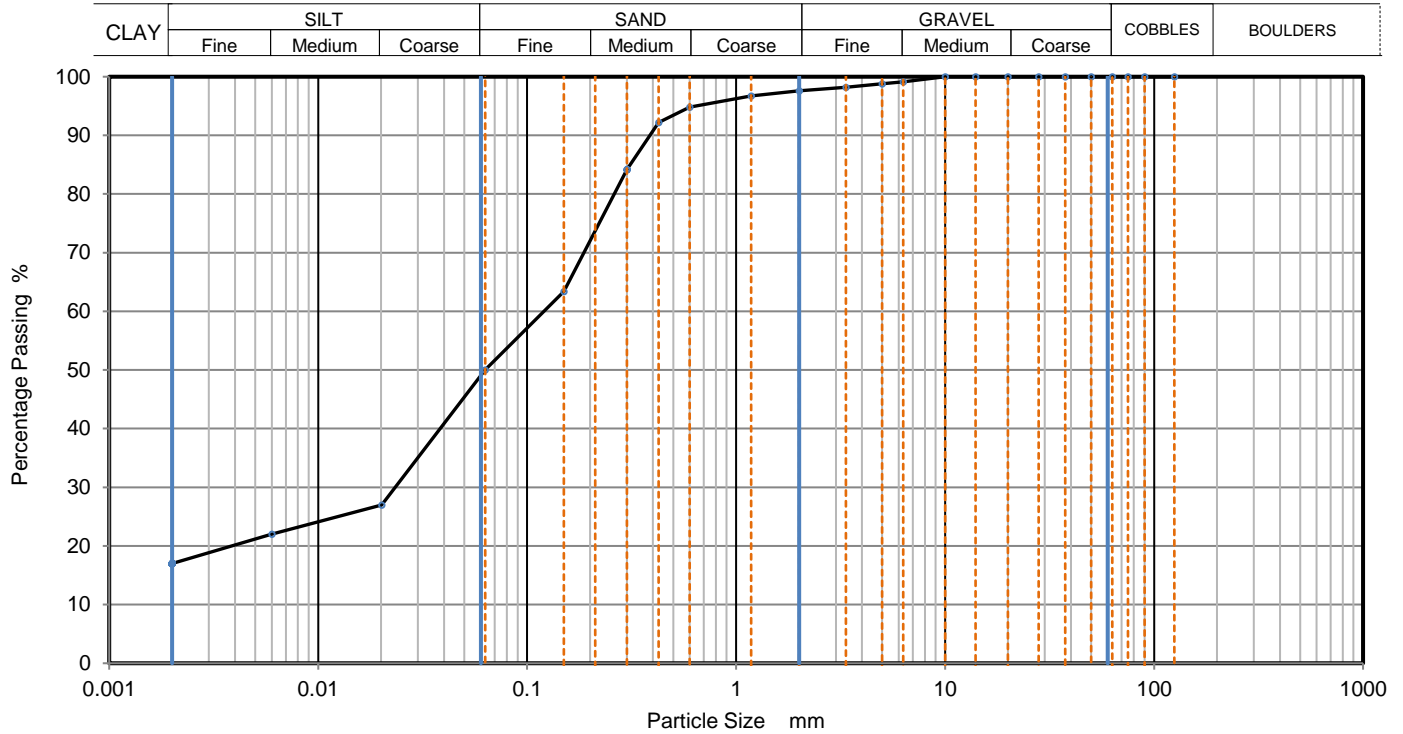
Operator	Checked	Approved	Sheet printed	<b>Fig 2</b>
Harry	Jude	Harry	31/10/2019	
				Sheet 2

<b>PARTICLE SIZE DISTRIBUTION</b>				Job Ref	<b>C251/19/L/372</b>
				Borehole/Pit No.	BH02
Site Name	Irlam, Stockport (YG 0134-19)			Sample No.	1
Soil Description	Brown/reddish brown silty SAND			Depth, m	4.00
Specimen Reference	D1	Specimen Depth	4 m	Sample Type	D
Test Method	BS1377:Part 2:1990, clauses 9.2 and 9.4			KeyLAB ID	RGS_201910187

Sieving		Sedimentation	
Particle Size mm	% Passing	Particle Size mm	% Passing
125	100	0.0201	27
90	100	0.0060	22
75	100	0.0020	17
63	100		
50	100		
37.5	100		
28	100		
20	100		
14	100		
10	100		
6.3	99		
5	99		
3.35	98		
2	98		
1.18	97		
0.6	95	Particle density (assumed) 2.65 Mg/m <sup>3</sup>	
0.425	92		
0.3	84		
0.15	63		
0.063	50

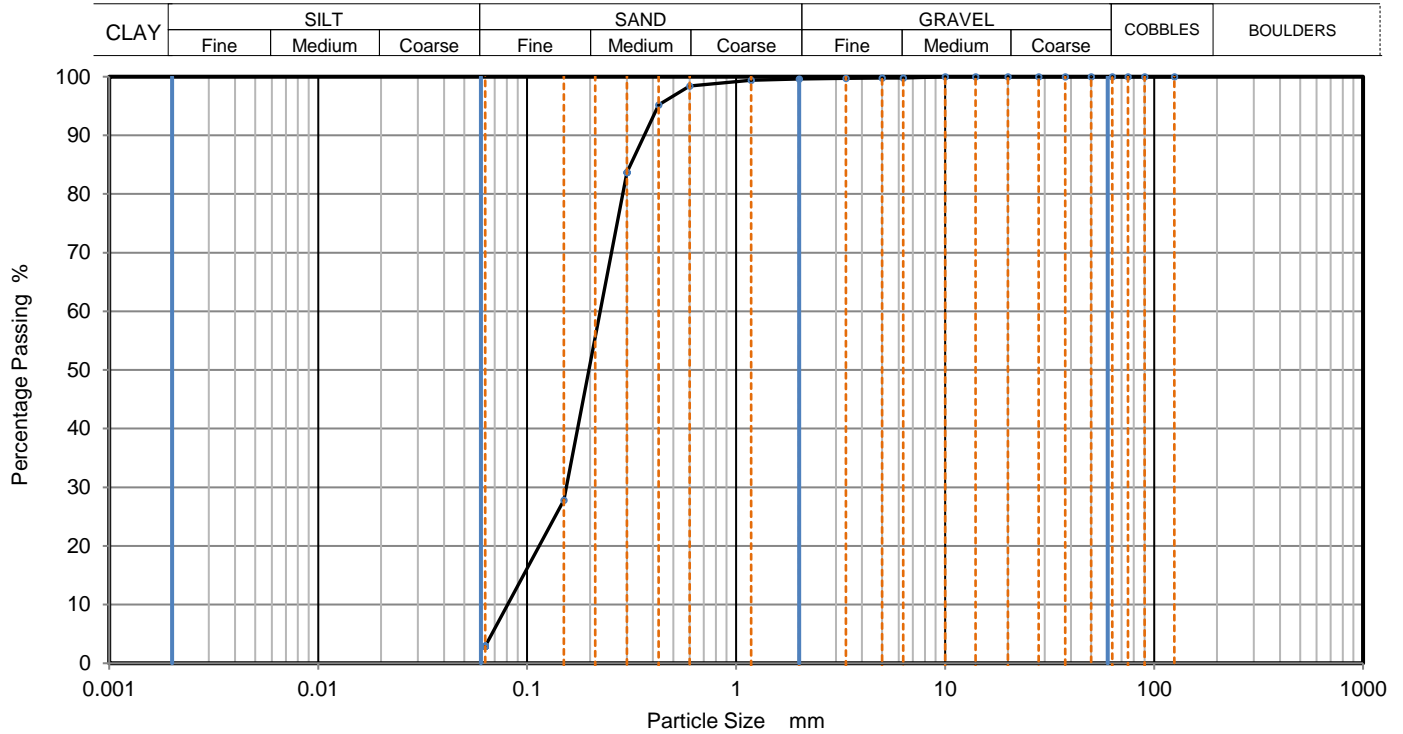
Operator	Checked	Approved	Sheet printed	<b>Fig 2</b>
Harry	Jude	Harry	31/10/2019	
				Sheet 3

<b>PARTICLE SIZE DISTRIBUTION</b>				Job Ref	<b>C251/19/L/372</b>
				Borehole/Pit No.	BH04
Site Name	Irlam, Stockport (YG 0134-19)			Sample No.	1
Soil Description	Light Brown SAND			Depth, m	2.50
Specimen Reference	D1	Specimen Depth	2.5 m	Sample Type	D
Test Method	BS1377:Part 2:1990, clause 9.2			KeyLAB ID	RGS_201910188

Sieving		Sedimentation	
Particle Size mm	% Passing	Particle Size mm	% Passing
125	100		
90	100		
75	100		
63	100		
50	100		
37.5	100		
28	100		
20	100		
14	100		
10	100		
6.3	100		
5	100		
3.35	100		
2	100		
1.18	99		
0.6	98		
0.425	95		
0.3	84		
0.15	28		
0.063	3

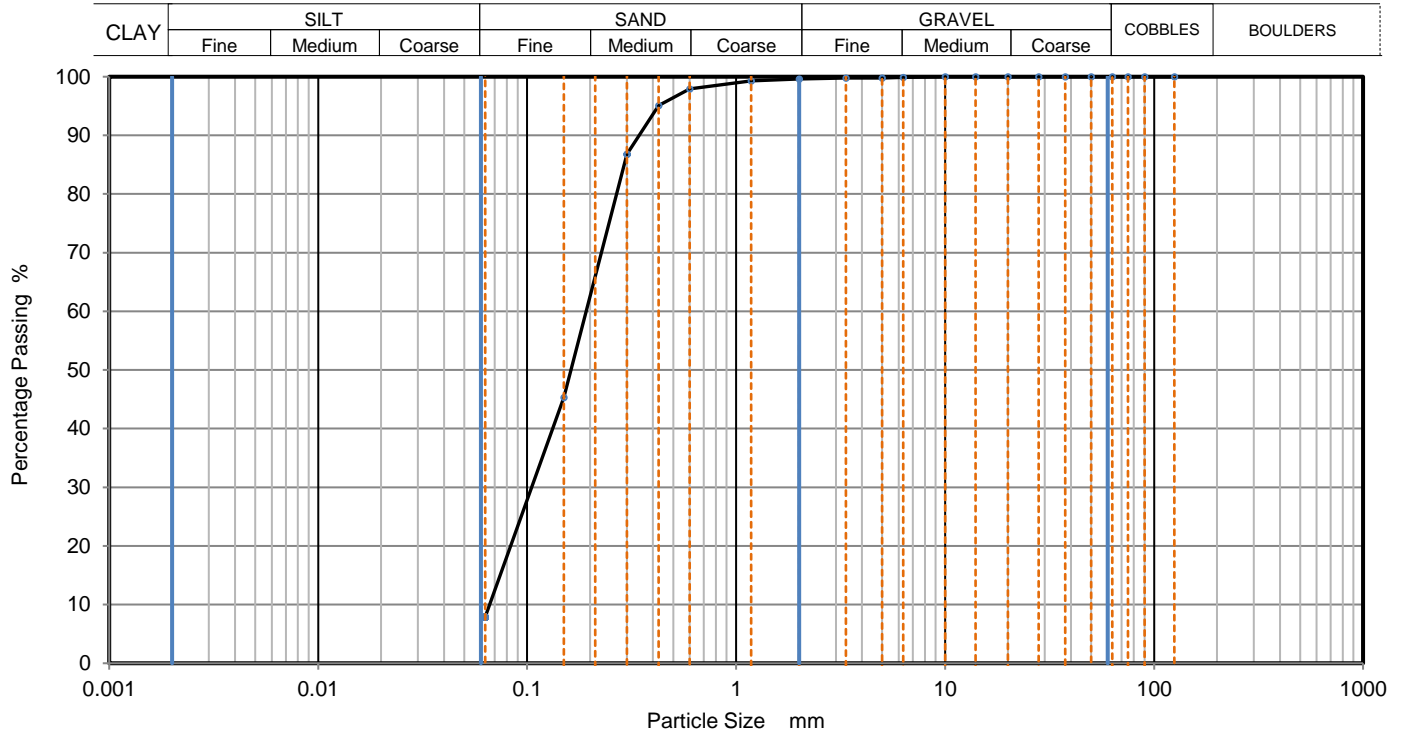
Operator	Checked	Approved	Sheet printed	<b>Fig 2</b>
Dev	Jude	Harry	31/10/2019	
				Sheet 4

<b>PARTICLE SIZE DISTRIBUTION</b>				Job Ref	<b>C251/19/L/372</b>
				Borehole/Pit No.	BH06
Site Name	Irlam, Stockport (YG 0134-19)			Sample No.	1
Soil Description	Grey SAND			Depth, m	4.60
Specimen Reference	D	Specimen Depth	4.6 m	Sample Type	D
Test Method	BS1377:Part 2:1990, clause 9.2			KeyLAB ID	RGS_201910189

Sieving		Sedimentation	
Particle Size mm	% Passing	Particle Size mm	% Passing
125	100		
90	100		
75	100		
63	100		
50	100		
37.5	100		
28	100		
20	100		
14	100		
10	100		
6.3	100		
5	100		
3.35	100		
2	100		
1.18	99		
0.6	98		
0.425	95		
0.3	87		
0.15	45		
0.063	8

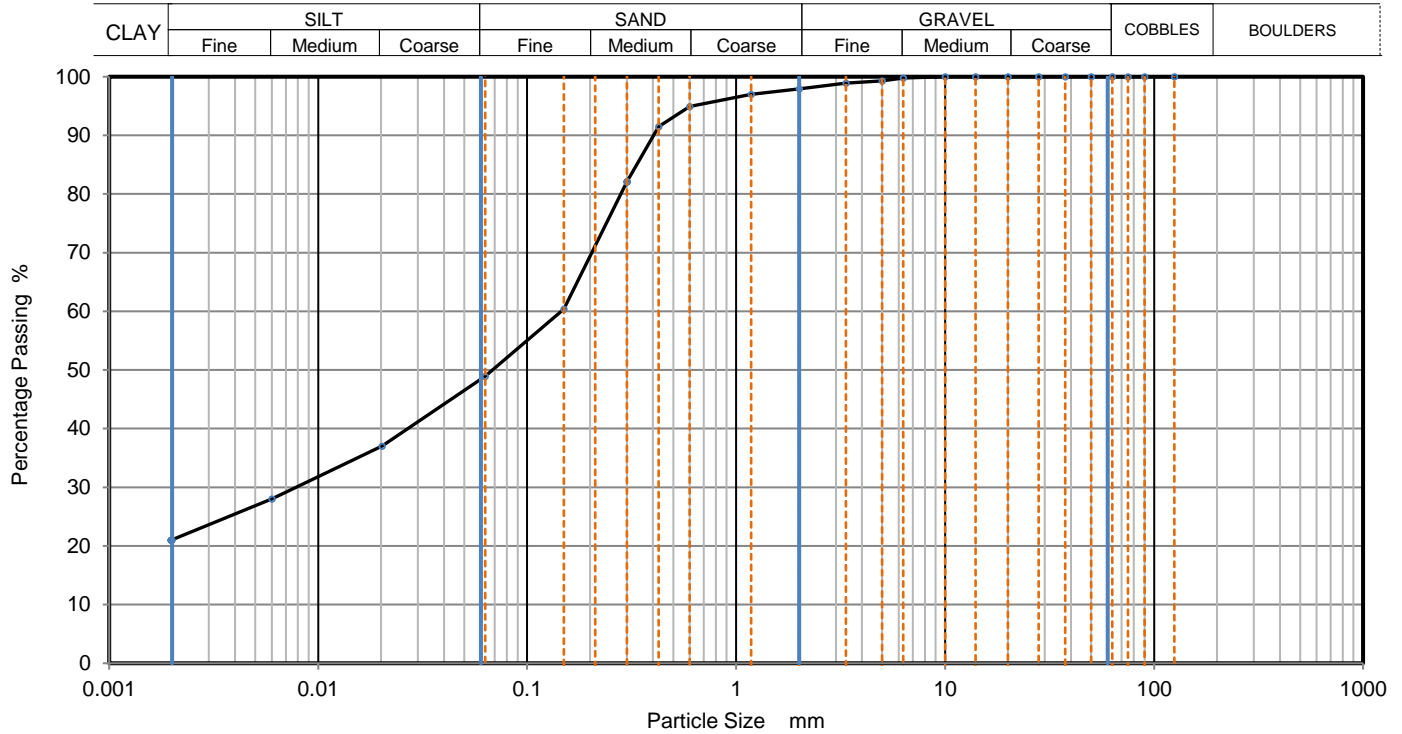
Operator	Checked	Approved	Sheet printed	<b>Fig 2</b>
Harry	Jude	Harry	31/10/2019	
				Sheet 5

<b>PARTICLE SIZE DISTRIBUTION</b>				Job Ref	<b>C251/19/L/372</b>
				Borehole/Pit No.	BH08
Site Name	Irlam, Stockport (YG 0134-19)			Sample No.	1
Soil Description	Brown clayey silty SAND			Depth, m	4.70
Specimen Reference	D1	Specimen Depth	4.7 m	Sample Type	D
Test Method	BS1377:Part 2:1990, clauses 9.2 and 9.4			KeyLAB ID	RGS_2019101810

Sieving		Sedimentation	
Particle Size mm	% Passing	Particle Size mm	% Passing
125	100	0.0202	37
90	100	0.0060	28
75	100	0.0020	21
63	100		
50	100		
37.5	100		
28	100		
20	100		
14	100		
10	100		
6.3	100		
5	99		
3.35	99		
2	98		
1.18	97		
0.6	95	Particle density (assumed) 2.65 Mg/m <sup>3</sup>	
0.425	92		
0.3	82		
0.15	60		
0.063	49

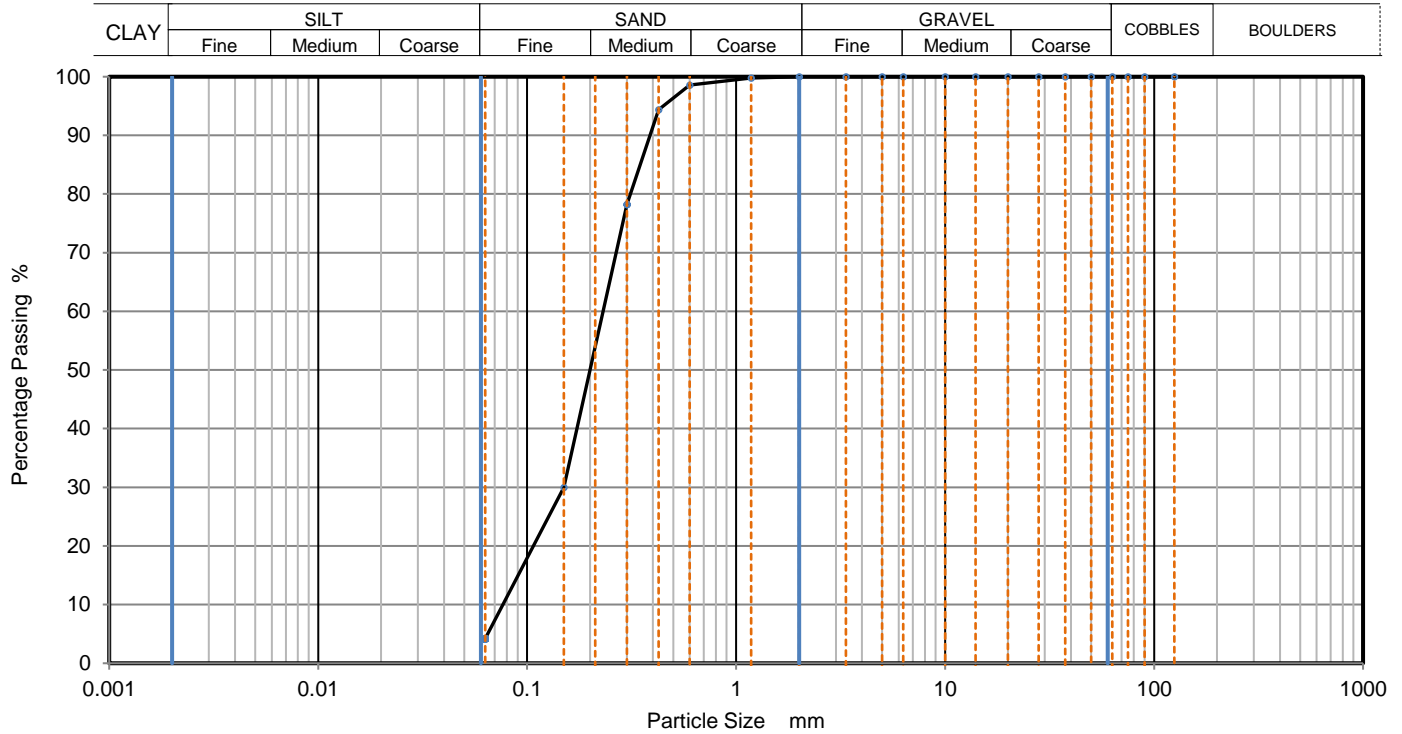
Operator	Checked	Approved	Sheet printed	<b>Fig 2</b>
Harry	Jude	Harry	31/10/2019	
				Sheet 6

<b>PARTICLE SIZE DISTRIBUTION</b>				Job Ref	<b>C251/19/L/372</b>
				Borehole/Pit No.	BH11
Site Name	Irlam, Stockport (YG 0134-19)			Sample No.	1
Soil Description	Greyish light brown SAND			Depth, m	2.60
Specimen Reference	D1	Specimen Depth	2.6 m	Sample Type	D
Test Method	BS1377:Part 2:1990, clause 9.2			KeyLAB ID	RGS_2019101811

Sieving		Sedimentation	
Particle Size mm	% Passing	Particle Size mm	% Passing
125	100		
90	100		
75	100		
63	100		
50	100		
37.5	100		
28	100		
20	100		
14	100		
10	100		
6.3	100		
5	100		
3.35	100		
2	100		
1.18	100		
0.6	99		
0.425	94		
0.3	78		
0.15	30		
0.063	4

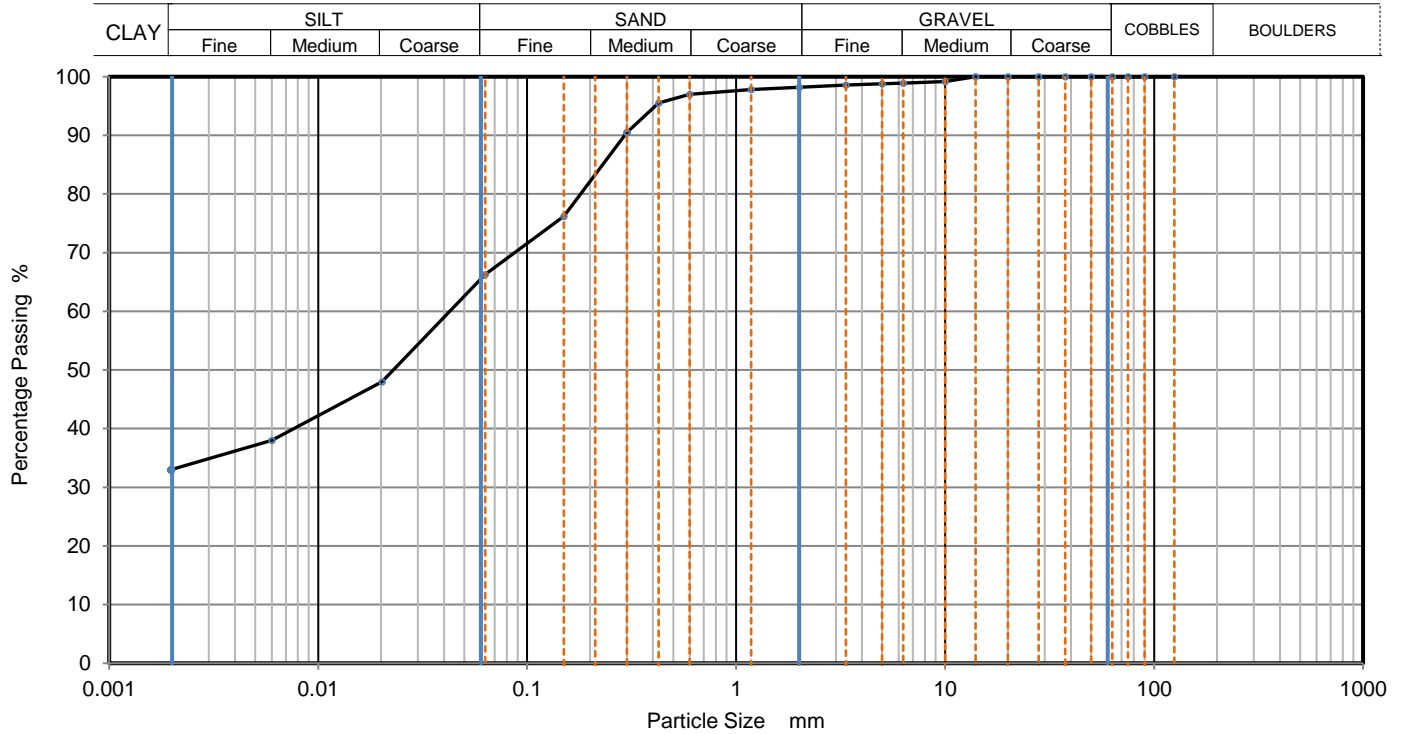
Operator	Checked	Approved	Sheet printed	<b>Fig 2</b>
Harry	Jude	Harry	31/10/2019	
				Sheet 7

<b>PARTICLE SIZE DISTRIBUTION</b>				Job Ref	<b>C251/19/L/372</b>
				Borehole/Pit No.	BH14
Site Name	Irlam, Stockport (YG 0134-19)			Sample No.	1
Soil Description	Dark brown sandy clayey SILT			Depth, m	4.70
Specimen Reference	D1	Specimen Depth	4.7 m	Sample Type	D
Test Method	BS1377:Part 2:1990, clauses 9.2 and 9.4			KeyLAB ID	RGS_2019101812

Sieving		Sedimentation	
Particle Size mm	% Passing	Particle Size mm	% Passing
125	100	0.0202	48
90	100	0.0060	38
75	100	0.0020	33
63	100		
50	100		
37.5	100		
28	100		
20	100		
14	100		
10	99		
6.3	99		
5	99		
3.35	99		
2	98		
1.18	98		
0.6	97	Particle density (assumed) 2.65 Mg/m <sup>3</sup>	
0.425	96		
0.3	91		
0.15	76		
0.063	66

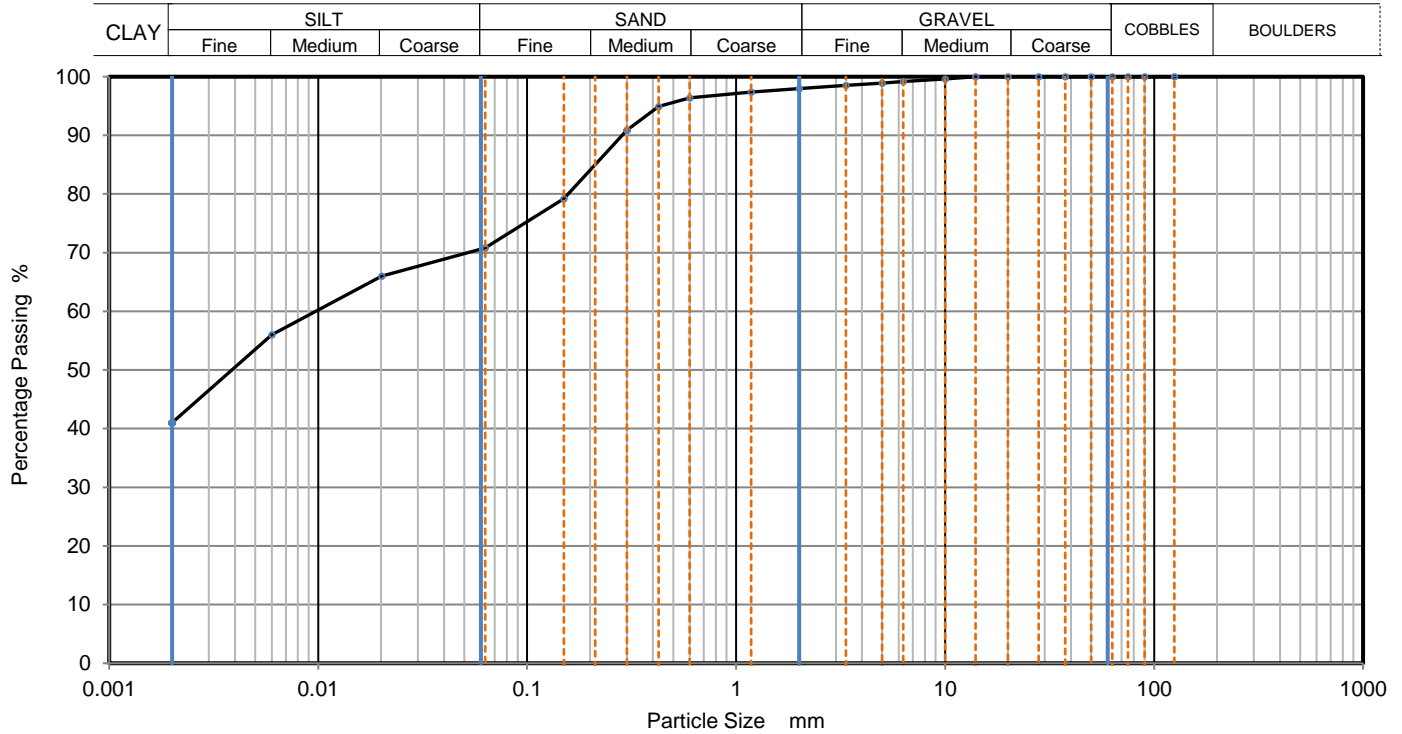
Operator	Checked	Approved	Sheet printed	<b>Fig 2</b>
Dev	Jude	Harry	31/10/2019	
				Sheet 8

<b>PARTICLE SIZE DISTRIBUTION</b>				Job Ref	<b>C251/19/L/372</b>
				Borehole/Pit No.	BH15
Site Name	Irlam, Stockport (YG 0134-19)			Sample No.	1
Soil Description	Reddish brown sandy silty CLAY			Depth, m	4.80
Specimen Reference	D1	Specimen Depth	4.8 m	Sample Type	D
Test Method	BS1377:Part 2:1990, clauses 9.2 and 9.4			KeyLAB ID	RGS_2019101813

Sieving		Sedimentation	
Particle Size mm	% Passing	Particle Size mm	% Passing
125	100	0.0201	66
90	100	0.0060	56
75	100	0.0020	41
63	100		
50	100		
37.5	100		
28	100		
20	100		
14	100		
10	100		
6.3	99		
5	99		
3.35	99		
2	98		
1.18	97		
0.6	96		
0.425	95	Particle density (assumed) 2.65 Mg/m <sup>3</sup>	
0.3	91		
0.15	79		
0.063	71

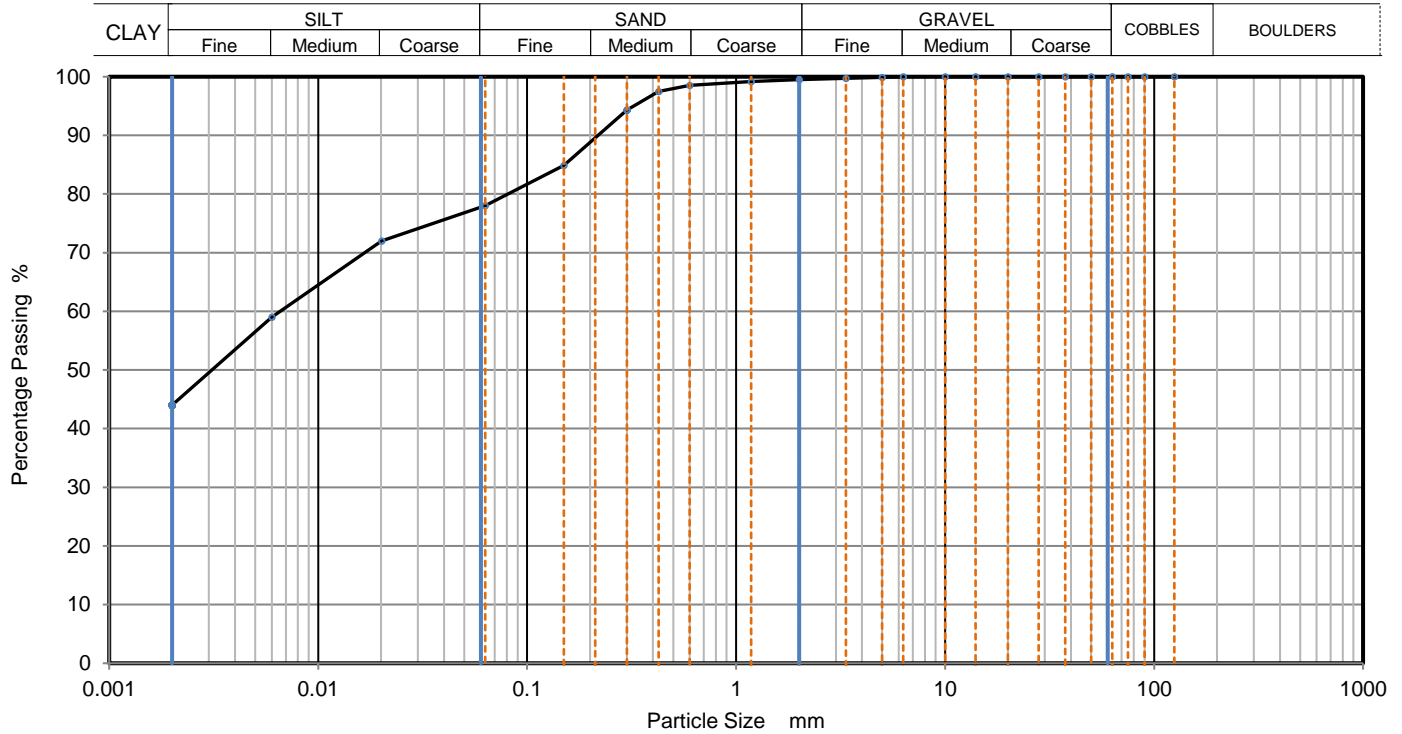
Operator	Checked	Approved	Sheet printed	<b>Fig 2</b>
Dev	Jude	Harry	31/10/2019	
				Sheet 9

<b>PARTICLE SIZE DISTRIBUTION</b>				Job Ref	<b>C251/19/L/372</b>
				Borehole/Pit No.	BH17
Site Name	Irlam, Stockport (YG 0134-19)			Sample No.	1
Soil Description	Brown sandy silty CLAY			Depth, m	5.80
Specimen Reference	D1	Specimen Depth	5.8 m	Sample Type	D
Test Method	BS1377:Part 2:1990, clauses 9.2 and 9.4			KeyLAB ID	RGS_2019101814

Sieving		Sedimentation	
Particle Size mm	% Passing	Particle Size mm	% Passing
125	100	0.0201	72
90	100	0.0060	59
75	100	0.0020	44
63	100		
50	100		
37.5	100		
28	100		
20	100		
14	100		
10	100		
6.3	100		
5	100		
3.35	100		
2	100		
1.18	99		
0.6	99	Particle density (assumed) 2.65 Mg/m <sup>3</sup>	
0.425	98		
0.3	94		
0.15	85		
0.063	78

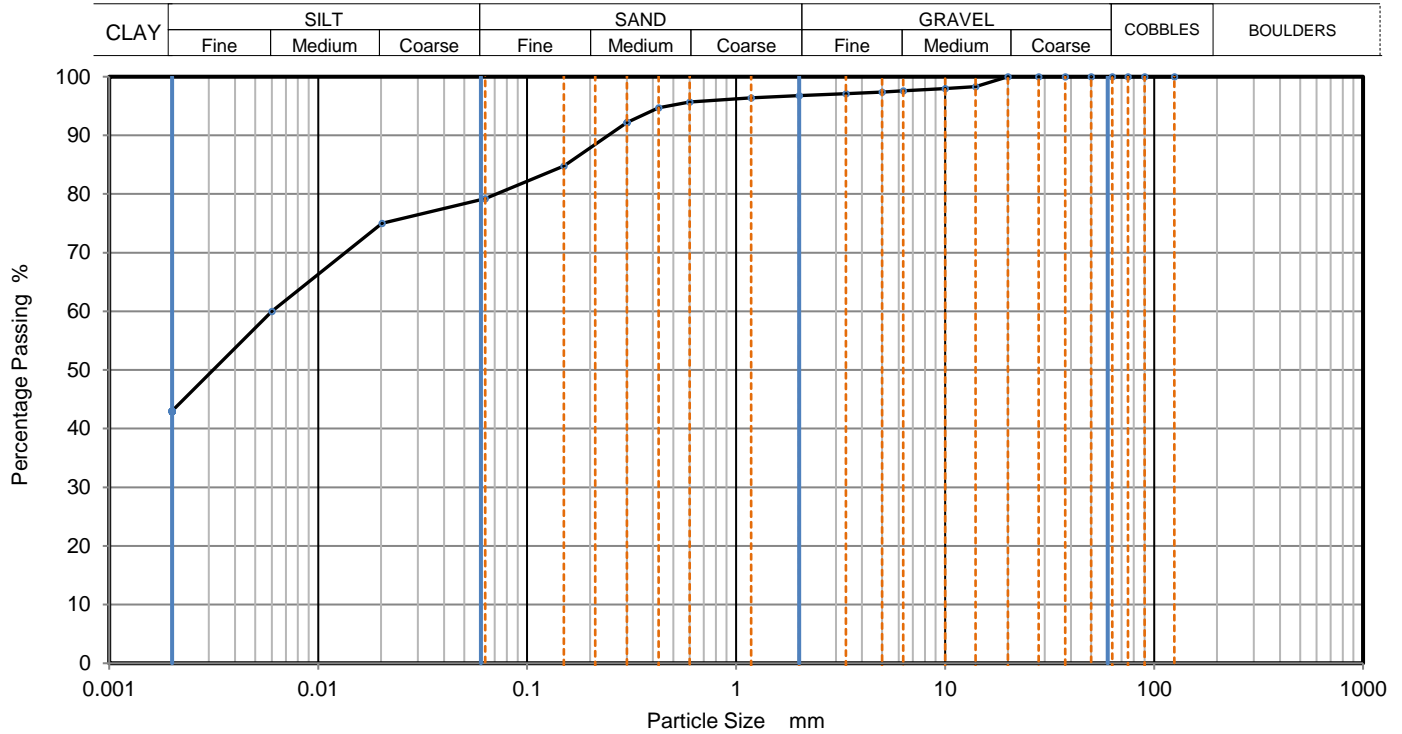
Operator	Checked	Approved	Sheet printed	<b>Fig 2</b>
Harry	Jude	Harry	31/10/2019	
				Sheet 10

<b>PARTICLE SIZE DISTRIBUTION</b>				Job Ref	<b>C251/19/L/372</b>
				Borehole/Pit No.	BH18
Site Name	Irlam, Stockport (YG 0134-19)			Sample No.	1
Soil Description	Brown slightly sandy silty CLAY			Depth, m	5.00
Specimen Reference	D1	Specimen Depth	5 m	Sample Type	D
Test Method	BS1377:Part 2:1990, clauses 9.2 and 9.4			KeyLAB ID	RGS_2019101815

Sieving		Sedimentation	
Particle Size mm	% Passing	Particle Size mm	% Passing
125	100	0.0202	75
90	100	0.0060	60
75	100	0.0020	43
63	100		
50	100		
37.5	100		
28	100		
20	100		
14	98		
10	98		
6.3	98		
5	97		
3.35	97		
2	97		
1.18	96		
0.6	96	Particle density (assumed) 2.65 Mg/m <sup>3</sup>	
0.425	95		
0.3	92		
0.15	85		
0.063	79

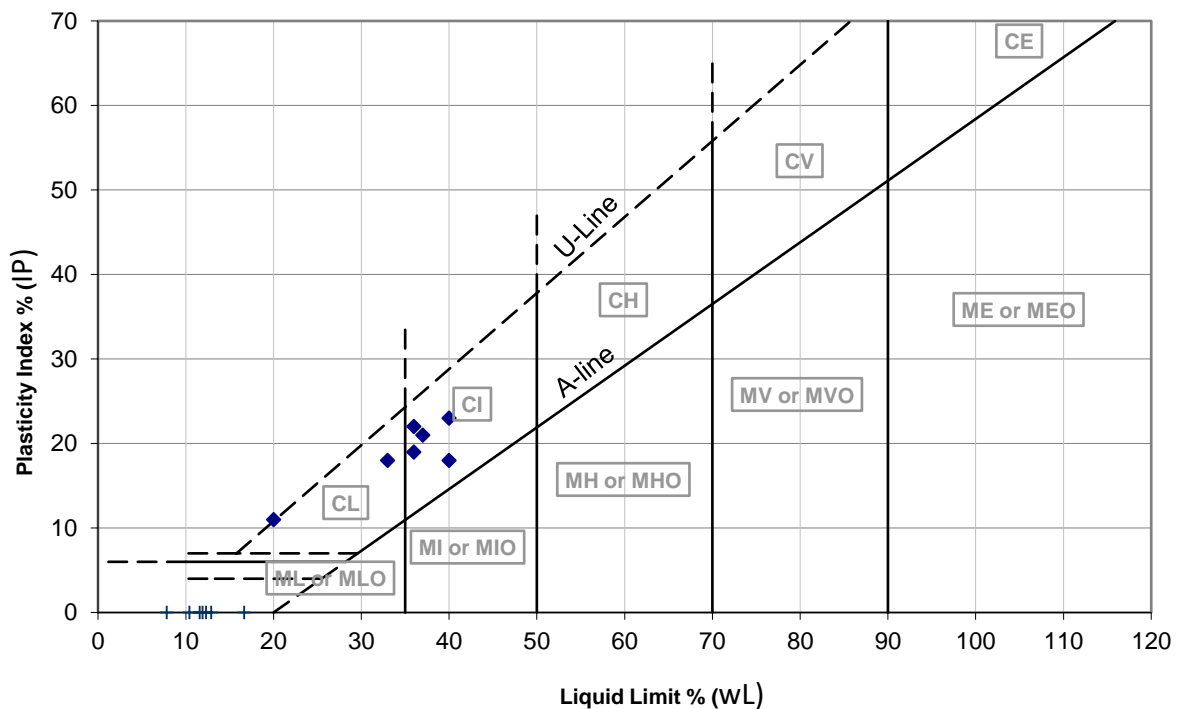
## Interpretation of Moisture Content, Liquid and Plastic Limits

Location	Depth (m)	Moisture Content	Liquid Limit	Plastic Limit	Plasticity Index	Retained by 0.425mm	Modified (w)	Modified (I <sub>p</sub> )	Liquidity/Consistency		Casagrande Class	N.H.B.C Class (%)
		(w) (%)	(w <sub>L</sub> ) (%)	(w <sub>P</sub> ) (%)	(I <sub>P</sub> ) (%)	(%)	(w') (%)	(I <sub>P</sub> ) (%)	(I <sub>L</sub> ) (%)	(I <sub>C</sub> ) (%)		
WS01	5.00	15	20	9	11	1	15	11	0.5	0.5	C? L	LOW
WS02	4.00	19	33	15	18	1	19	18	0.2	0.8	C L	LOW
WS08	5.00	18	36	14	22	2	18	22	0.2	0.8	C I	MEDIUM
WS14	5.00	19	36	17	19	0	19	19	0.1	0.9	C I	LOW
WS15	5.00	22	40	17	23	4	23	22	0.2	0.8	C I	MEDIUM
WS17	6.00	26	37	16	21	4	27	20	0.5	0.5	C I	MEDIUM
WS18	4.50	24	40	22	18	0	24	18	0.1	0.9	C I	LOW

<b>Borehole/Sample Depth (m bgl)</b>	<b>Moisture Content (%)</b>	<b>Liquid Limit (%)</b>	<b>Plastic Limit (%)</b>	<b>Plasticity Index (PI)</b>	<b>Casagrande Class</b>
BH01/5.0	15	20	9	11	CL
BH02/4.0	19	33	15	18	CL
BH08/5.0	18	36	14	22	CI
BH14/5.0	19	36	17	19	CI
BH15/5.0	22	40	17	23	CI
BH17/6.0	26	37	16	21	CI
BH18/4.5	24	40	22	18	CI
