# PRELIMINARY RISK ASSESSMENT (Phase 1 Desk Study)

# GMSF Allocation: Land North of Irlam Station Irlam M28 0AZ

Date: 14<sup>th</sup> September 2020 Job Ref: UV/0088926-01-0010

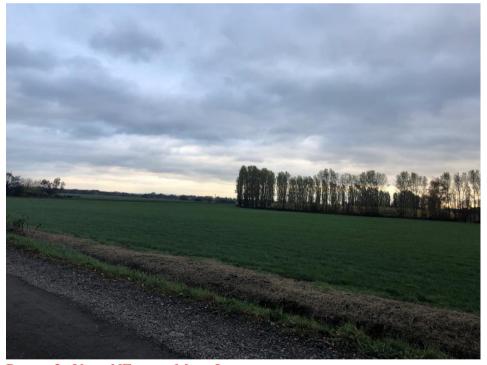
PHOTO 2: VIEW NE FROM MOSS LANE – DRAINAGE DITCH IN FOREGROUND

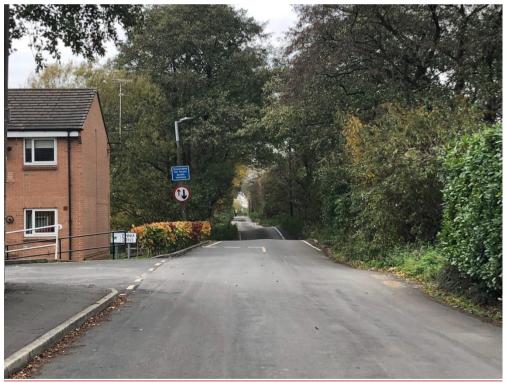
Astley Road itself transects the site in a north-westerly direction. At the point where Astley Road enters the site there is significant subsidence of the road surface (see photograph 4 in appendix F). Astley Road is bounded on both sides by drainage ditches. No significant features within the site were observed.

PHOTO 4: VIEW N ALONG ASTLEY ROAD INTO THE SITE (SEVERE SUBSIDENCE OBSERVED)

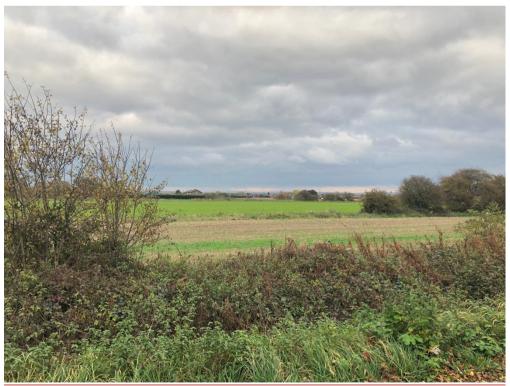
PHOTO 6: VIEW E FROM ASTLEY LANE TOWARDS ROSCOE ROAD (DRAINAGE DITCH IN FOREGROUND)

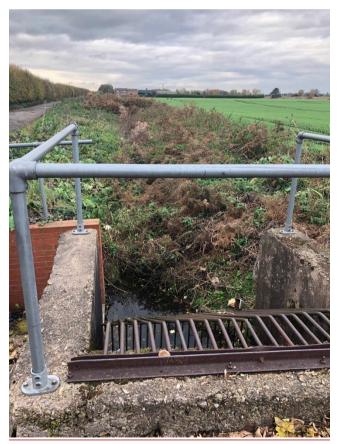
PHOTO 10: VIEW NW UP ROSCOE ROAD – END OF FIELD DRAIN ENTERING CULVERT
