## **Historic Environment Assessment**

GMSF Land  
Allocations, Trafford

GMA45 New  
Carrington

Appendix 3 (Built  
Heritage)

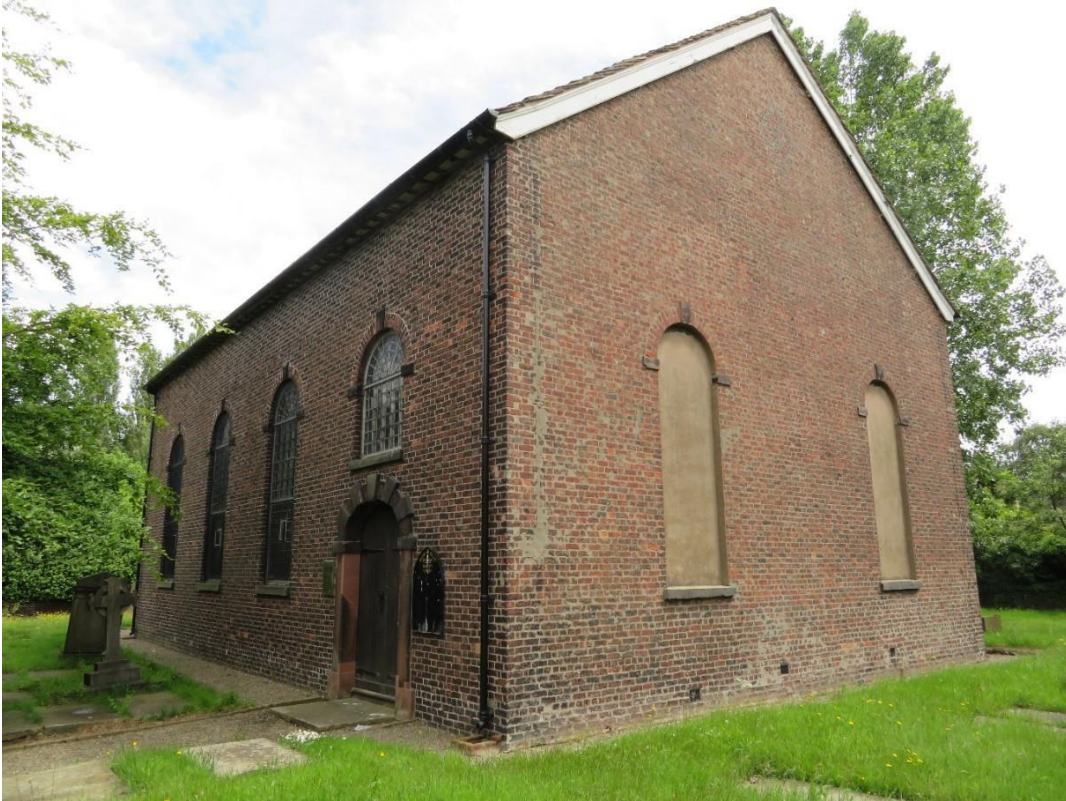
*Plate 1: Church of St George*

The Church was commissioned by Mary, Countess of Stamford, designed by Isaac Shaw and was built between 1757 and 1759. It is listed at Grade II\* as it has only had minor alterations since construction and retains a number of original fixtures and fittings, both externally and internally. Historic England notes that “This church, which is in the care of the Churches Conservation Trust, is outstanding as a remarkably little altered mid-18<sup>th</sup> Century small church which retains so many of its original fittings intact”. The Church is constructed of handmade brick, laid in Flemish bond with a graduated stone slate roof. It is a tall, single storey building, 4 x 2 bays with a round-headed arched window within each bay. All windows except one retain their original oak frames and original glazing in the upper half of the lights. The elliptical arched door has a rusticated stone surround and the original oak-boarded entrance doors retain their iron strap hinges as well. There are a number of original fixtures and fittings surviving internally as well, including box pews, plasterwork and flooring.

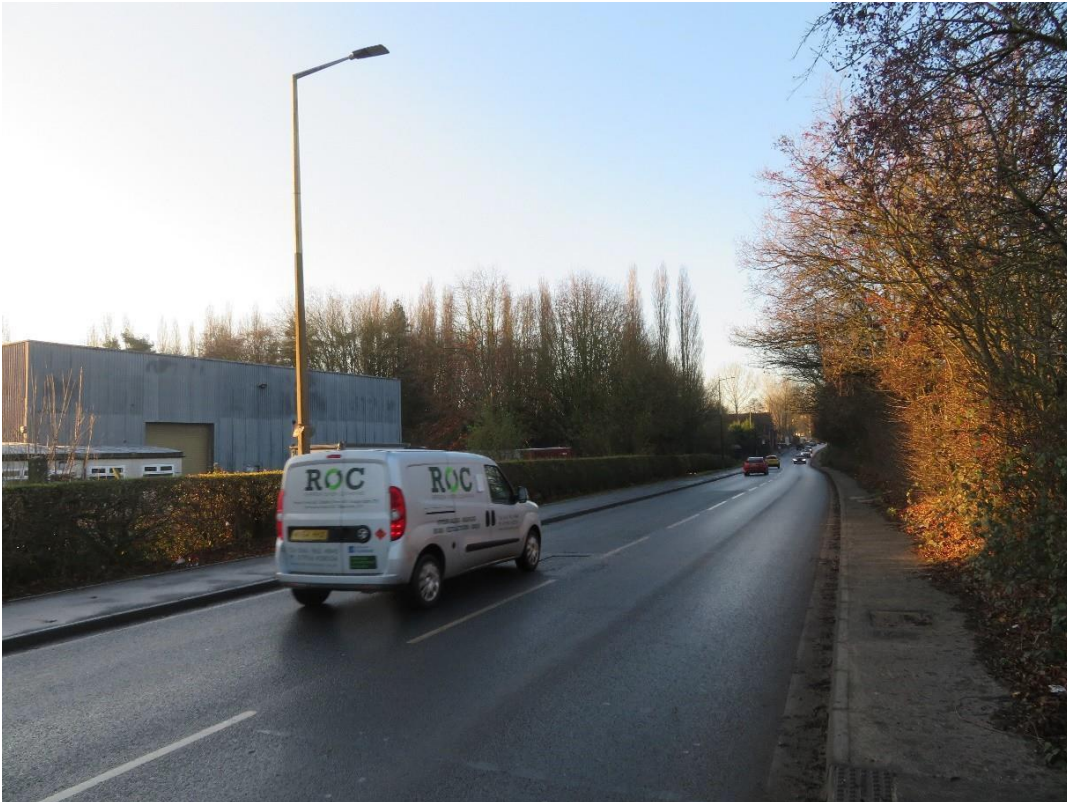
*Plate 2 Looking south-westwards towards the church which is screened from the surrounding industrial development*

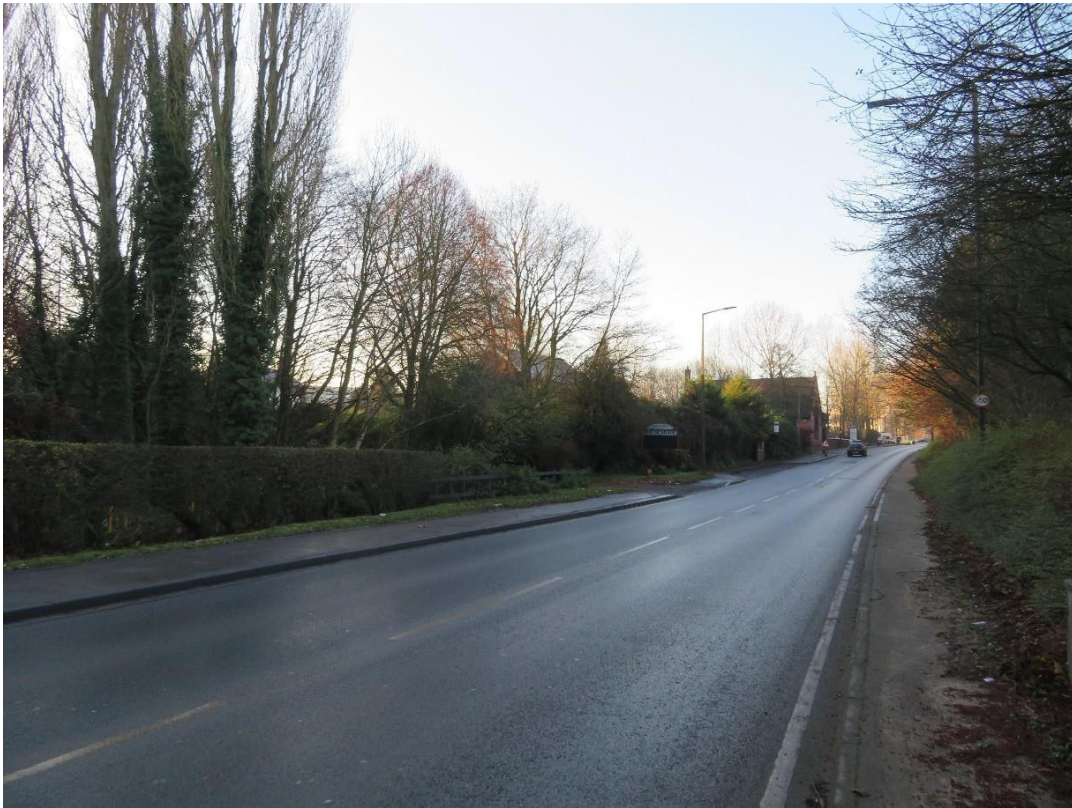
*Plate 3 Looking south-westwards towards the church. The upper part of it is just visible from the main road. Note the Sunday school in the middle distance*

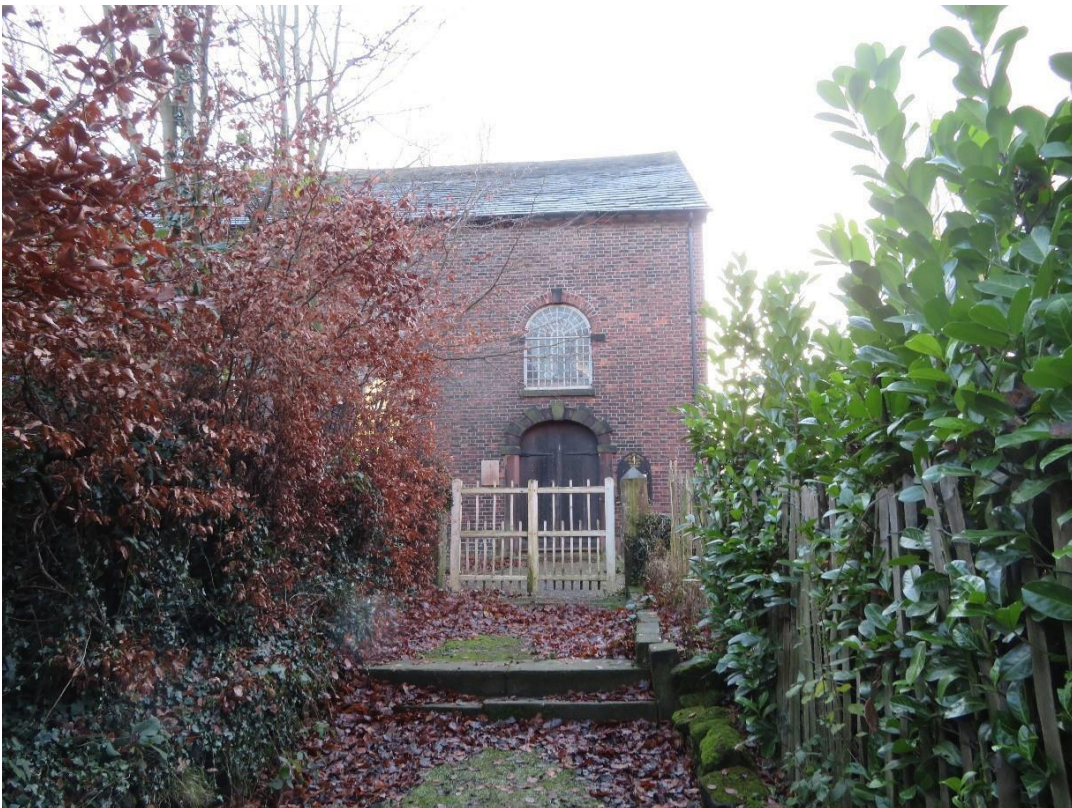
*Plate 4 Looking south-east along the public access towards the church. Note the closed views towards the church*

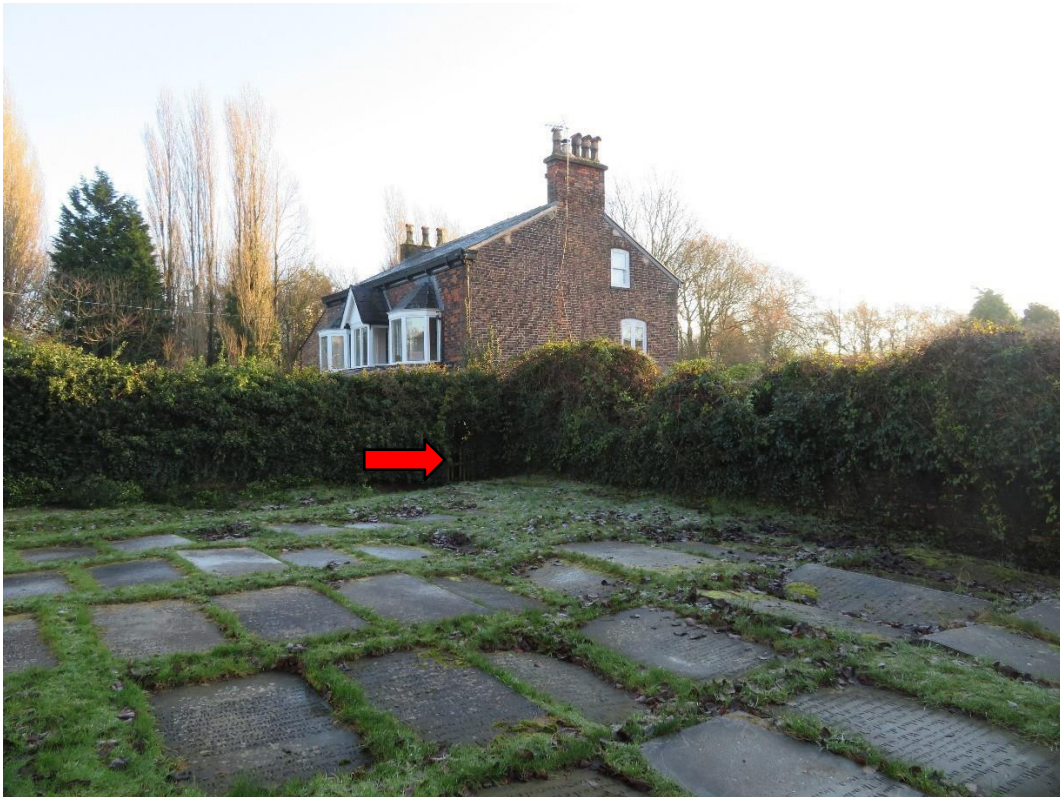
*Plate 5 Looking south-east towards the vicarage which has a strong visual connection with the church. The original entrance for the priest to access the church is heavily overgrown (arrowed)*

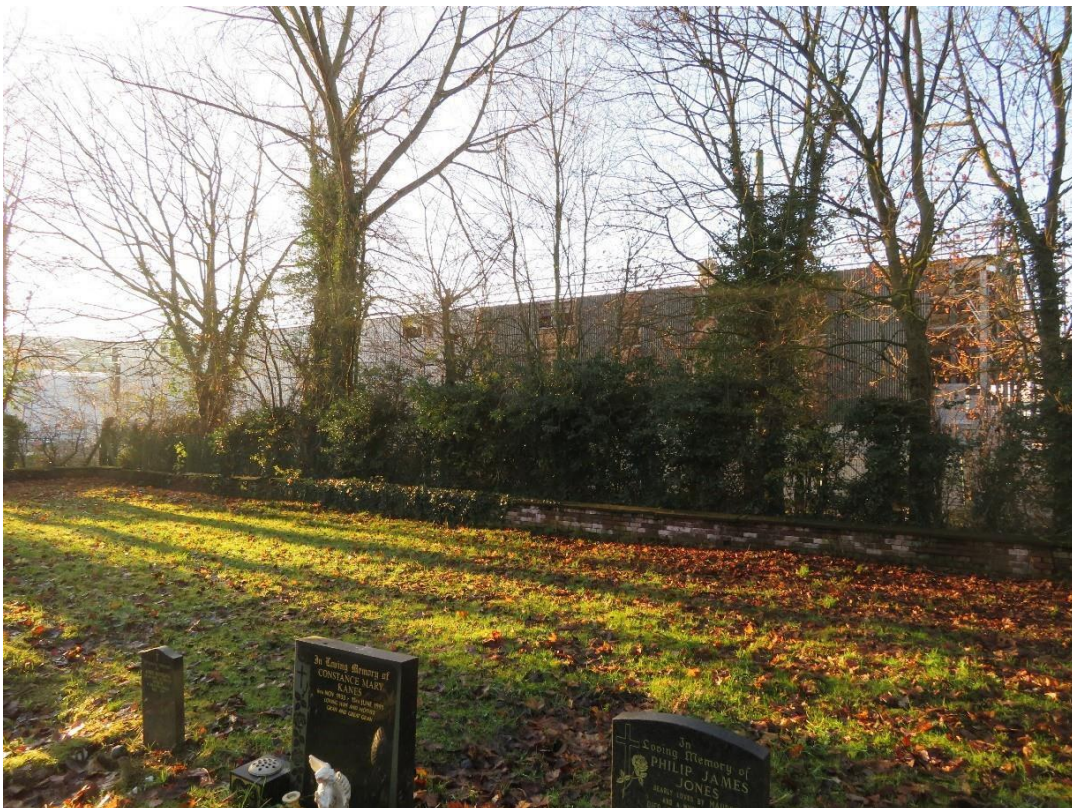
*Plate 6 Looking south towards the new Industrial development, visible through the screening*

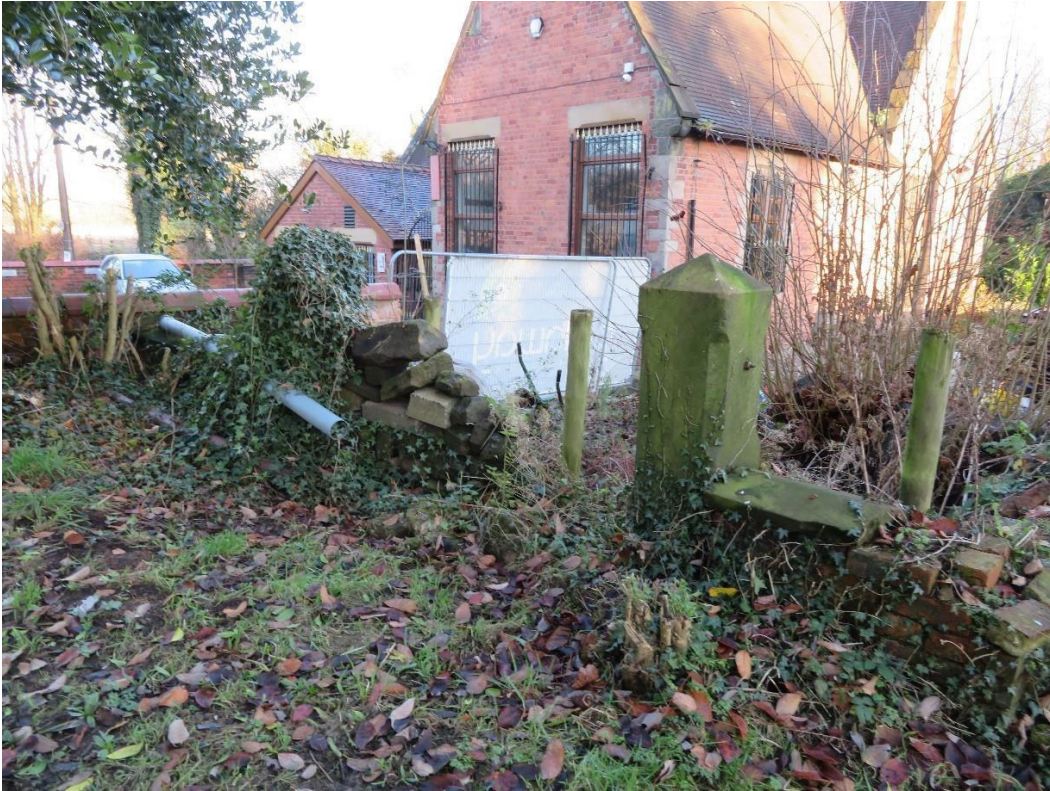
*Plate 7 Looking north-east towards the Sunday school. The original boundary and access to the graveyard is in a poor state of repair*

- Restore and reopen the Church as a community asset to benefit the new inflow of residents to the area following development of the land allocation.
- Carry out research on the Church and the School, particularly on those buried there and attendees of the School.
- Work to re-reveal ledger stones and carry out repair work, including repair and maintenance of the boundary wall. Although generally well kept, the majority of

burials lie under flat stones and a number have these have sunk and are damaged through subsidence; some of the stones are illegible and are overgrown. Some of this research and conservation could be carried out by local members of the community, to re- establish the church as a centre of the community for future Carrington residents.

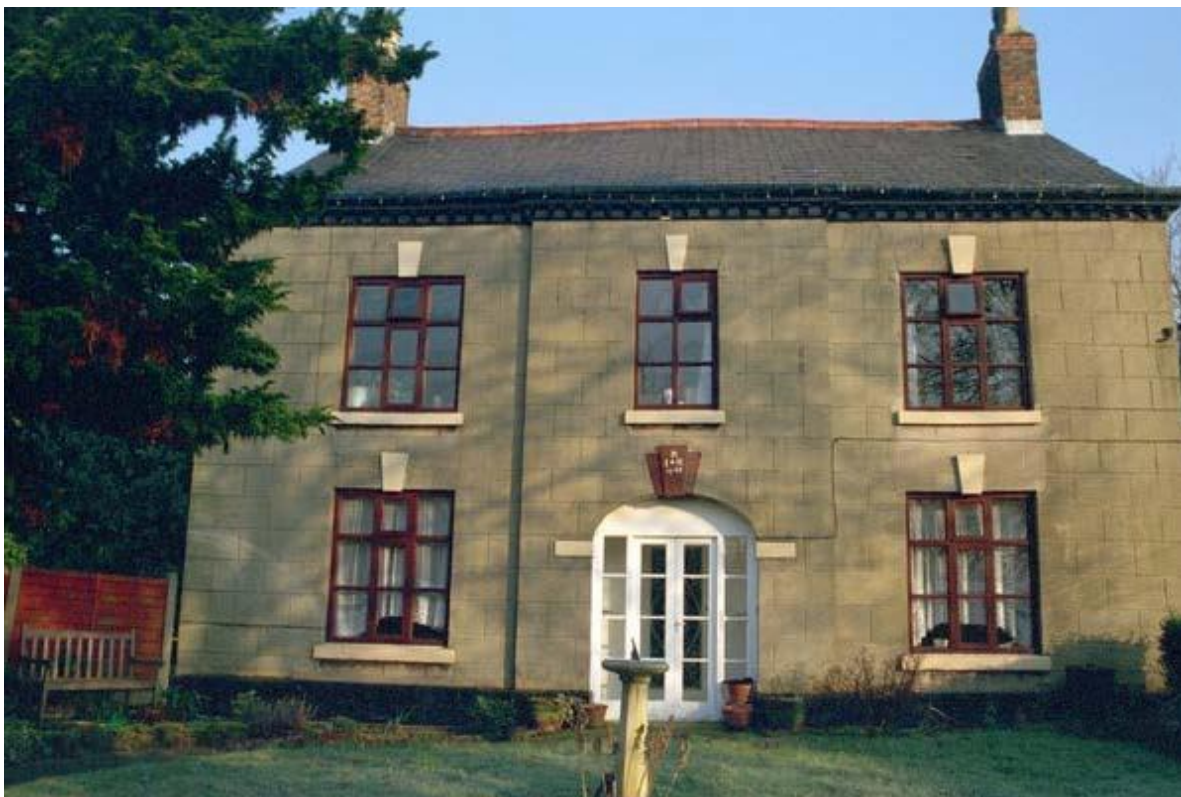
Westwood Lodge (formerly known as Dambank Farm) is a Grade II listed building erected in the mid-18<sup>th</sup> century in a neo classical style. The residential property utilises a typical Georgian, double depth central staircase plan. The principal elevation faces Crampton Lane and is separated by a spacious garden with mature planting, 5 bar gate and vehicular access. Symmetrical in design, the building is enlivened with classical detailing such as a projecting plinth, modillion eaves cornice, keystones, elliptical arches and slightly advanced central-bay. The 1841 tithe map identifies the owner of the farm as Isaac Collins and he owned a large area of adjacent land.

*Plate 8 Westwood Lodge photographed in 2001, prior to rendering © IoE Mr Barrie  
S. Dixon (Historic England Archive)*

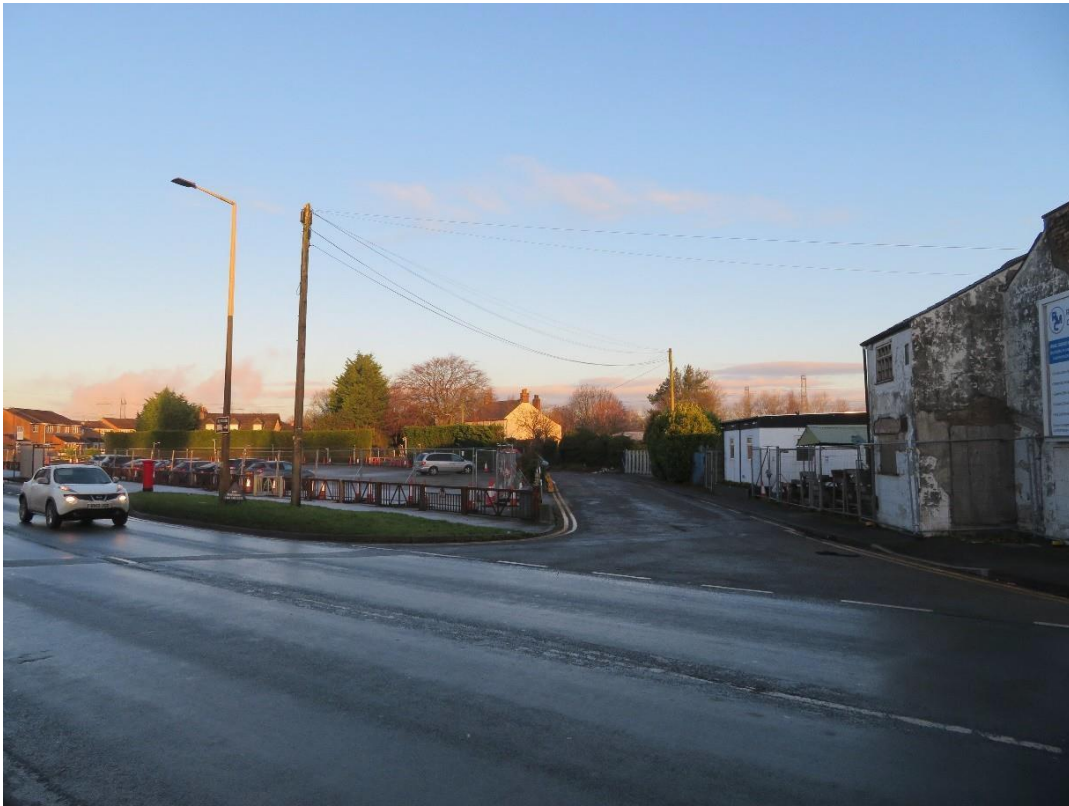
*Plate 9 Looking north-west from Manchester Road towards Westwood Lodge.*

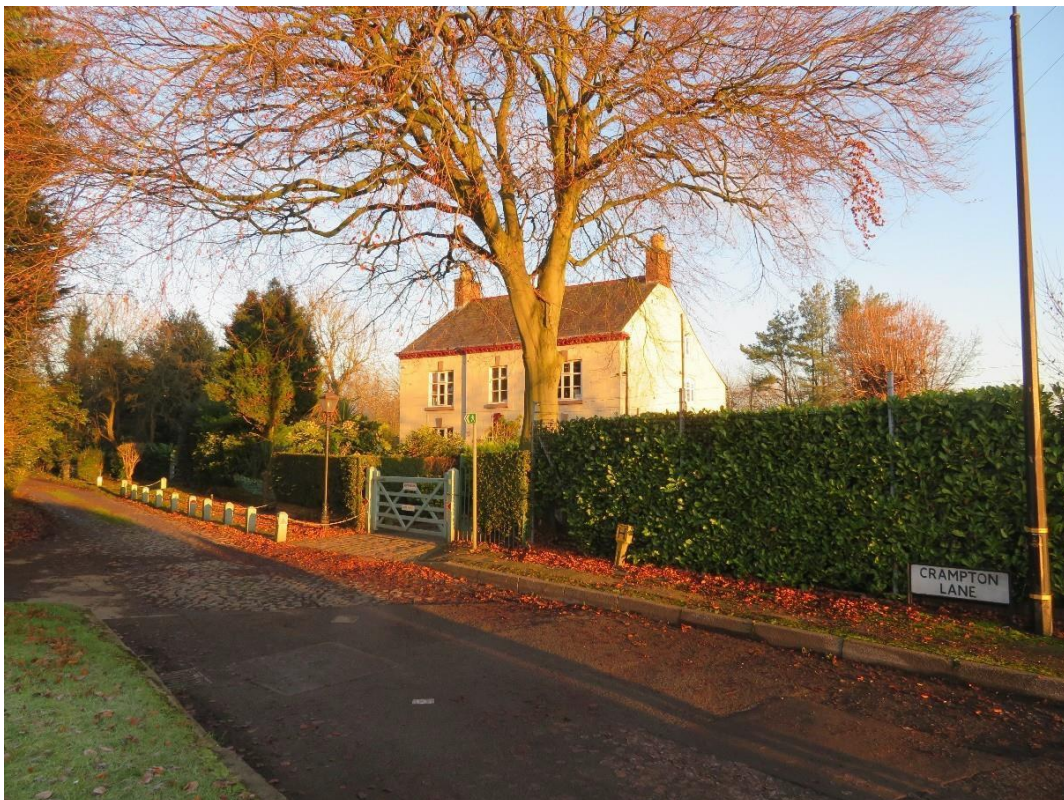
*Plate 10 Looking north-west towards Westwood Lodge. Note the survival of the cobbled road and the former Crampton Lane*

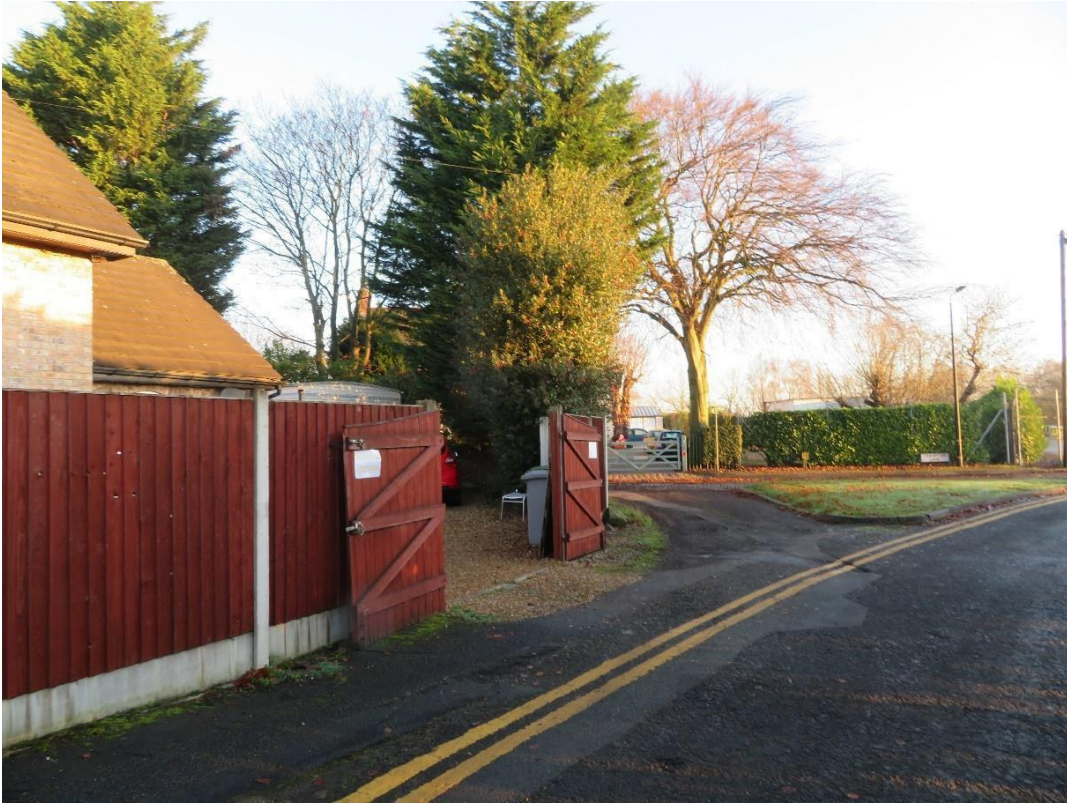
*Plate 11 Looking north-east towards Westwood Lodge. Views are partially blocked by trees and later housing*

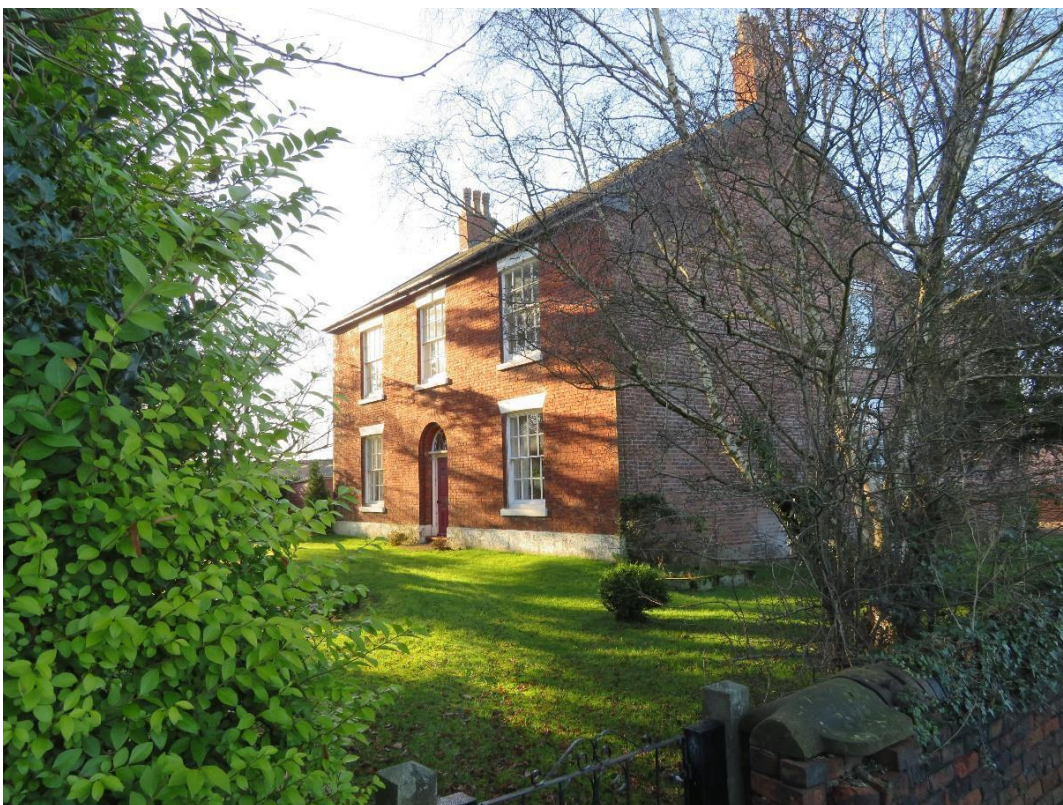
*Plate 12 Ackers Farmhouse*

Ackers Farmhouse was built between 1840 and 1870 (not 1830 as stated on the National Heritage List) and is constructed of handmade brick in Flemish bond with a graduated slate roof. It is two storeys, built on a double-depth staircase plan with a wing to the rear. It has a symmetrical elevation with a central 6-panel door, 3 bays and a stone plinth. At the time of listing in 1987, a number of original features had been retained including a dogleg stair with rosewood handrail, 6-panel doors and fireplaces.

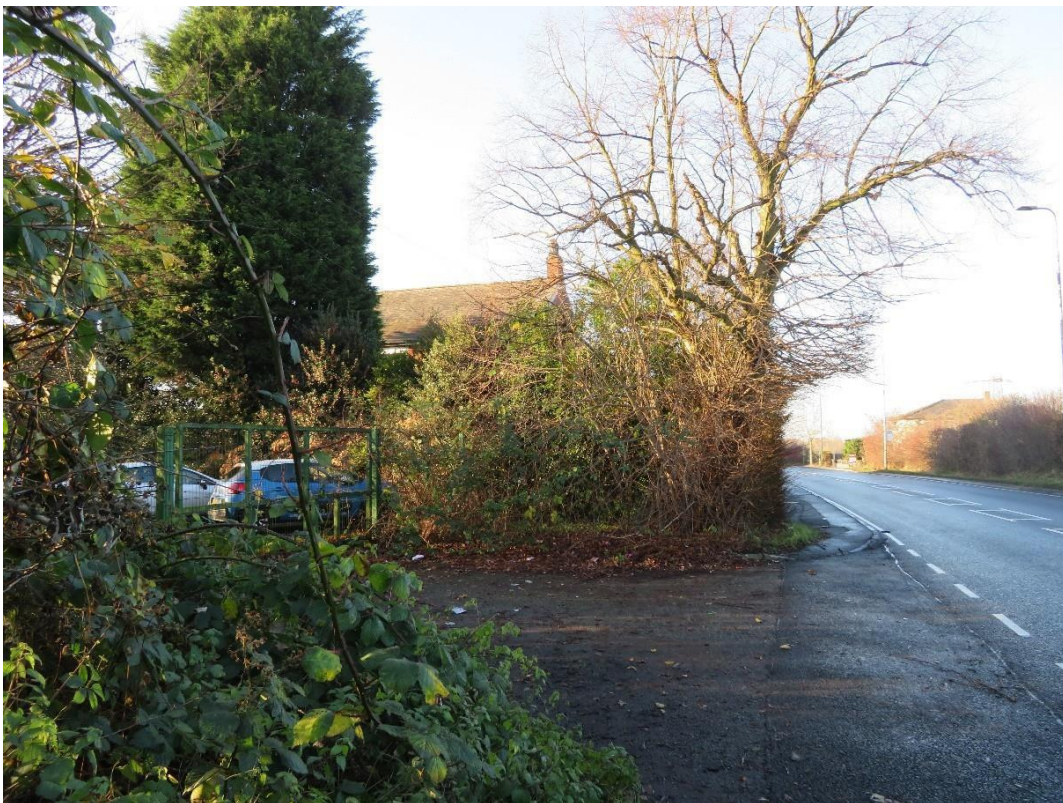
*Plate 13 Looking west from Manchester Road. Only the upper part of the farmhouse is in view*

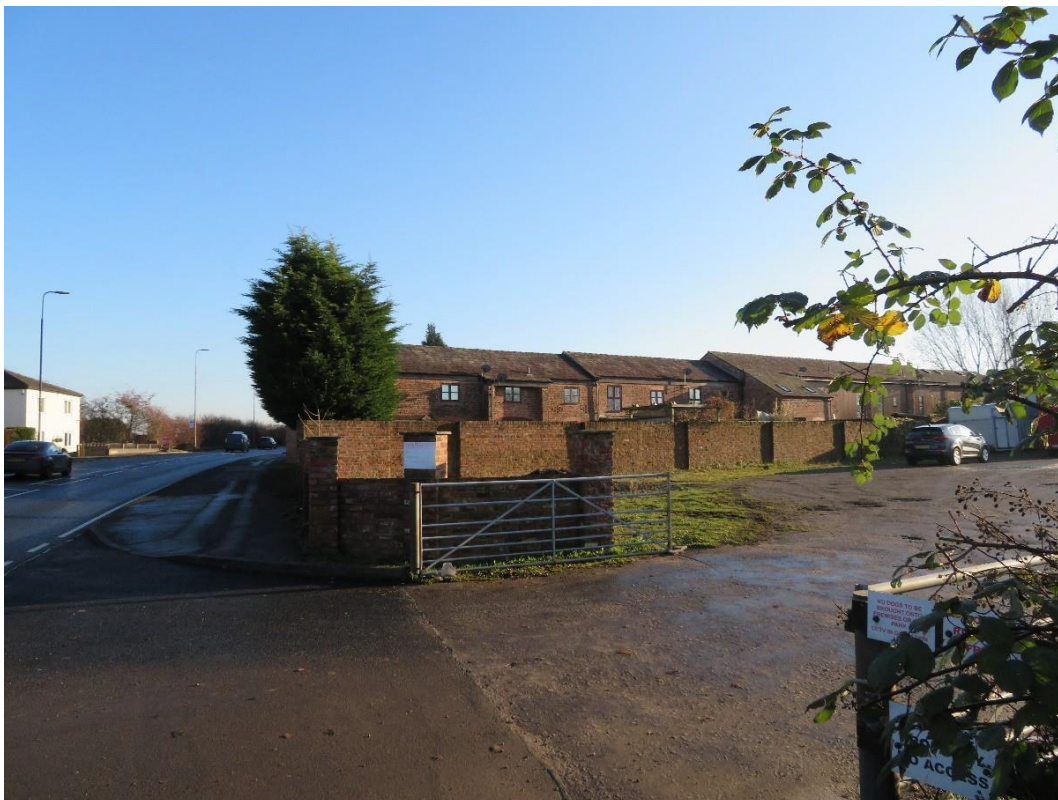
*Plate 14 Looking south-east towards the barn at Ackers Farm. This blocks any views towards the farmhouse*

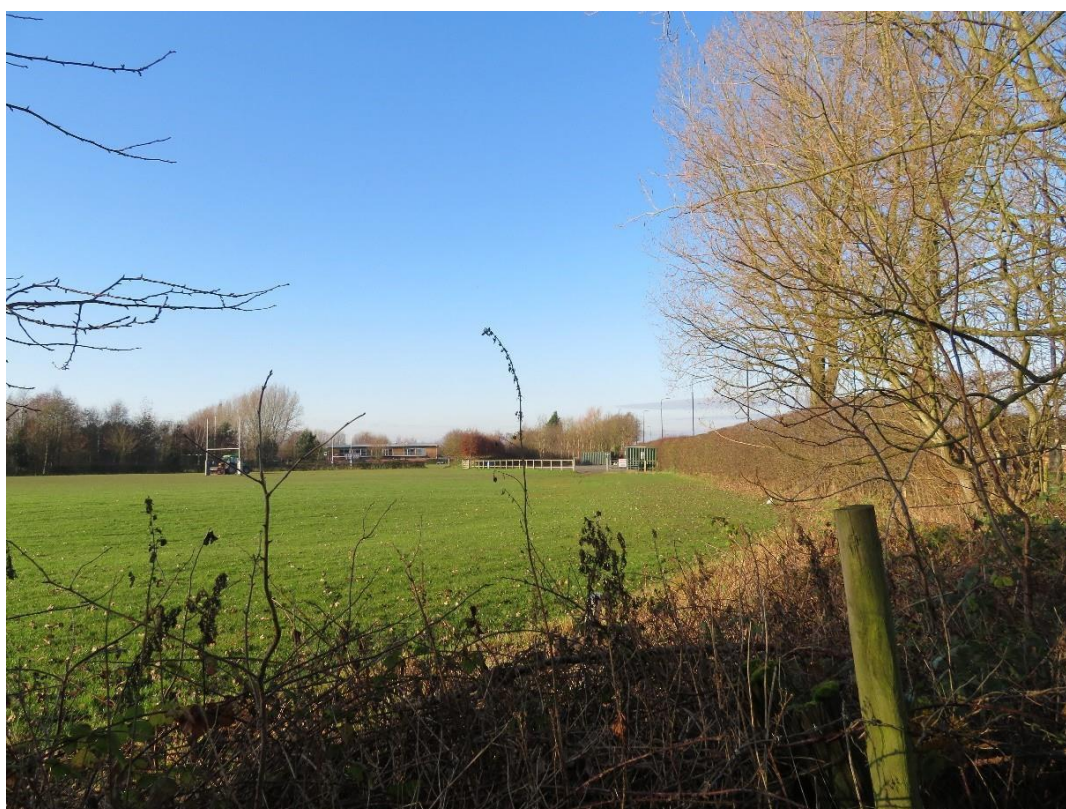
*Plate 15 Looking across the rugby training pitches towards Ackers Farmhouse, which is not visible from this distance*

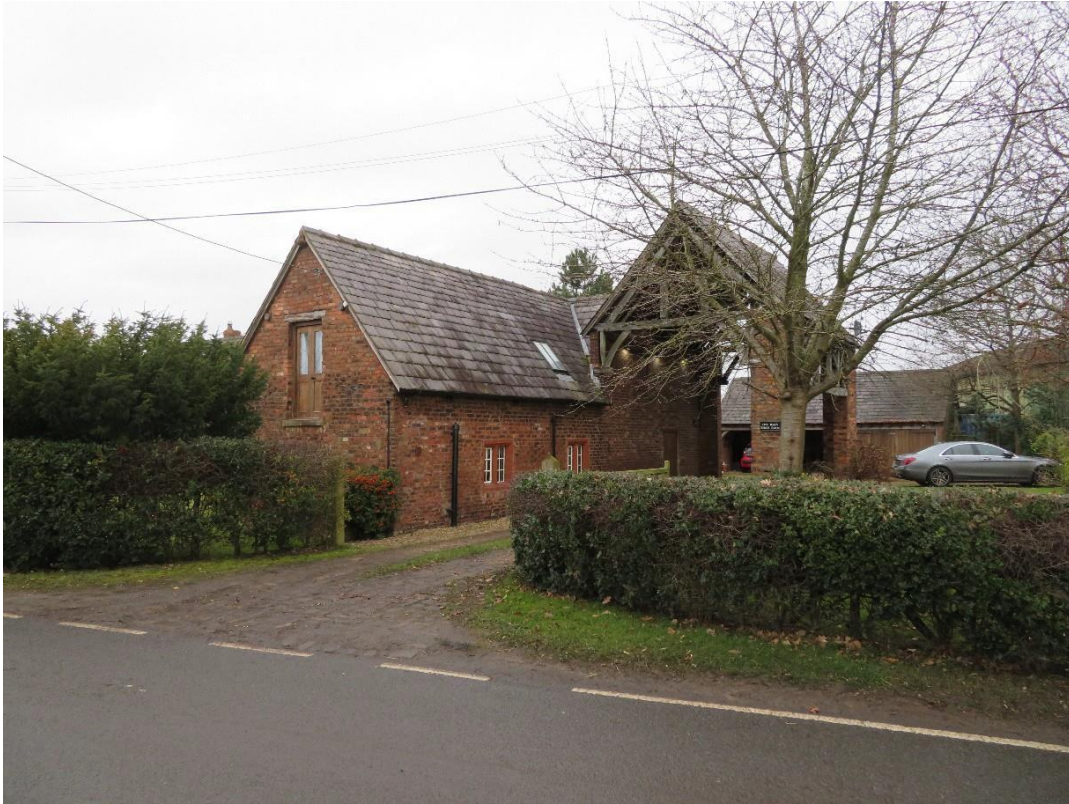
*Plate 16 The barn at Birch Farm*

The barn at Birch Farm is part of a larger, well preserved, historic farmstead and it is mostly 18<sup>th</sup> century in construction, however it incorporates cruck timber framing which could be 17<sup>th</sup> century or earlier. It is constructed of handmade brick in English Garden Wall bond and has a slate roof. The two storey wing to the south includes a shippon and hayloft and there are diamond shaped honeycomb breathers. The cruck frames stand either side of the former threshing floor and have collar yokes and tie beams. The farmhouse is probably late 18<sup>th</sup> century in date (though this may have earlier origins, with evidence for older timbers inside) however a second barn to the rear appears to be earlier, with evidence for timber framing and is thought to be 17<sup>th</sup> century in date. Attached to this is what appears to be a single storey pig sty as well as other late 19<sup>th</sup> century outbuildings to the north of the farmhouse. There are a number of 20<sup>th</sup> century farm buildings which were added to the north and east side of the farmstead. The Grade II listed barn has been converted into residential use and is in separate ownership to the rest of the farm, however there is still a discernible dispersed plan and close visual connection between the historic farm buildings. Therefore the farmhouse, a second barn, pig sty and 'shant' are considered to be curtilage.

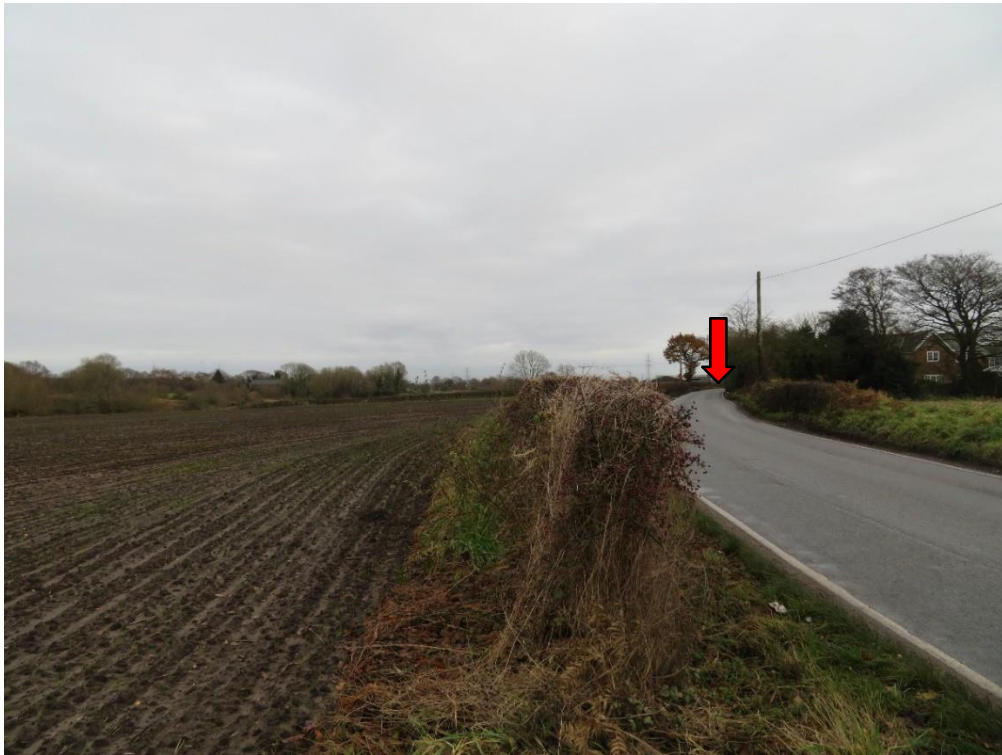
*Plate 17 Looking east towards Birch Farm. The barn and farmstead just comes into view along the lane here (arrowed)*

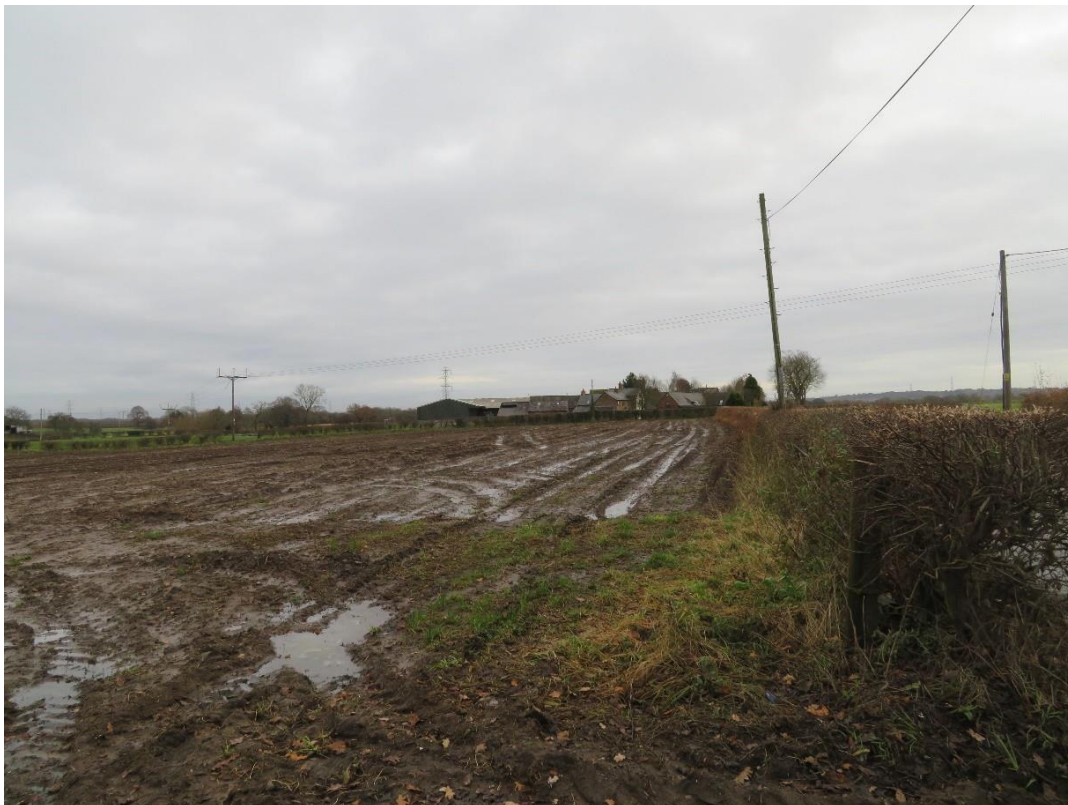
*Plate 18 Looking east across the agricultural land towards the barn*

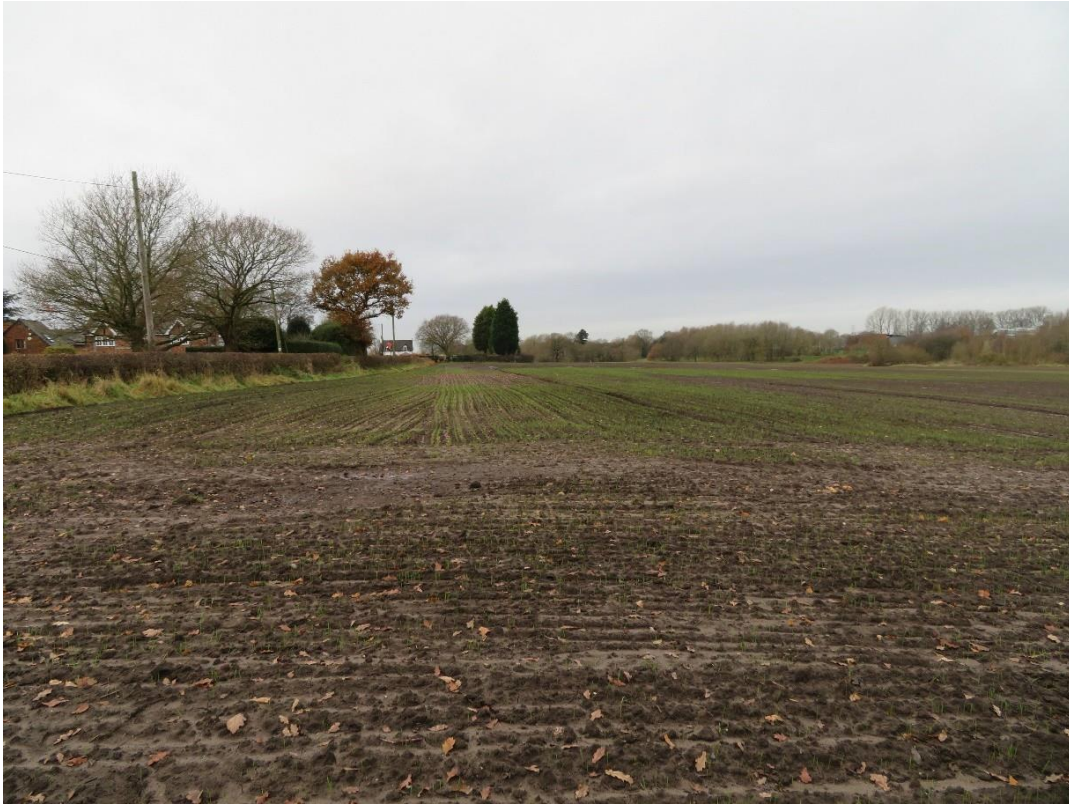
*Plate 19 Looking west across the agricultural land that is and was historically associated with Birch Farm*

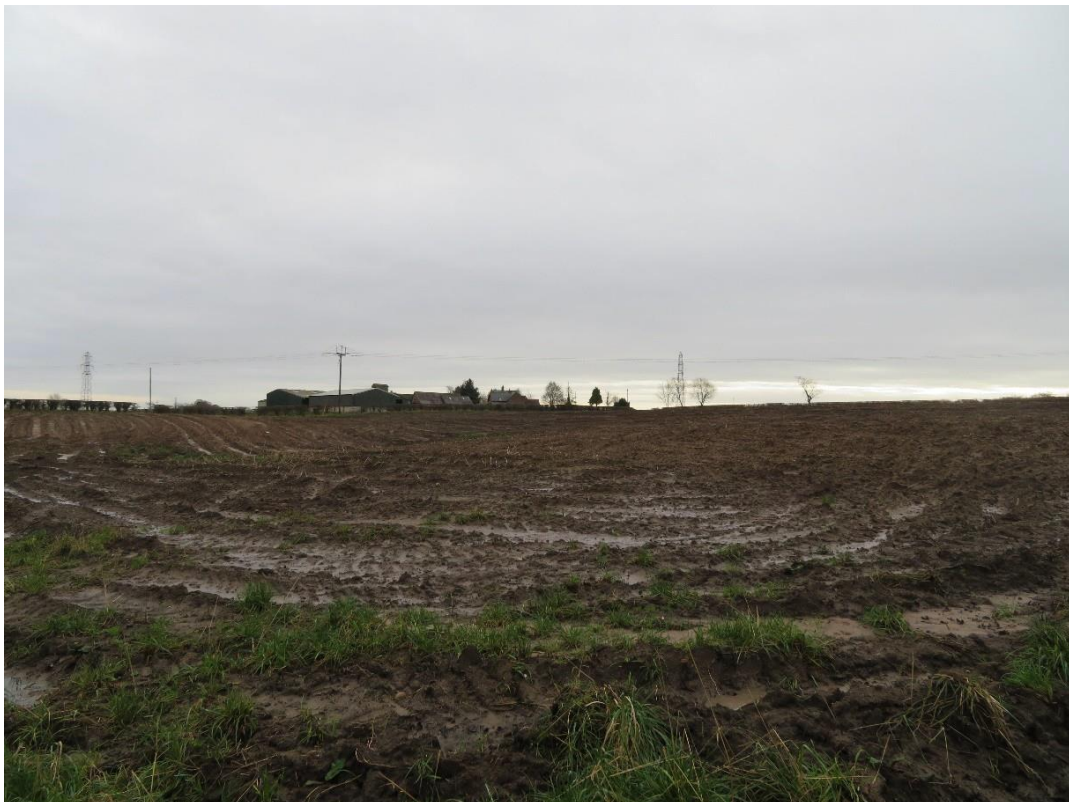
*Plate 20 Looking from Red Brook towards Birch Farm. The barn is only just partly visible to the right of the farmhouse, however the whole farmstead can be appreciated in kinetic views along this footpath*

- Incorporation of an extensive landscape buffer zone. The farmstead can be appreciated in views, particularly along the footpath towards Red Brook and Moss Lane. It is recommended preserve the agricultural setting and continue to allow visual appreciation of the buildings.

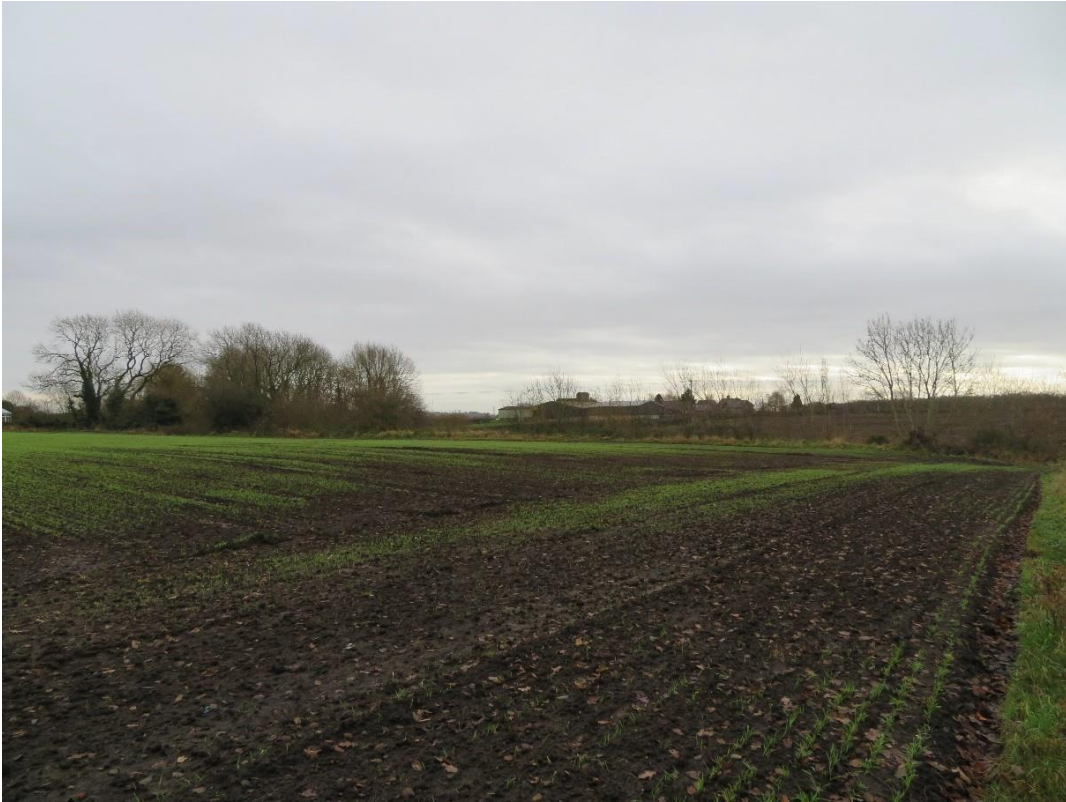
*Plate 21 Looking south-eastwards towards Birch Farm from the agricultural land north of Red Brook.  
The farm complex is still visible although it is difficult to discern the historic elements*

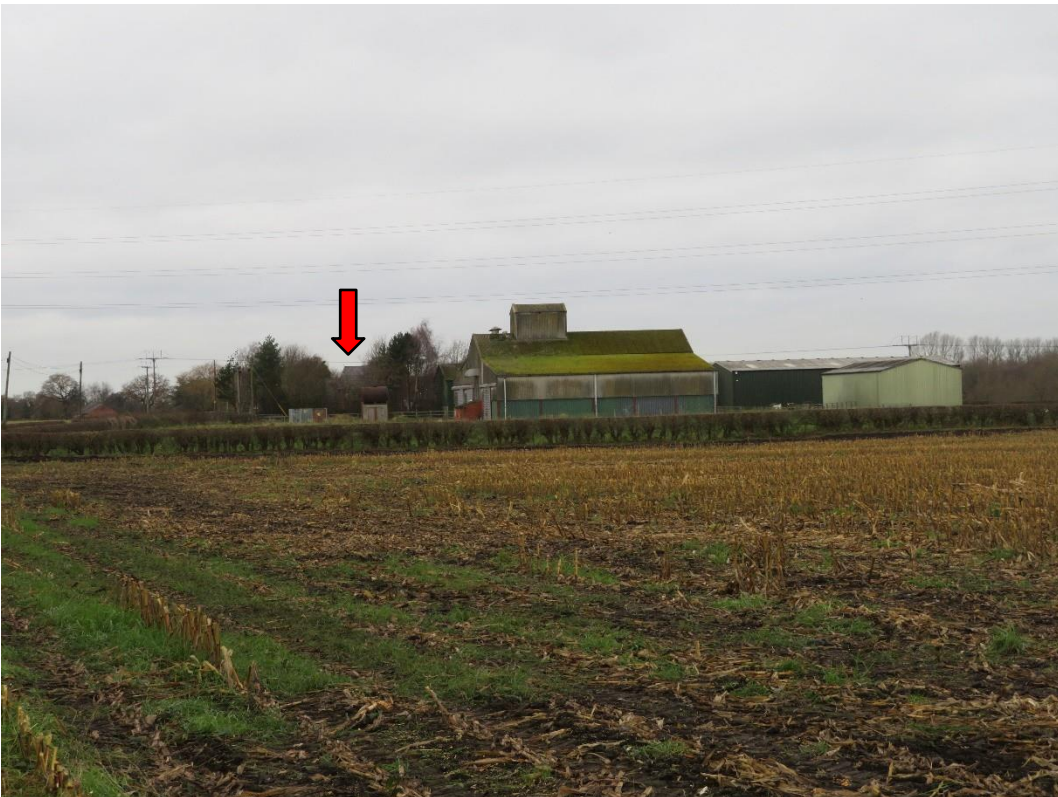
*Plate 22 Looking north-west from Moss Lane towards Birch Farm. The current screening means that only the barn is partially visible from this direction (arrowed)*

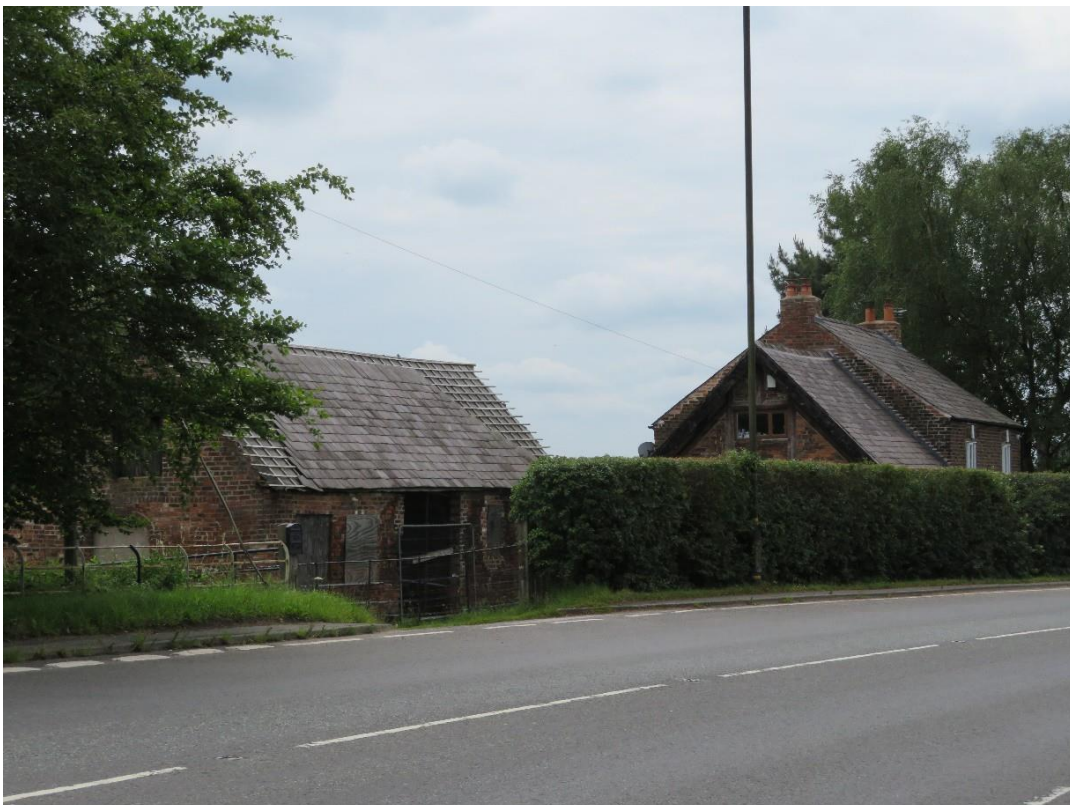
Both of these buildings are Grade II listed and are situated outside the land allocation boundary. However, the buildings' settings may potentially be affected by the proposed development. The barn is the earlier of the two structures and originated as a cruck framed building, possibly of 15<sup>th</sup>-16<sup>th</sup> century date. The main building is 18<sup>th</sup> century in date and constructed of handmade brick, a slate roof (though was probably originally thatched) with three bays, with a later extension for pig sties. The farmhouse is mid-late 18<sup>th</sup> century date, constructed in Flemish bond handmade brick, with a slate roof. It has a double-depth central entrance plan, of 2 storeys, with four symmetrically placed windows with segmented brick arch heads. The building was originally known as Mossend Farm, as it marked the western edge of Warburton Moss and historically, the area to the east was farmed by the occupants here.

*Plate 23 Heathlands Farmhouse (right) and Heathlands Barn (left)*

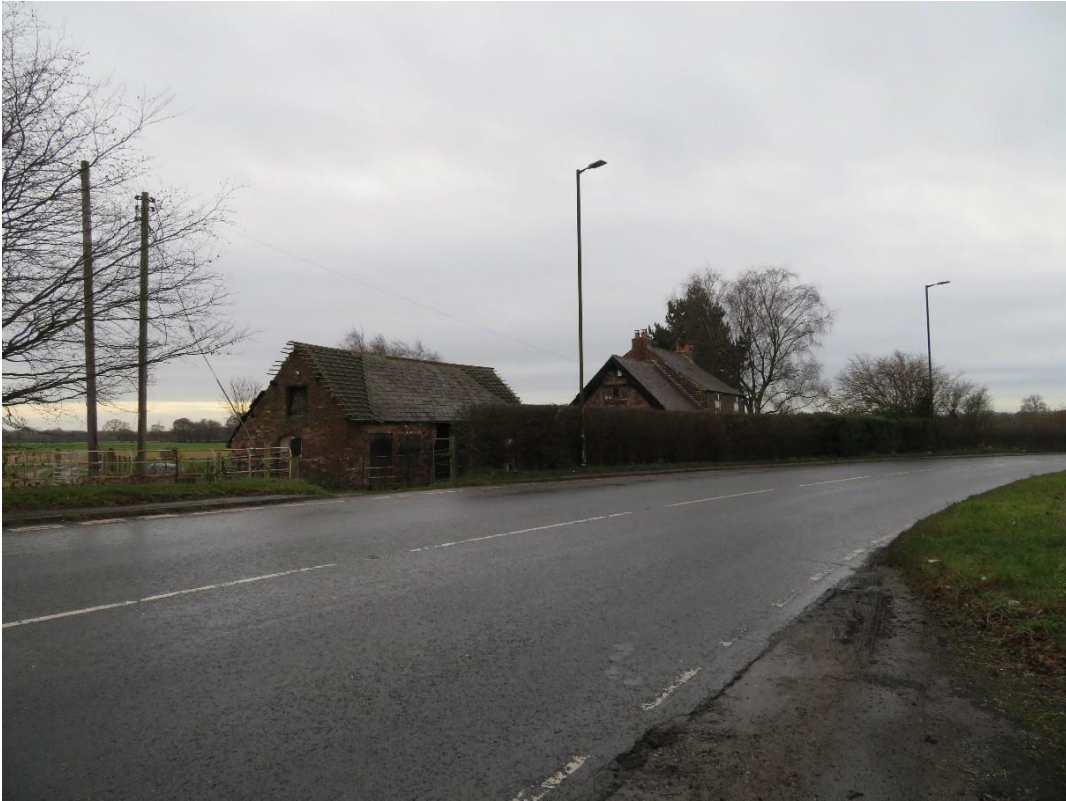
*Plate 24 Looking south along Warburton Lane towards Heathlands Farm and Barn*
