## **Historic Environment Assessment**

GMSF Land  
Allocations, Trafford

GMA45 New  
Carrington

Appendix 3 (Built  
Heritage)

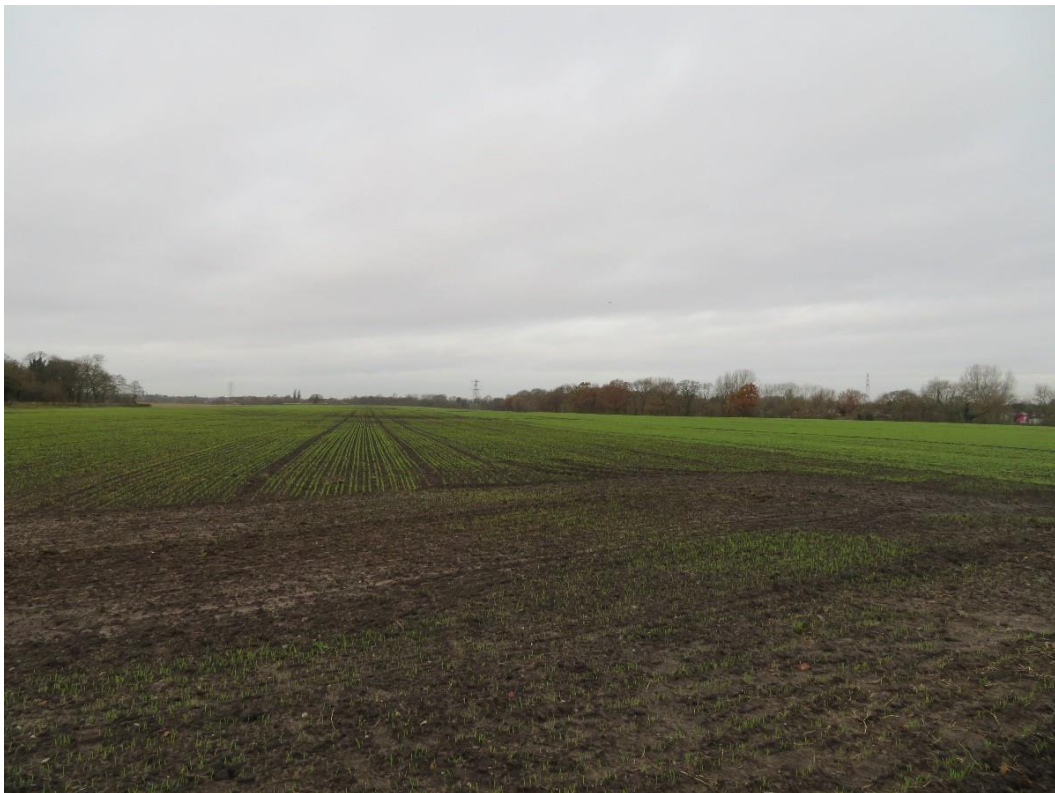
*Plate 25 Looking north-west across the agricultural land that lies to the west of Warburton Lane*

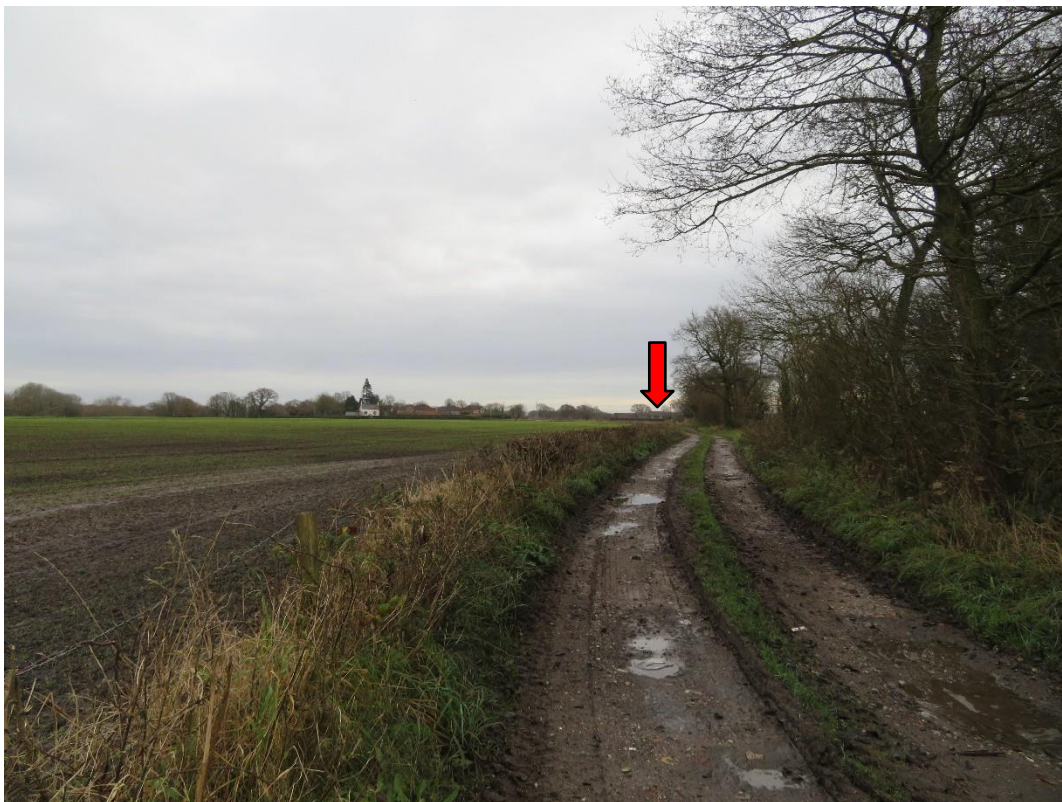
*Plate 26 Looking south-east towards Heathlands Farm. Due to the hedgerow defining the residential plot, only the upper part is visible and becomes imperceptible from a distance (arrowed), however Brook House is also visible to the left*

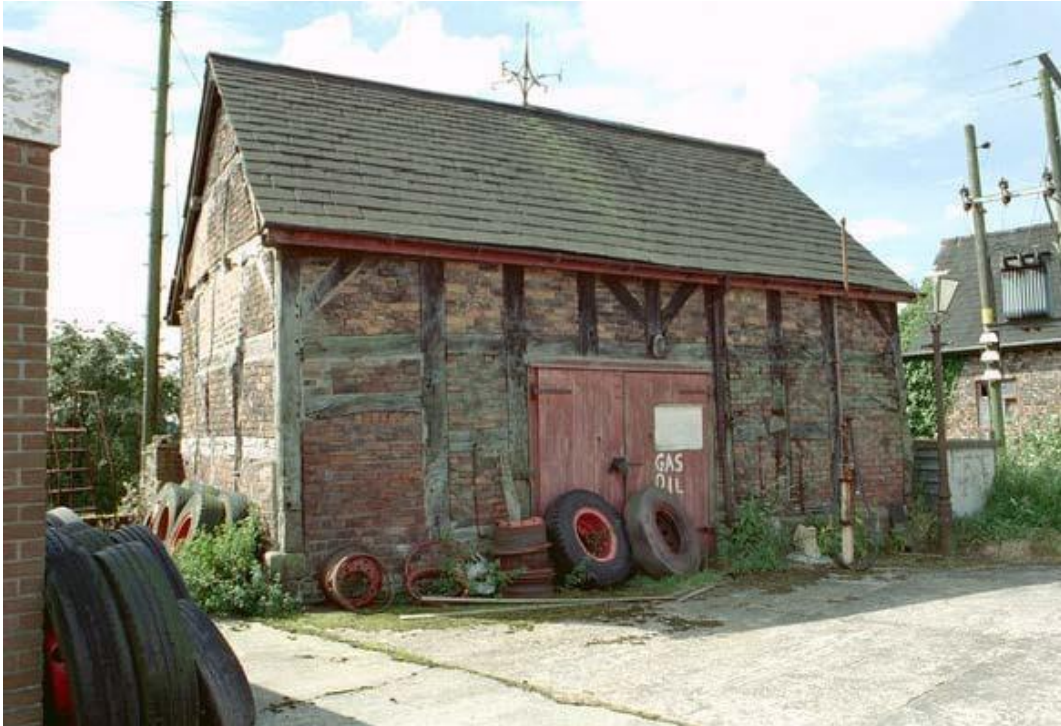
This building lies outside the land allocation boundary, however it is close enough to be potentially affected by any development therefore it is assessed below. The listed building at Warburton Park is a farm outbuilding, probably 17<sup>th</sup> century in date. The building is box-framed with a stone plinth, brick noggin and a slate roof and consists of two bays, which are open to the roof and has had large double doors inserted. The structure is similar in appearance to the Grade II listed Paddy's Hut at Davenport Green and therefore may have been farm labourer's accommodation originally. It is closely associated with other farm buildings which appear to date from the late 18<sup>th</sup> century onwards and are all arranged around a courtyard. The other farm buildings consist of a range of 1-1/2 storey outbuildings including a barn, possible stables and the farmhouse. In addition, there are two cottages on the approach road from the south which are late 19<sup>th</sup> century in date. There have been a number of alterations and modifications, including the addition of later 20<sup>th</sup> century agricultural buildings to the north, west and north-east of the complex. The farmstead is believed to be on the site of the original medieval Warburton manor, which once sat within the Deer Park (see Appendix 1 and 3 for more detail).

*Plate 27 Timber framed building at Warburton Park Farm, taken in 2001 © IoE F.*

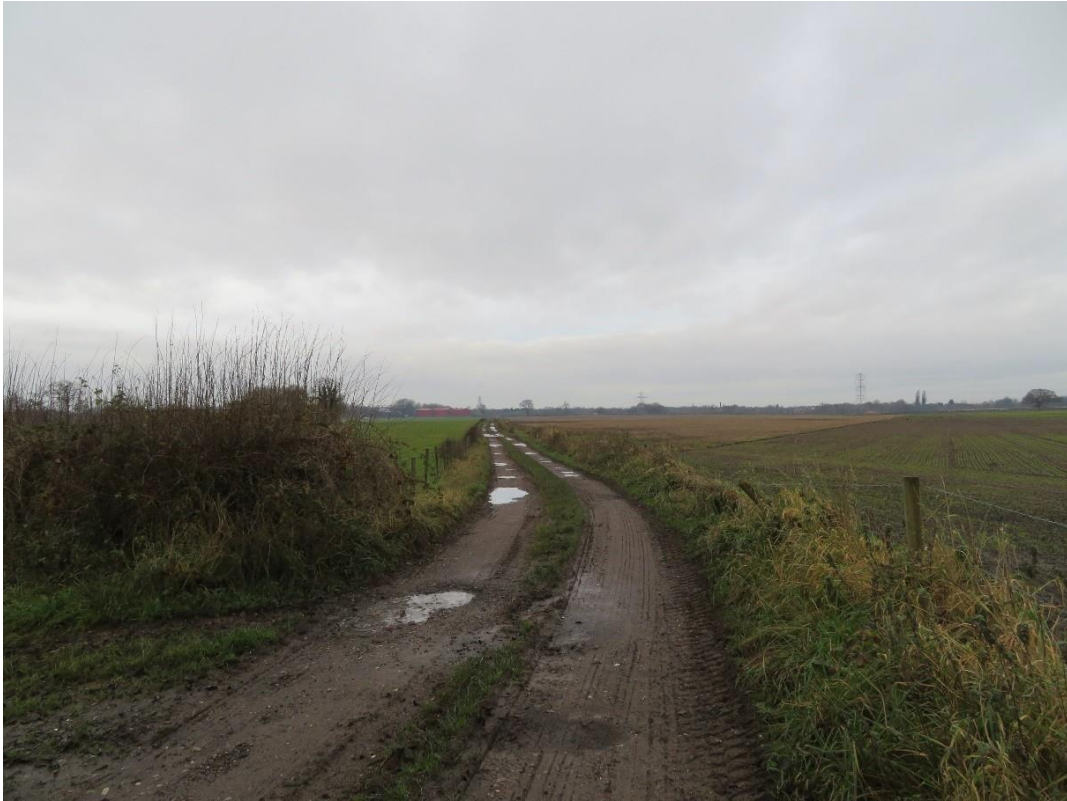
*Plate 28 Looking south-west towards Park Farm. The historic buildings are almost imperceptible from here. The later 20th century buildings to the north of the complex can be seen*

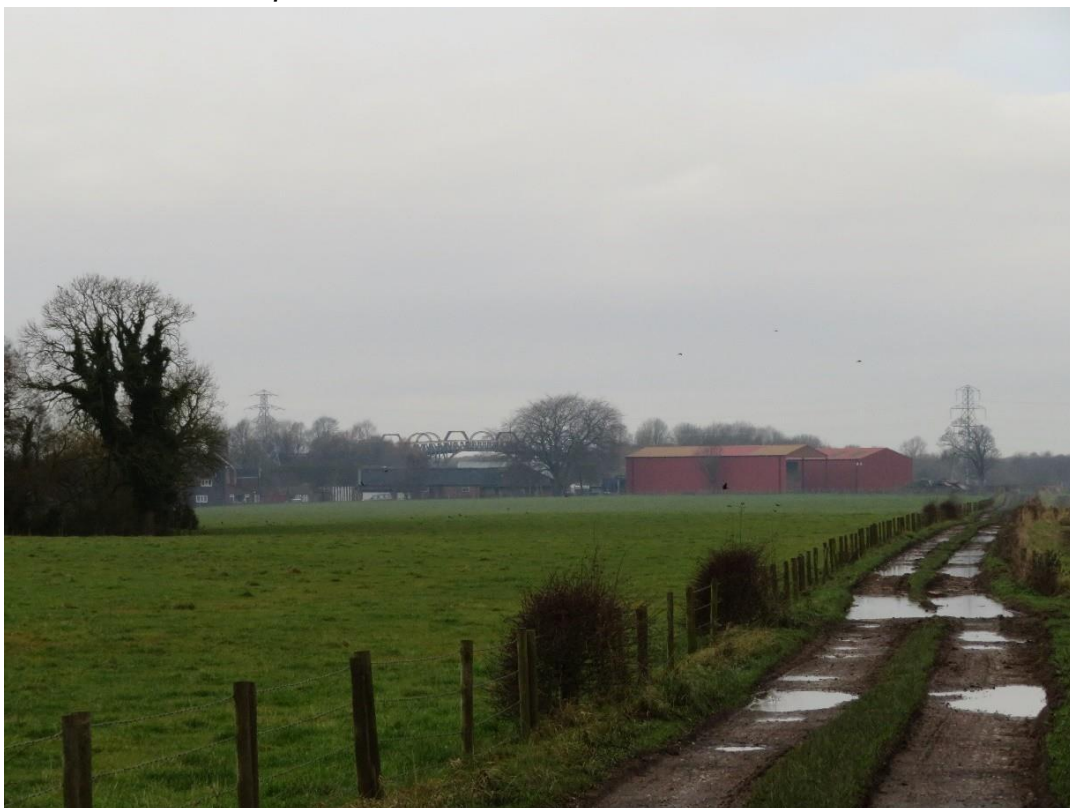
*Plate 29 Looking south-west towards Warburton Park Farm. Note the cantilever bridge over Manchester Ship Canal in the distance (see Section 9.5.3)*

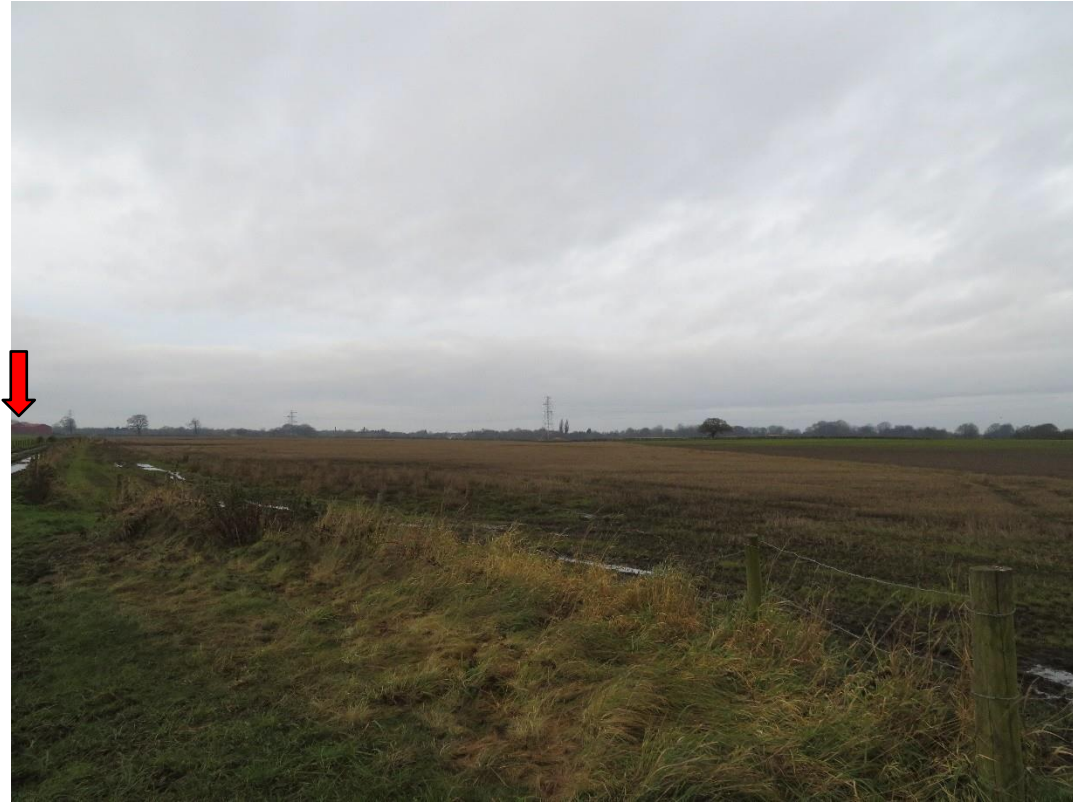
*Plate 30 Looking north-west across the agricultural land north of Warburton Park Farm (arrowed).  
Note the flat, open nature of the landscape*

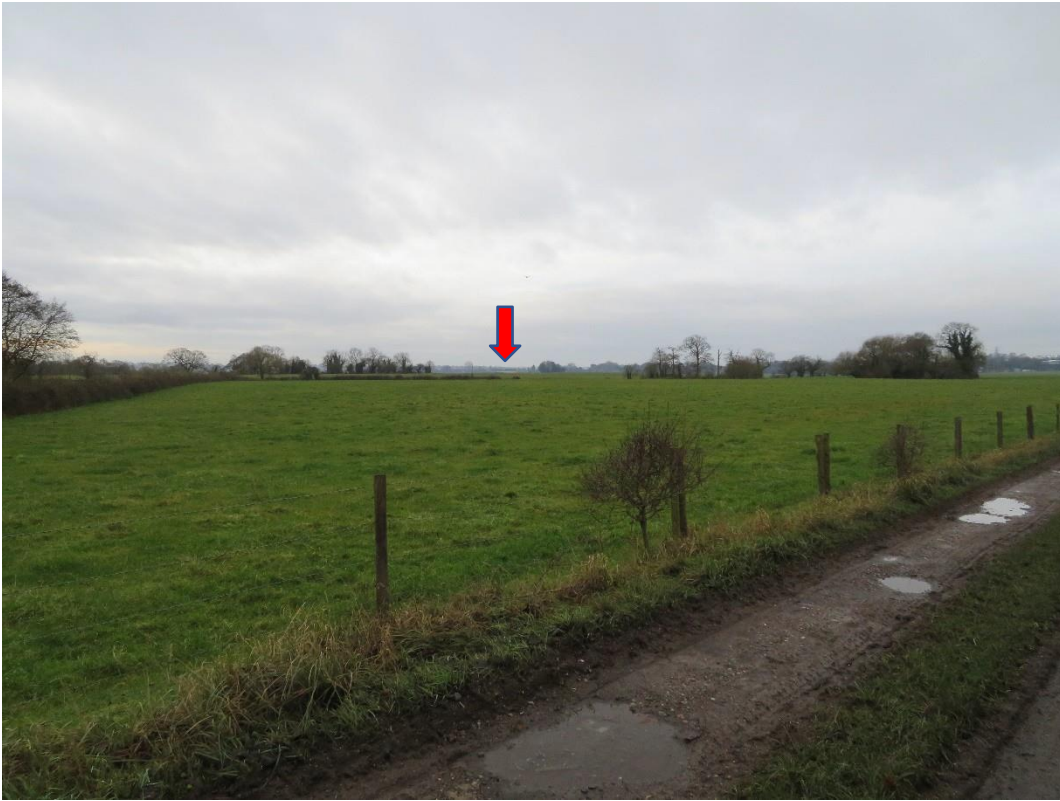
*Plate 31 Looking south-west towards Warburton. The village is barely visible from the Site (arrowed)*

Although the Site is not considered to form part of Warburton Conservation Area's setting, it is still recommended that any development along the SW part of the Site should not be visually dominant.

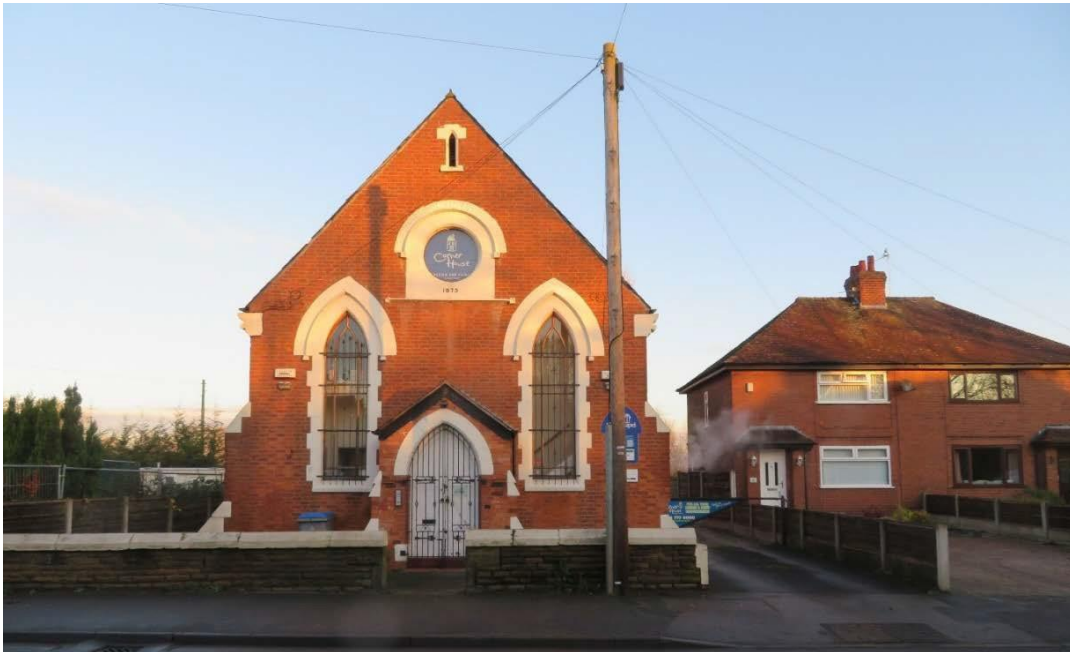
*Plate 32 Carrington Primitive Methodist Chapel*

Chapel, built in 1875. Originally for Primitive Methodists and later used as an Emmanuel Church. Now in use by a Design and Print company. Attractive building with Gothic-style features including tall pointed arch windows. High local significance

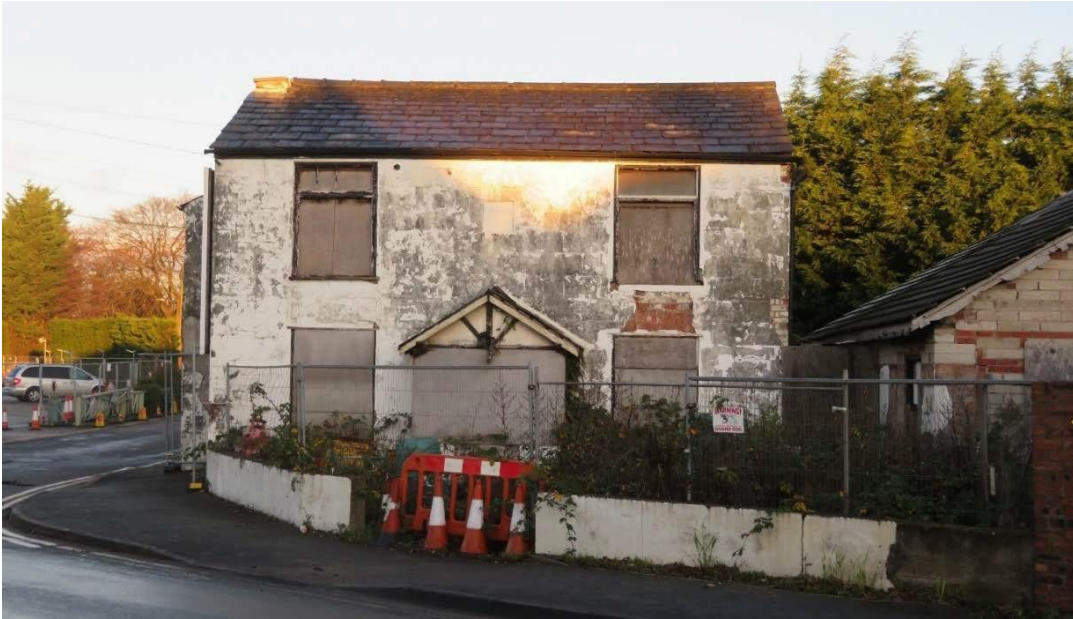
*Plate 33 Bluebell Cottage*

House, possibly early 19<sup>th</sup> century – there is a datestone but it is hard to decipher. It may say 1830, with initials above it. Appears to have once been attached to the corn mill which stood to the rear. Built of brick, but most of its exterior has been rendered. Currently unoccupied and derelict. Low local significance.

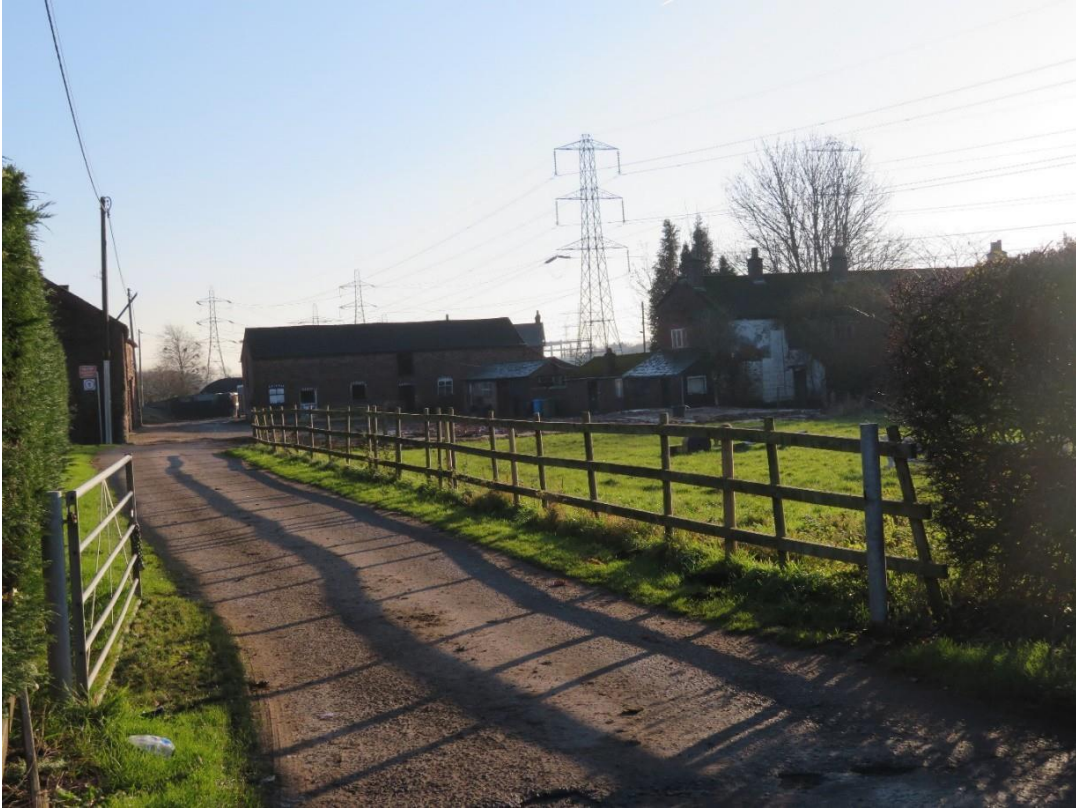
Farm complex, probably late 18<sup>th</sup> century. Dainewell Farm has supposedly been occupied since the 14<sup>th</sup> century, although the surviving buildings appear to be late 18<sup>th</sup> century in date. It appears the farm is named after the family occupants, the Daines, rather than having a connection to the Vikings. Most of the buildings shown on the Tithe maps still survive, albeit with some alterations and a number of 20<sup>th</sup> century structures have been added to the complex. The complex has high local significance.

*Plate 34 Dainewell Farm (viewed from the north)*

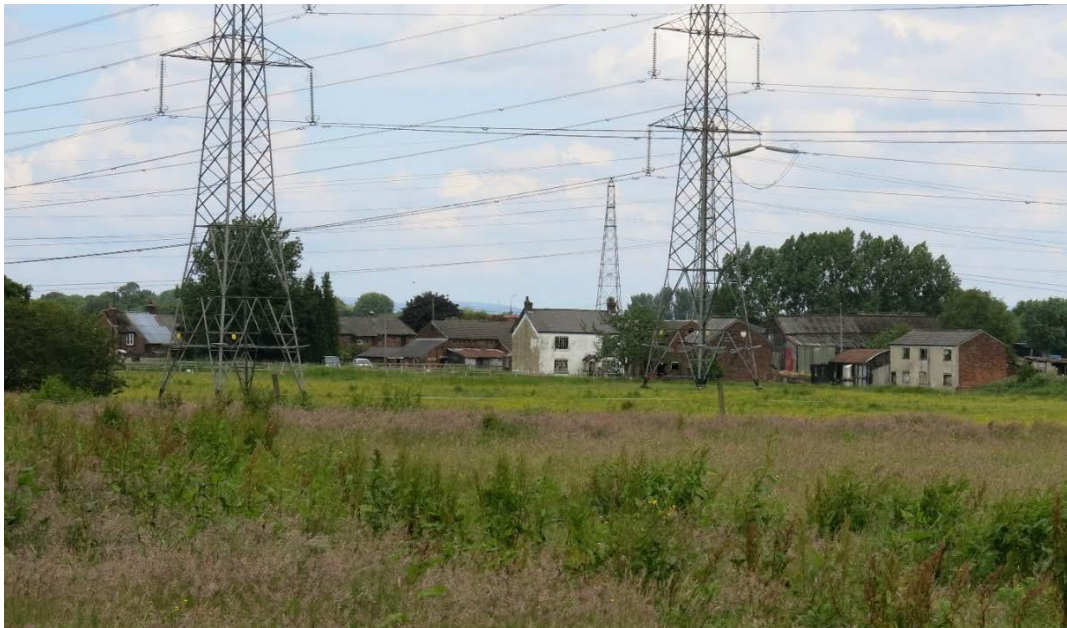
*Plate 35 Dainewell Farm, viewed from the south-west. Note the electricity pylons within the setting*

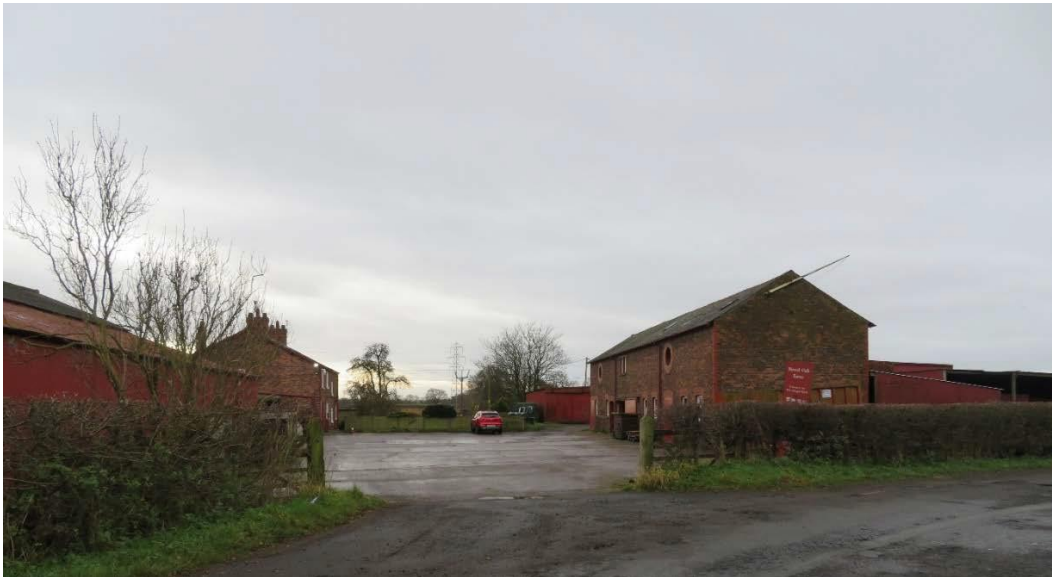
*Plate 36 Broadoak Farm*

19<sup>th</sup> century barn. The former may have earlier origins, evidenced by asymmetrical windows. Surrounded by later 20<sup>th</sup> century agricultural buildings. Sits within a flat, open agricultural landscape with narrow country lanes with low hedgerows and some tree cover; there is also some inter-visibility with Birch Farm. Reflection of the dispersed settlement pattern in the area and the setting makes a positive contribution to the significance of the Farm. The complex has High Local significance.

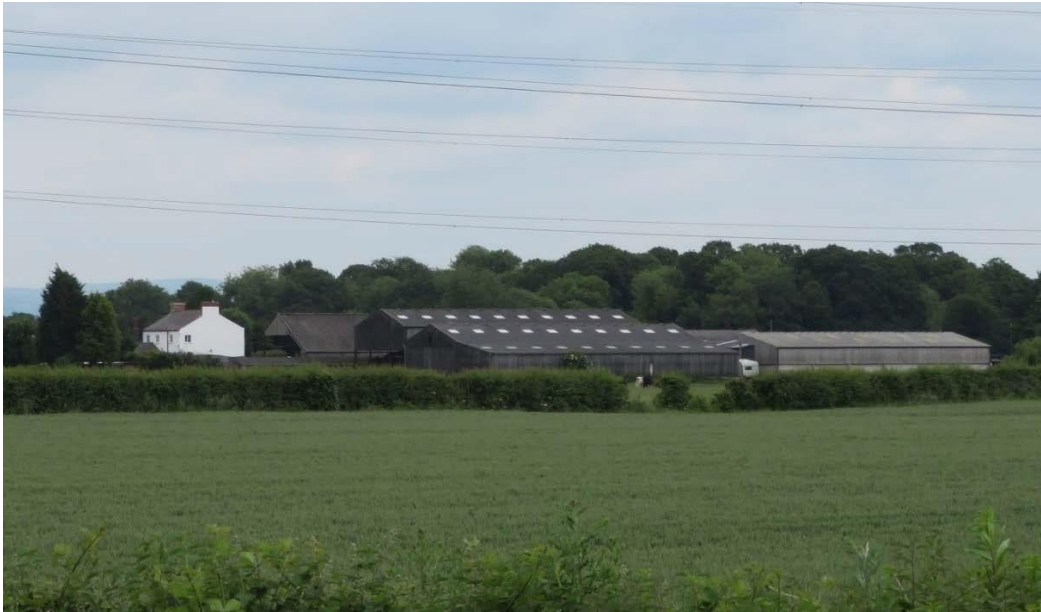
*Plate 37 Brookheys Farm*

Farmstead, early 19<sup>th</sup> century, with a main range built in the 1820s as a combined threshing barn and a mid-19<sup>th</sup> century farmhouse. The rest of the complex is mid-late 20<sup>th</sup> century in date. The farm is located within the Dunham Massey estate and was subject to an archaeological building survey (UMAU 2008). The farm sits within a flat, agricultural landscape but only the farmhouse is visible due to its distinctive colour against the rest of the farm complex. The former Cheshire Lines railway interrupts any views further northwards and there is a large number of later 20<sup>th</sup> century buildings which make a neutral contribution to the significance. Overall the setting makes a positive contribution to the significance of the Farm and it is of high local significance

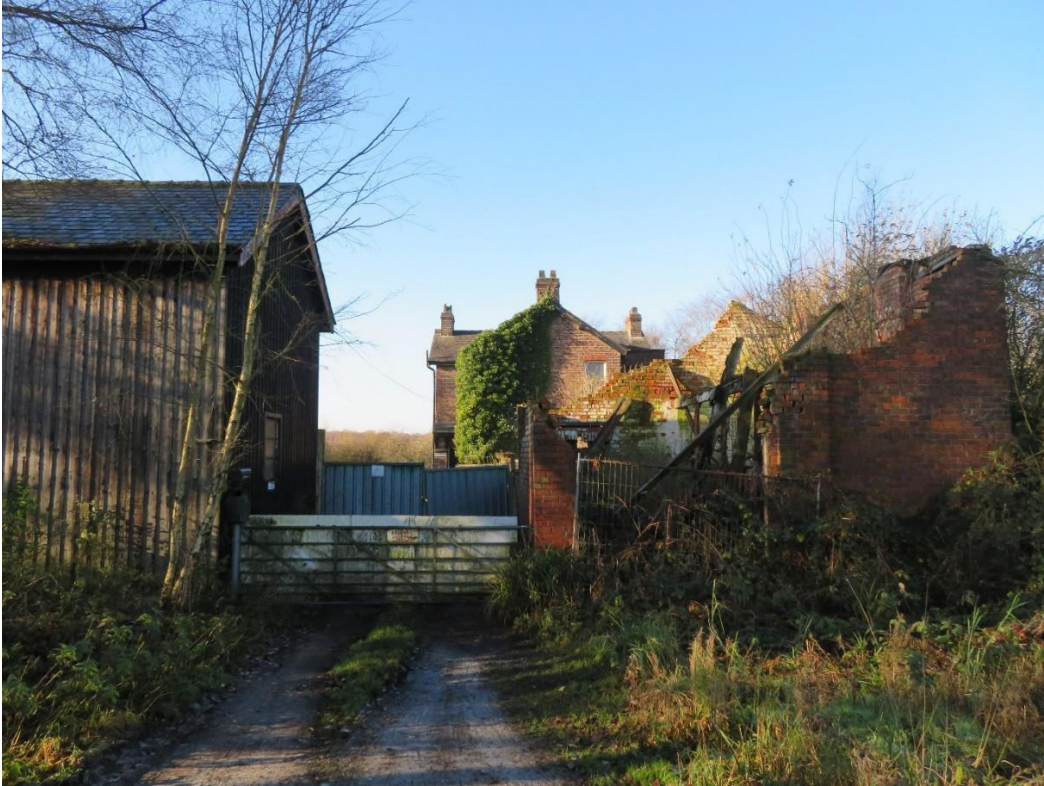
*Plate 38 Ashpodel Farm*

Small farmstead, late 19<sup>th</sup> century. Farmstead created during the reclamation of the Moss in the late 19<sup>th</sup> century. It appears to have been briefly located further south at the junction of Sinderland and Ashton roads, before being moved to its present location in 1896. The original buildings lie on the northern side of the farm complex with later 20<sup>th</sup> century buildings along the south-eastern side. One of the outbuildings is in ruins and the complex is heavily screened along all sides and the landscape to the north, west and south was all developed for the Gas and Chemical Works during the 20<sup>th</sup> century. Only its immediate setting makes a positive contribution to the significance of the farm. Low local significance

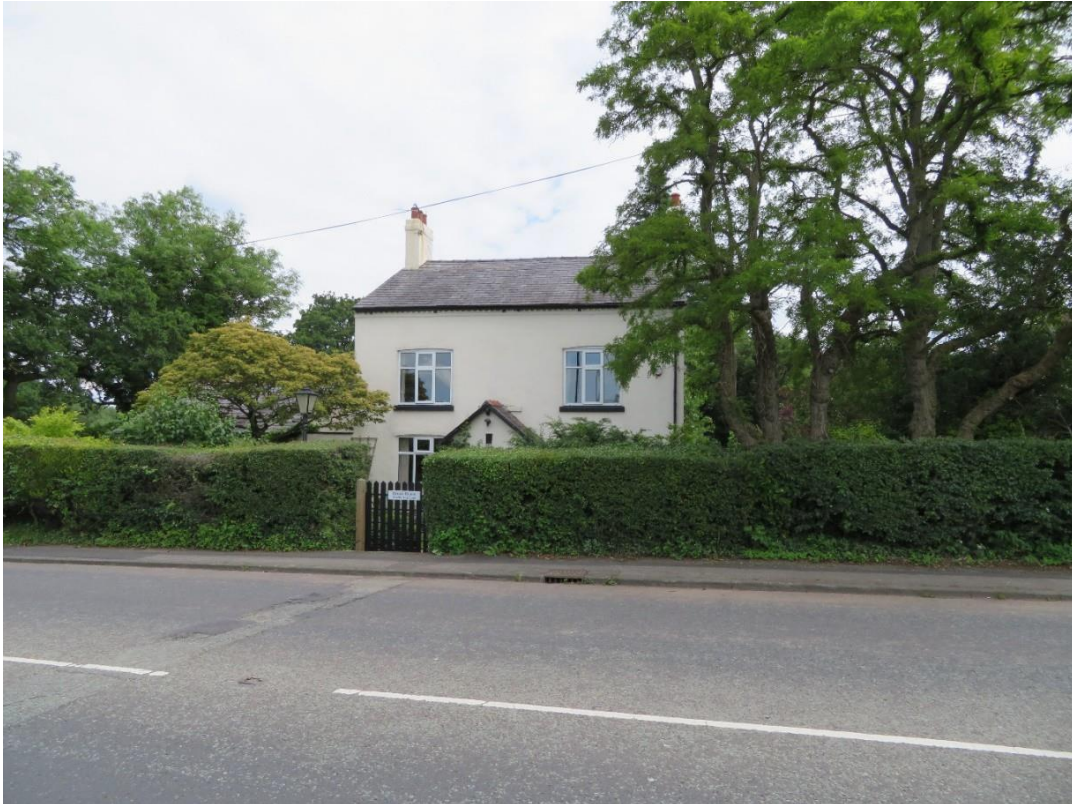
*Plate 39 Brook House*

Possible early 19<sup>th</sup> century cottage, now rendered so many details obscured. Visible from the agricultural land to the west, across Warburton Lane however setting eroded to the south by a later residential development. Trees and hedges block views to the north and a low hedge along the front elevation offers a sense of privacy, although there is some inter-visibility with the agricultural land to the west. Its significance is enhanced through inter-visibility with the agricultural landscape, as well as the nearby listed Heathlands Farm and Barn. High local significance.

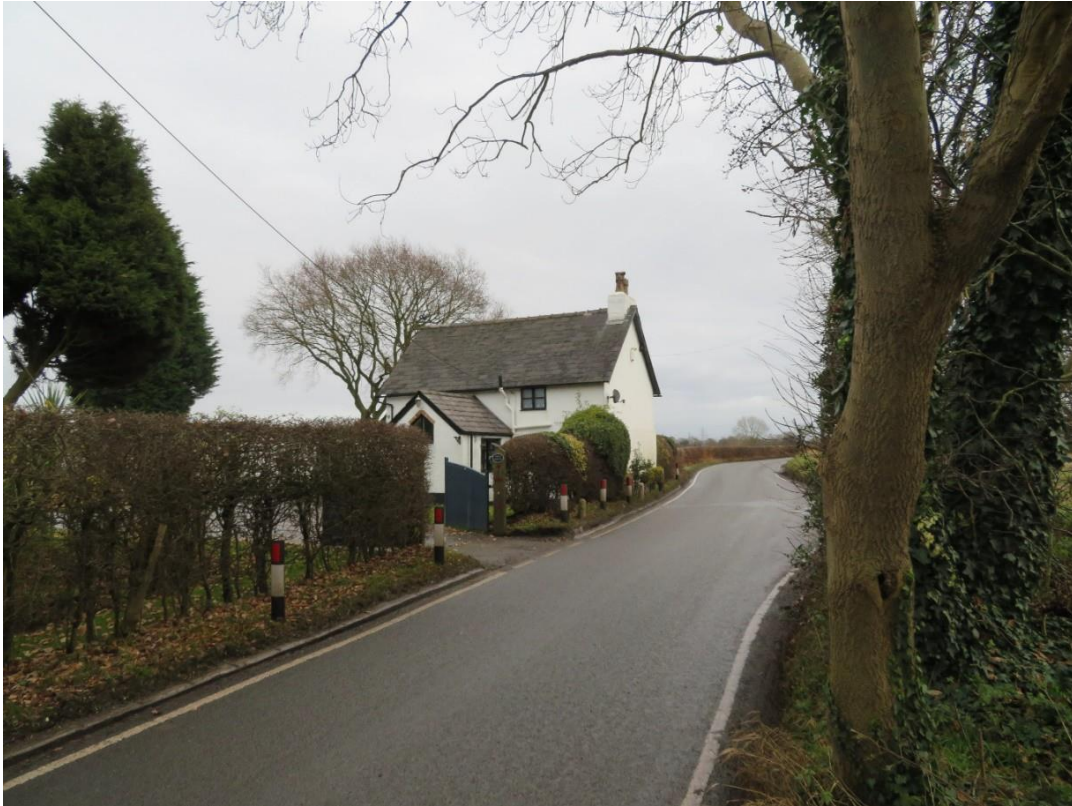
*Plate 40 Birch Cottage*

Cottage, originally one of three and probably late 18<sup>th</sup> century in date. The house was renamed Birch Cottage after the rest of the houses were demolished during the mid-20<sup>th</sup> century. Rendering has obscured any detail, however the building appears to be constructed of handmade bricks. There is a later conservatory attached to the rear (east) side and a later porch. The dwelling sits within a small residential garden plot with visibility across the flat, agricultural landscape and also sits close to Moss Lane, which is narrow and winding. Its significance is enhanced through inter-visibility with the agricultural landscape, as well as the nearby Pear Tree Cottage and contributes to the overall rural character of this landscape. The setting makes a positive contribution to the significance of this heritage asset. High local significance

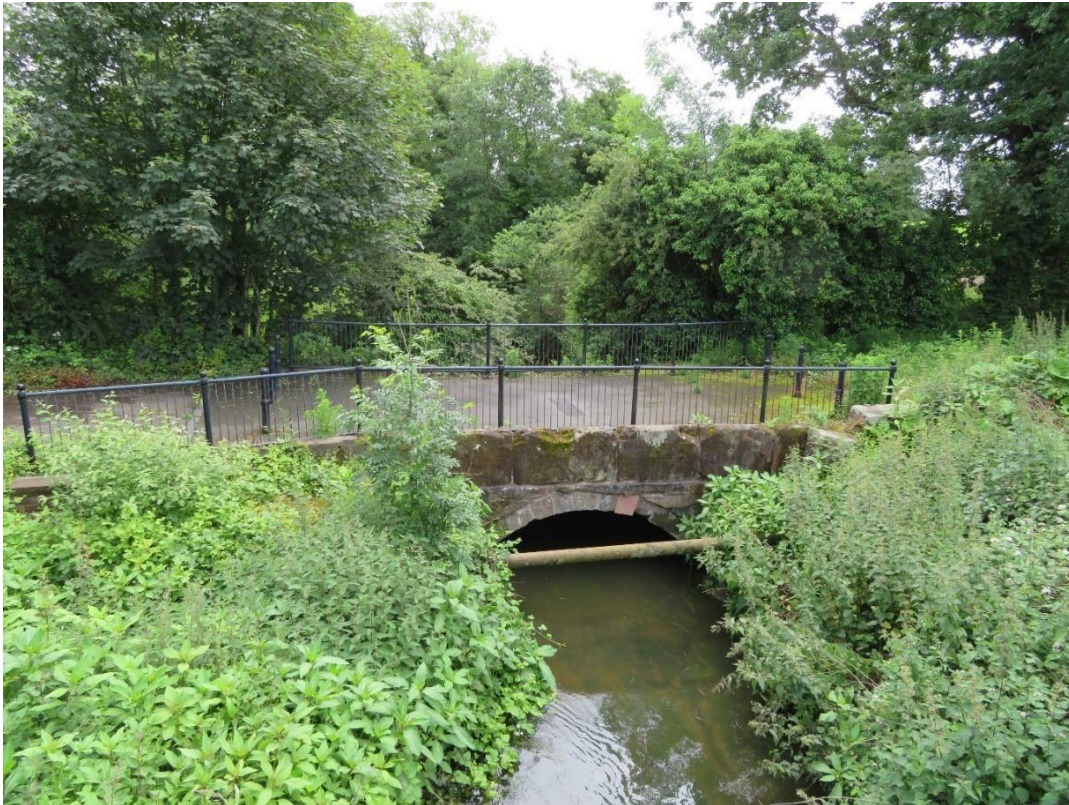
*Plate 41 Warburton Lane Old Bridge*

heritage trails and interpretation points and the footpath improved and signposted. This is a rare survival of an early stone bridge and is of potential regional significance.

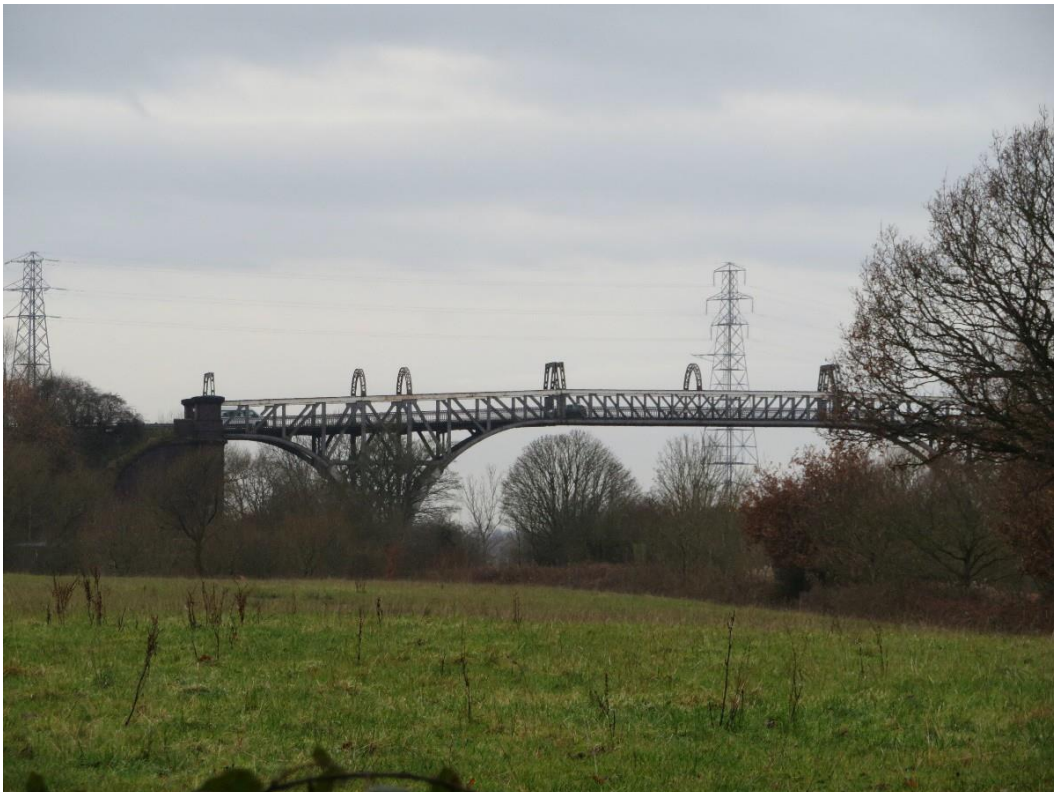
This is a late 19<sup>th</sup> century cast iron cantilever bridge, built to provide a new crossing across the Manchester Ship Canal (not to be confused with the 1863 toll bridge which crosses the now silted course of the River Mersey). The cast iron bridge was opened in 1890 and constructed by Andrew Handyside and Co. The structure stands on masonry piers and the cantilevered arms were built out northwards and southwards from each tower to maintain equilibrium. A series of arches span the bridge as well. The bridge is a distinctive local landmark across the landscape and can be viewed from the south-western extreme of the Site. Due to the tree cover and presence of hedges, the bridge is experienced through kinetic views which can be appreciated across the open agricultural landscape. It is of high local significance and any development, particularly at the south-west extreme of the Site should incorporate key views towards the Bridge.

*Plate 42 Warburton Bridge, as seen from the SW edge of the Site*
