# Flood Investigation Report

## Greater Manchester

### 26 December 2015

*This report is written to comply with Section 19 of the  
Flood and Water Management Act, 2010.*

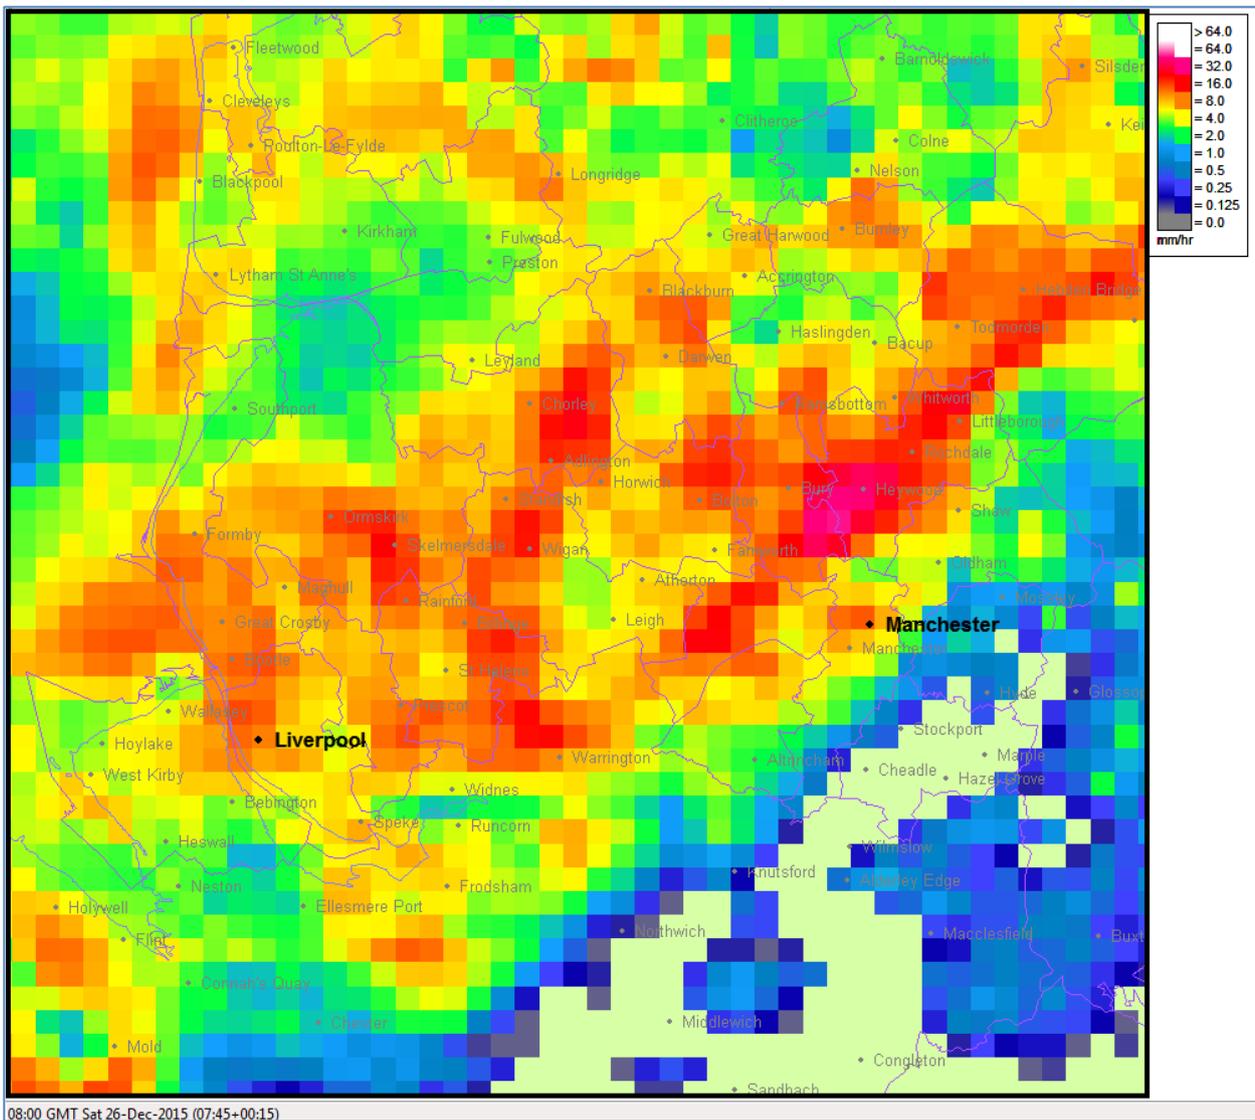
Figure 3 Rainfall intensity across Greater Manchester at 8am on Boxing Day

Further detail can be found in Appendix 3 which includes a tables showing the heaviest rainfall in the River Irwell catchment North of Manchester with totals of up to 51mm, 109mm and 128mm falling in periods of 6, 12, 24 and 36 hours respectively.

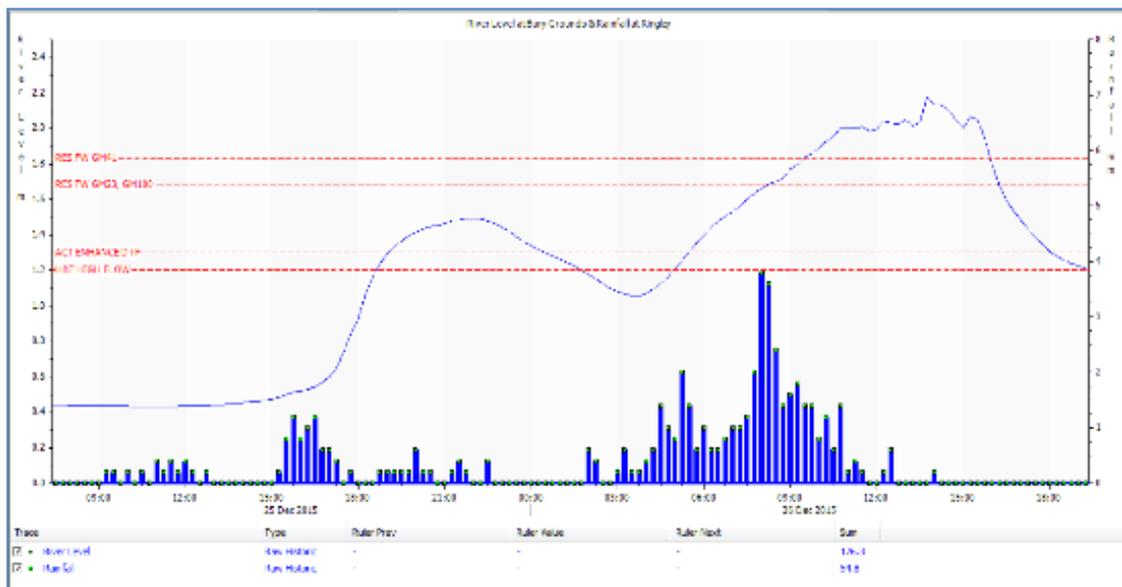
Figure 4 and Figure 5 below show river levels in the Irwell and Roch over the course of Boxing Day. These figures demonstrate just how quickly river levels were rising in response to the rainfall, due largely to the already saturated nature of the catchment from a month of double the average amount of rain.

Figure 4 River levels on the River Irwell level at Bury and the corresponding rainfall at the nearest rain gauge

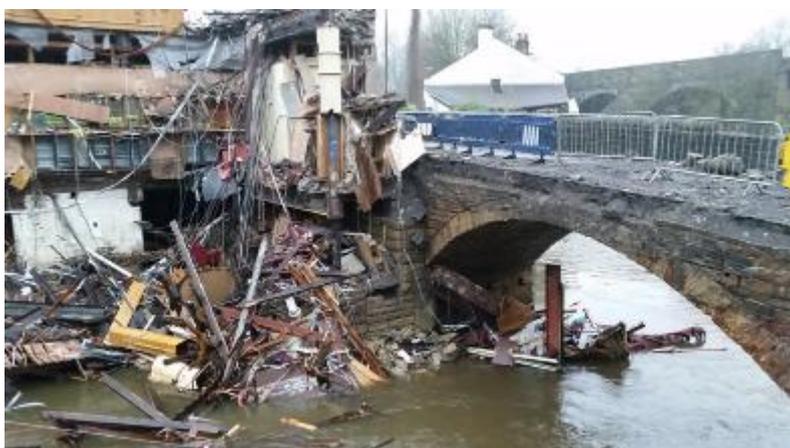
**Picture 1 Waterside Restaurant at Kay Street Bridge, Summerseat**

- Two bridges carrying cables at Milltown Street and Lomax Street, Bury were destroyed. This damage has been temporarily overcome using a new overhead line and re-routing an existing supply.
- The Waterside Restaurant in Summerseat, collapsed into the River Irwell. This also caused the partial collapse and subsequent closure of the associated masonry arch bridge. No-one was in this building at the time, however the event made national TV coverage. The bridge remains closed to traffic.

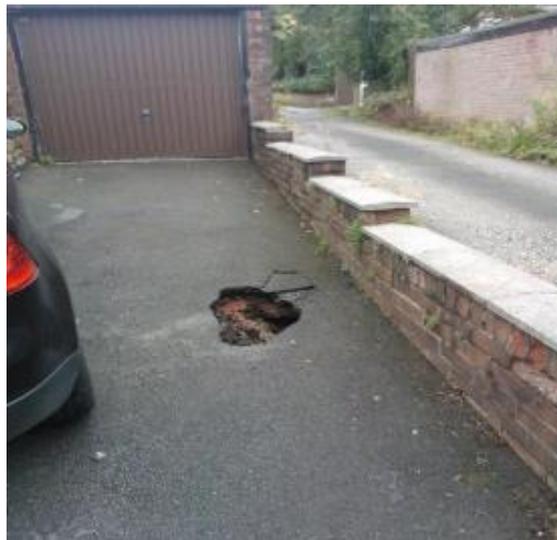
Picture 2 Hole appeared due to Pickhill Brook culvert collapse below

The gap in the flood wall was sandbagged immediately after the flood as a short term contingency measure; with the wall rebuilding works was included in an emergency repair programme. Minor repairs on other walls/ embankments on the River Roch at Rochdale and Littleborough are also programmed. Several debris screens around Bolton require repairs following damage.

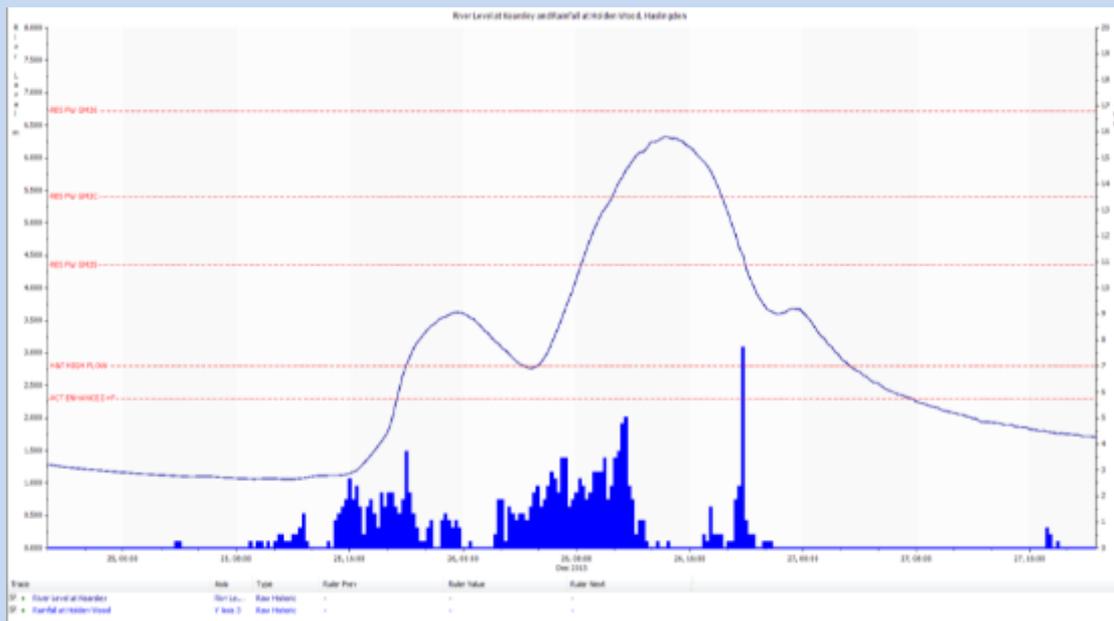
Figure 6 River Irwell level at Kearsley and the corresponding rainfall in the Upper Irwell catchment

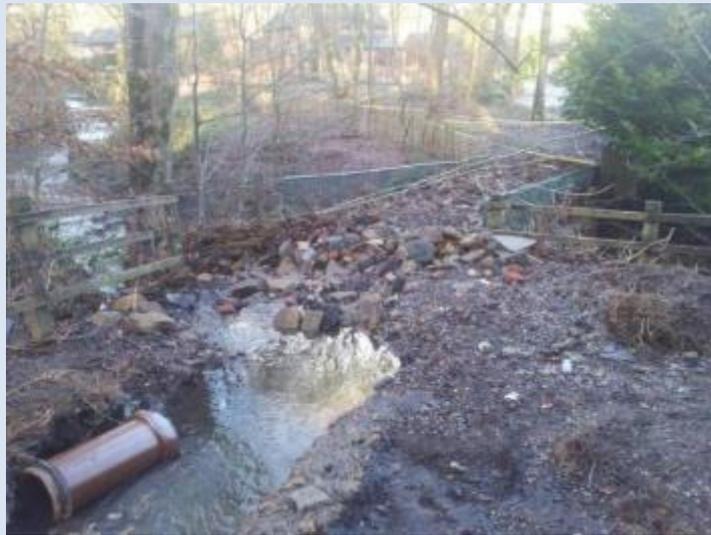
Picture 6 Landslip debris and damage to footbridge

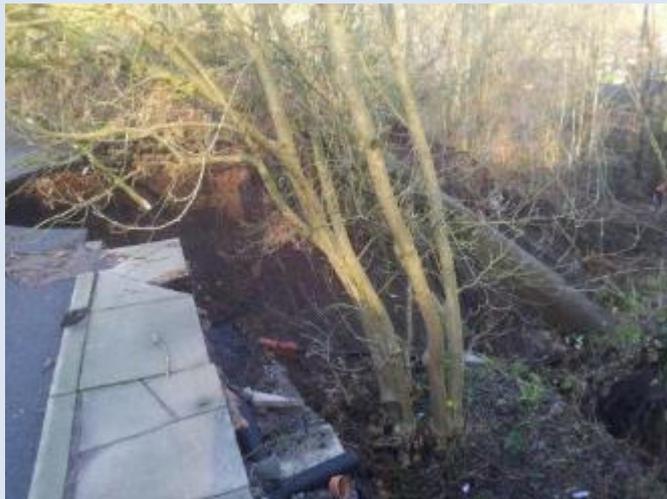
Picture 7 Highway embankment collapse

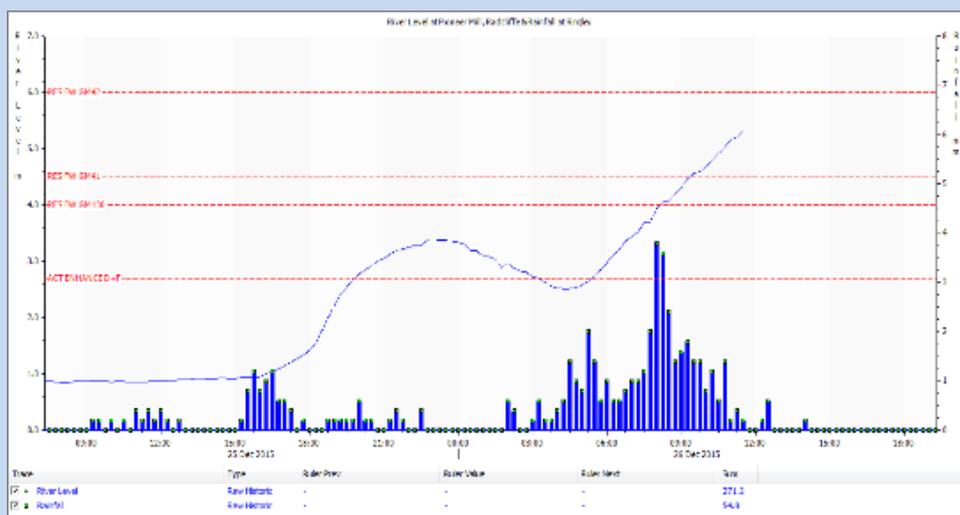
Figure 8 River Irwell at Pioneer Mill, Radcliffe (where the gauge was washed away at midday on Boxing Day) and the corresponding rainfall at the nearest rain gauge (again, note that rain in the Upper Irwell was far higher)

- Environment Agency river flow/level gauging stations were damaged including the complete destruction of the gauging station at Prestolee near Bolton and at Pioneer Mills, Radcliffe, both on the River Irwell. There was severe electrical damage to the station at Lower Broughton, Salford. These stations provide information to trigger flood warnings for properties nearby.

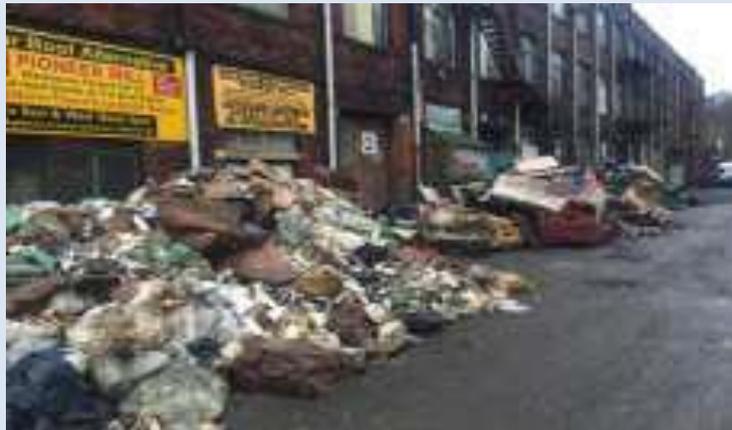
Picture 13 Flood damaged goods at Pioneer Mill

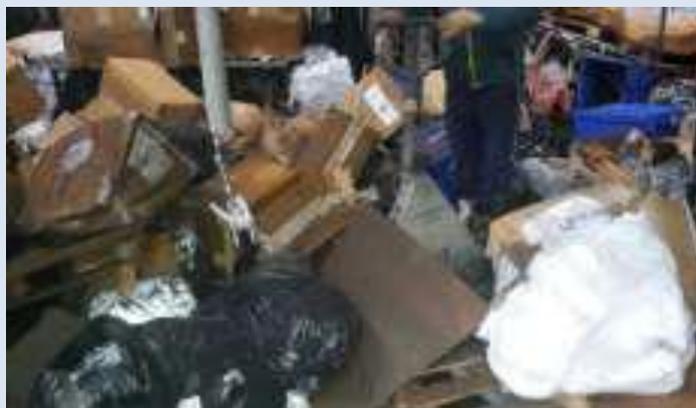
Picture 14 Flood damage at Pioneer Mill

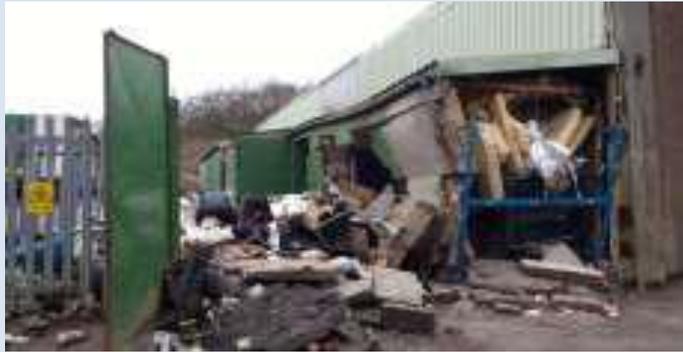
Picture 15 Structural damage at Pioneer Mill

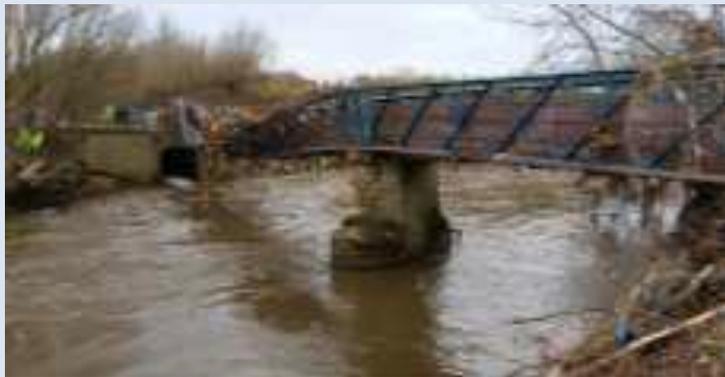
Picture 16 Milltown Street footbridge damaged beyond repair

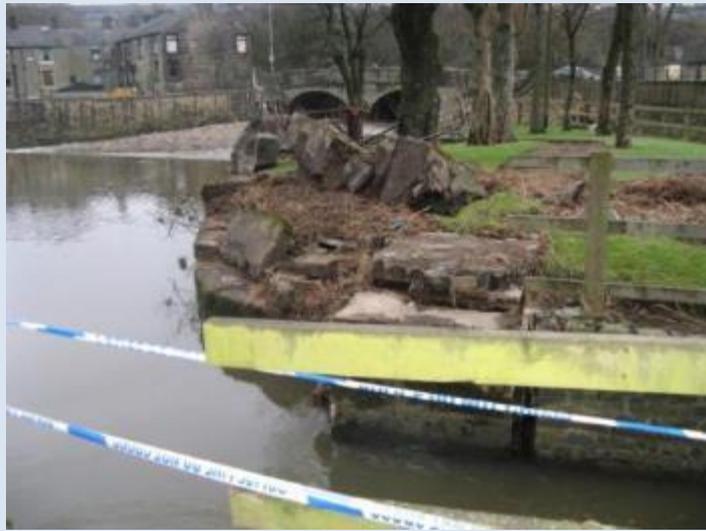
**Picture 22 Damage to canoe by-pass of Bridge Street weir**

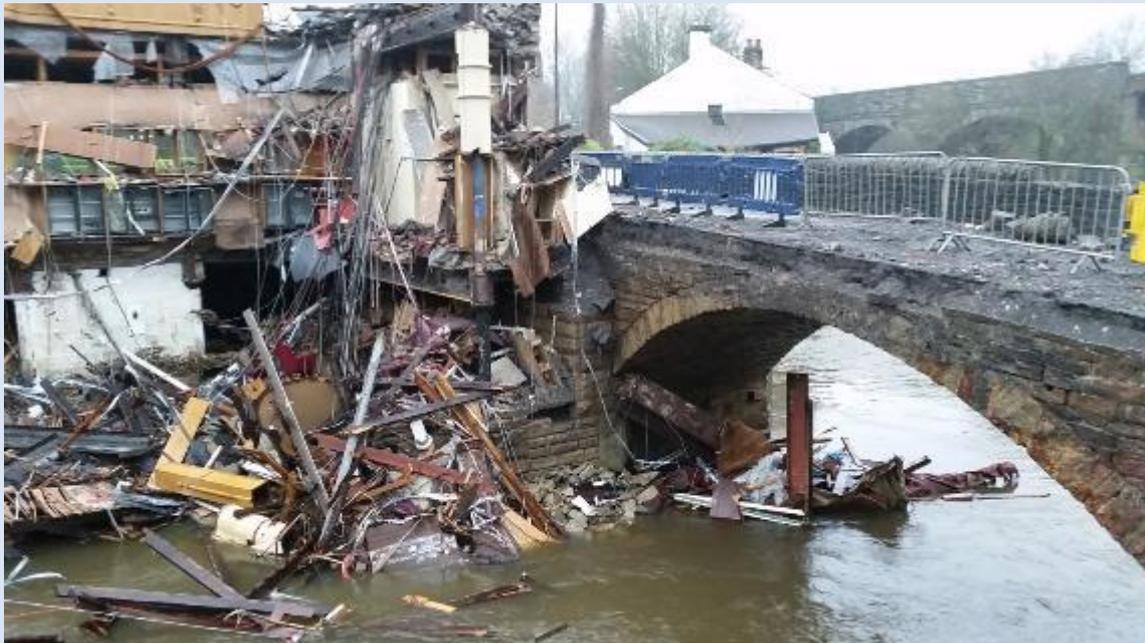
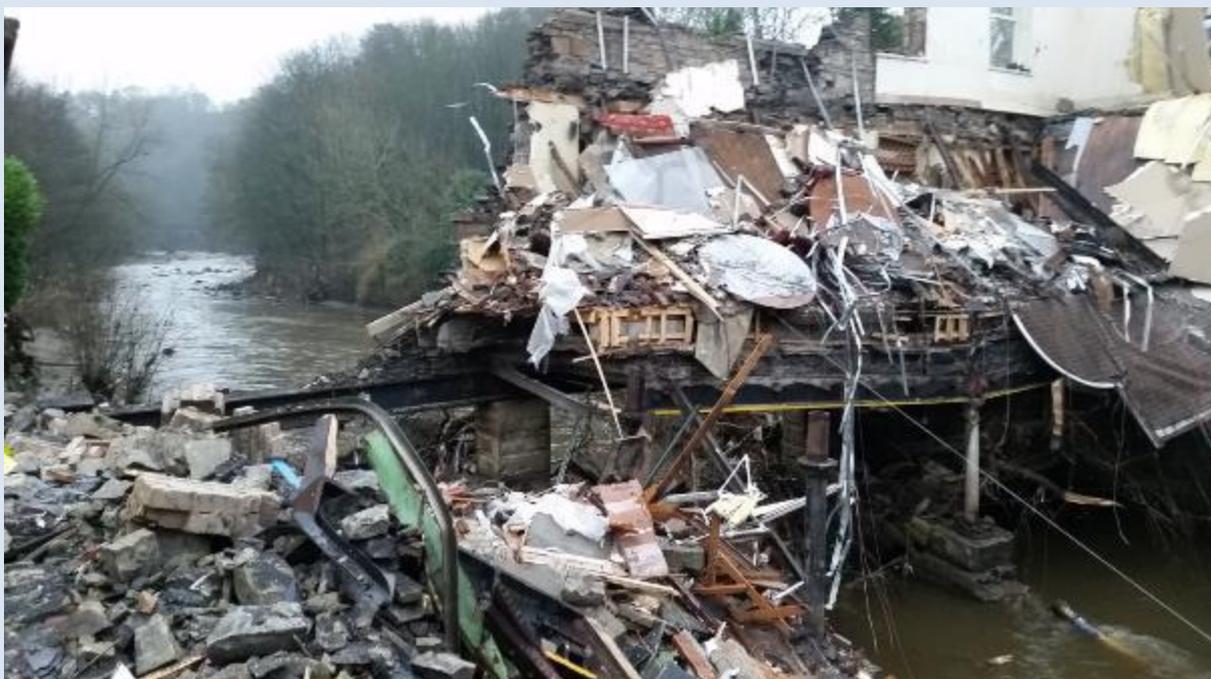
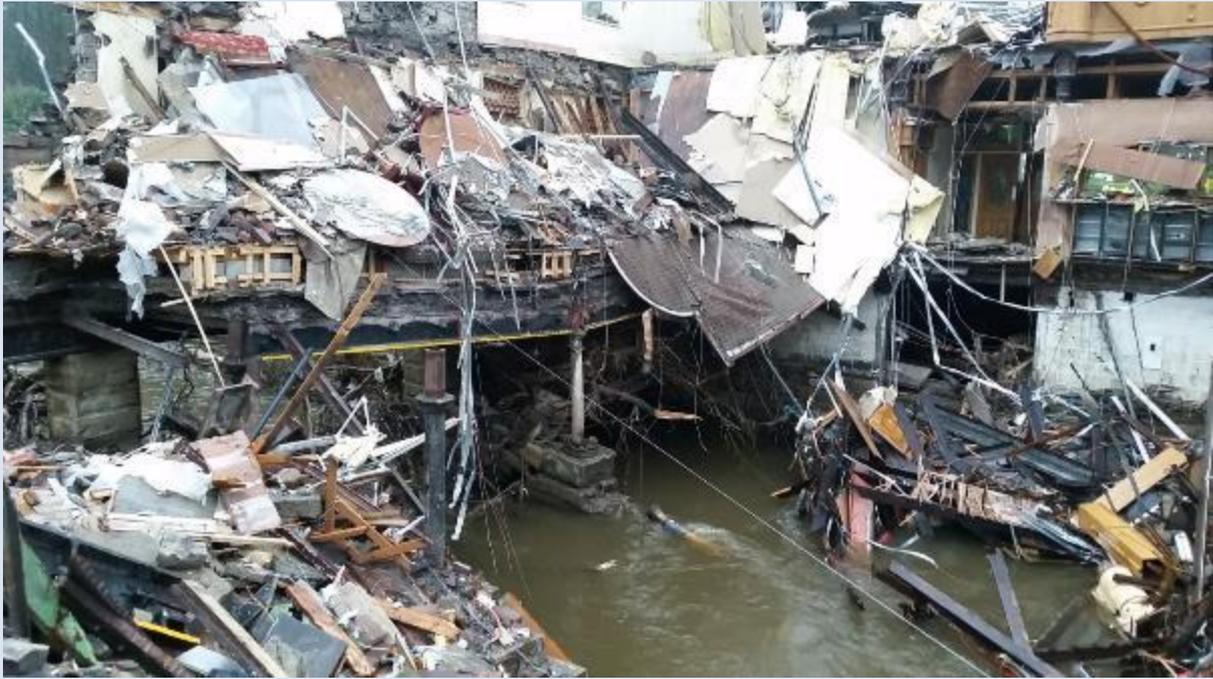
Picture 28 Debris from the collapse of the Waterside restaurant, Summerseat

Picture 29 Debris from the collapse of the Waterside restaurant, Summerseat

Picture 30 Debris from the collapse of the Waterside restaurant, Summerseat

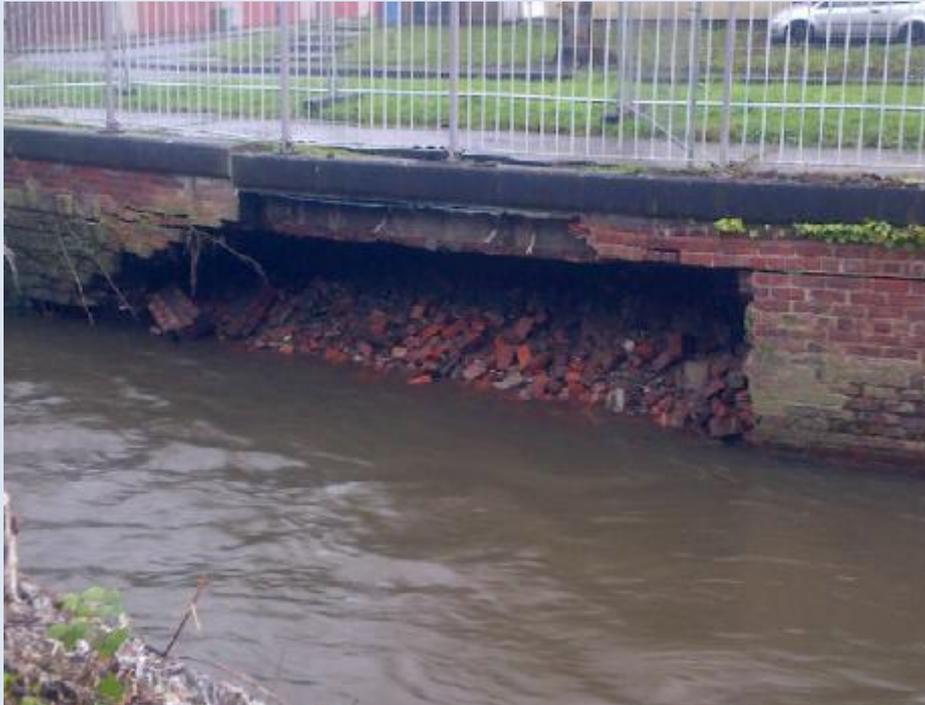
Picture 31 Damage to the footpath along the River Irk at Hendham Vale

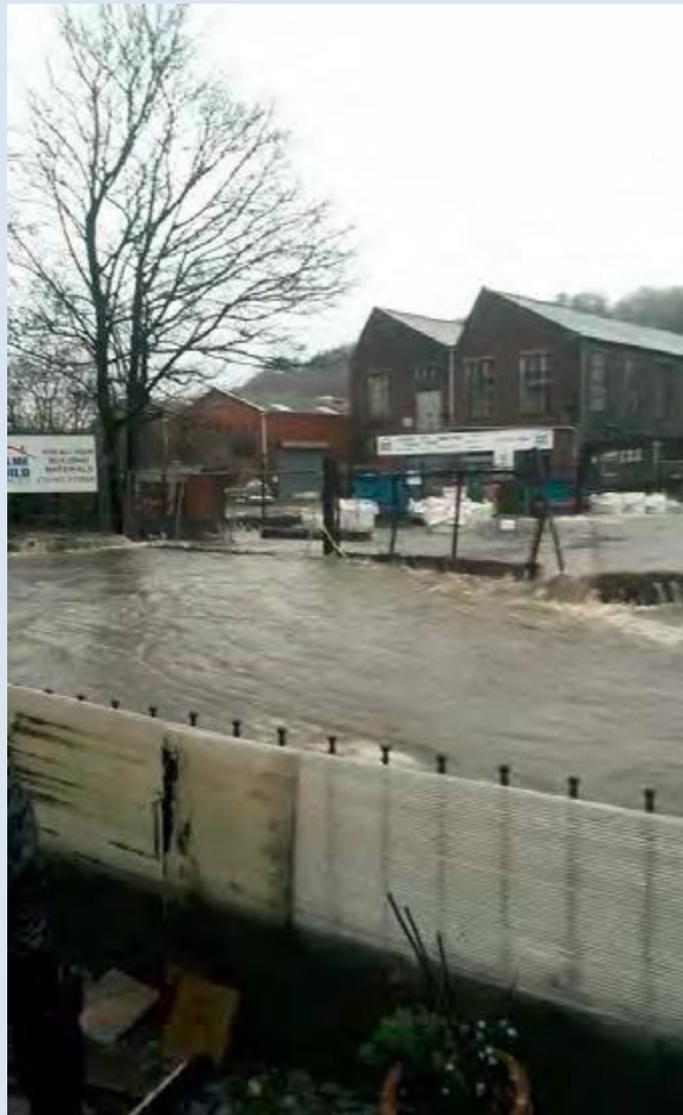
**Picture 34 Industrial units flooded from the River Tame**

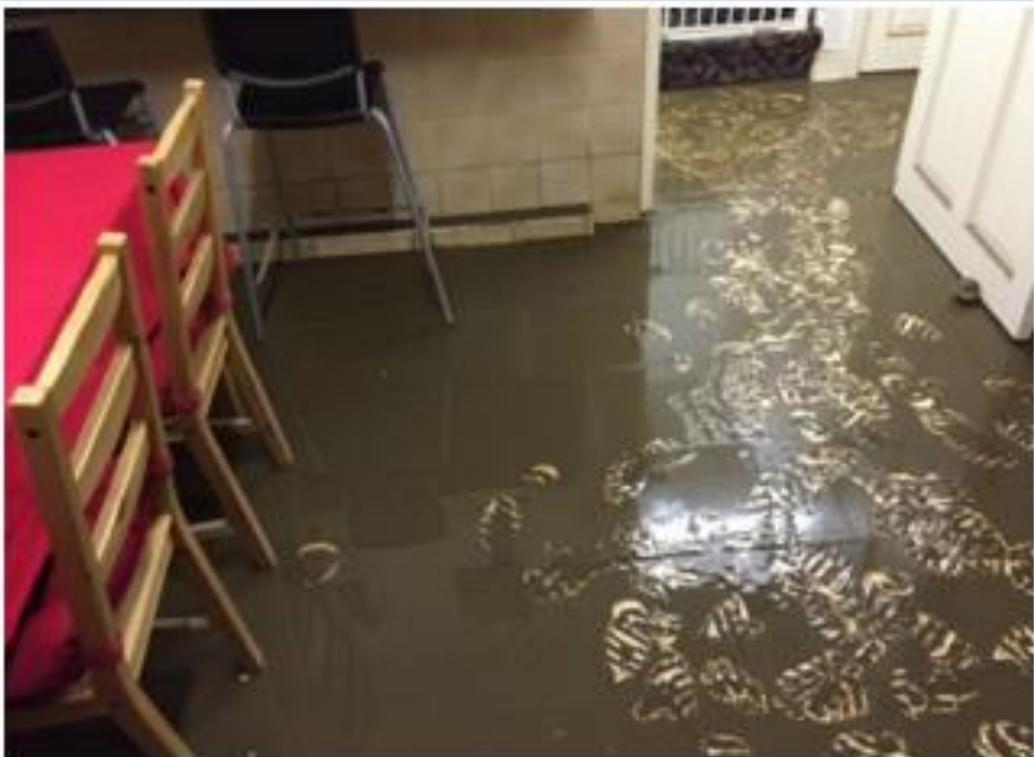
**Picture 82 Silt as a result of internal property flooding – Lower Broughton**

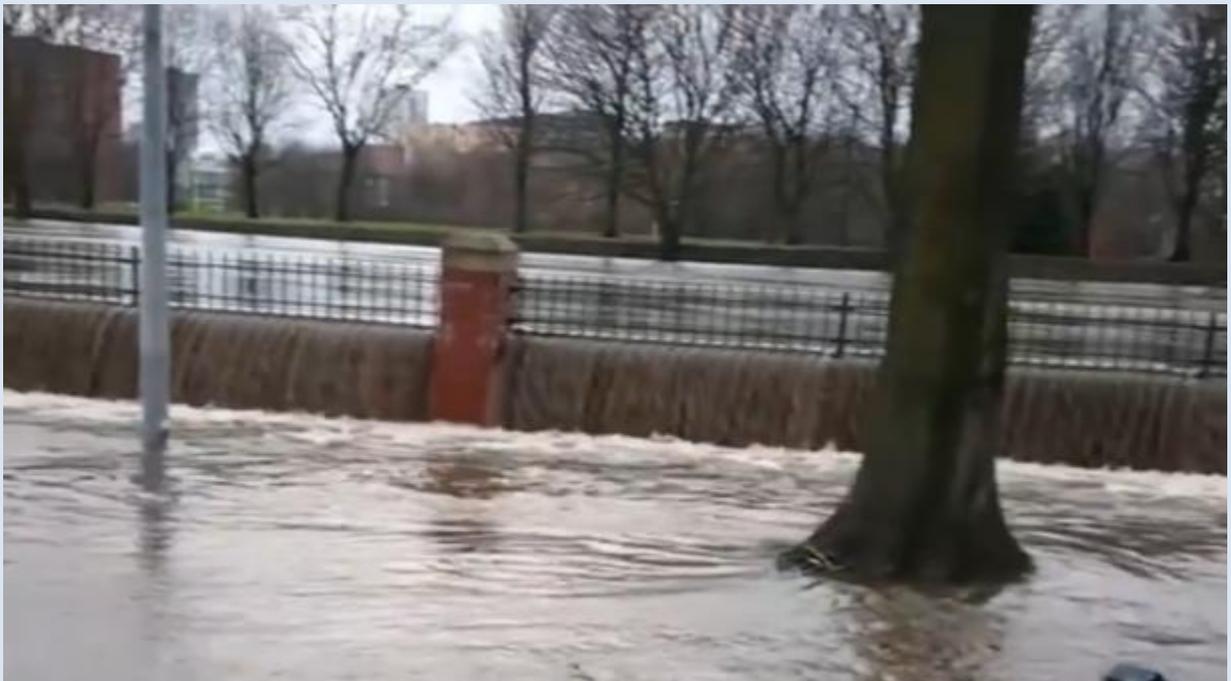
**Picture 84 River Irwell overtopping at Heath Avenue**

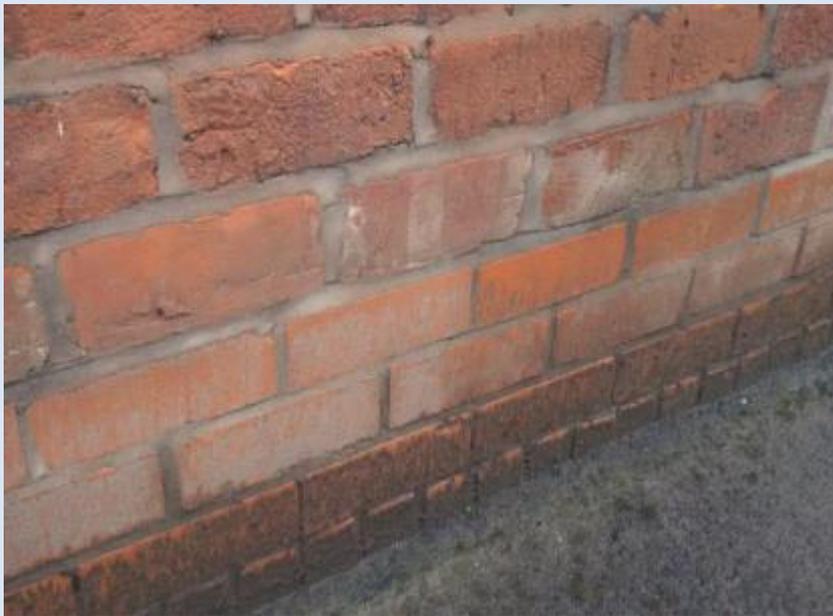
Picture 93 Water mark, Lord Street
